Siphumelele 1 Mine Rockburst Investigations

Presented by A Olivier
20 September 2017

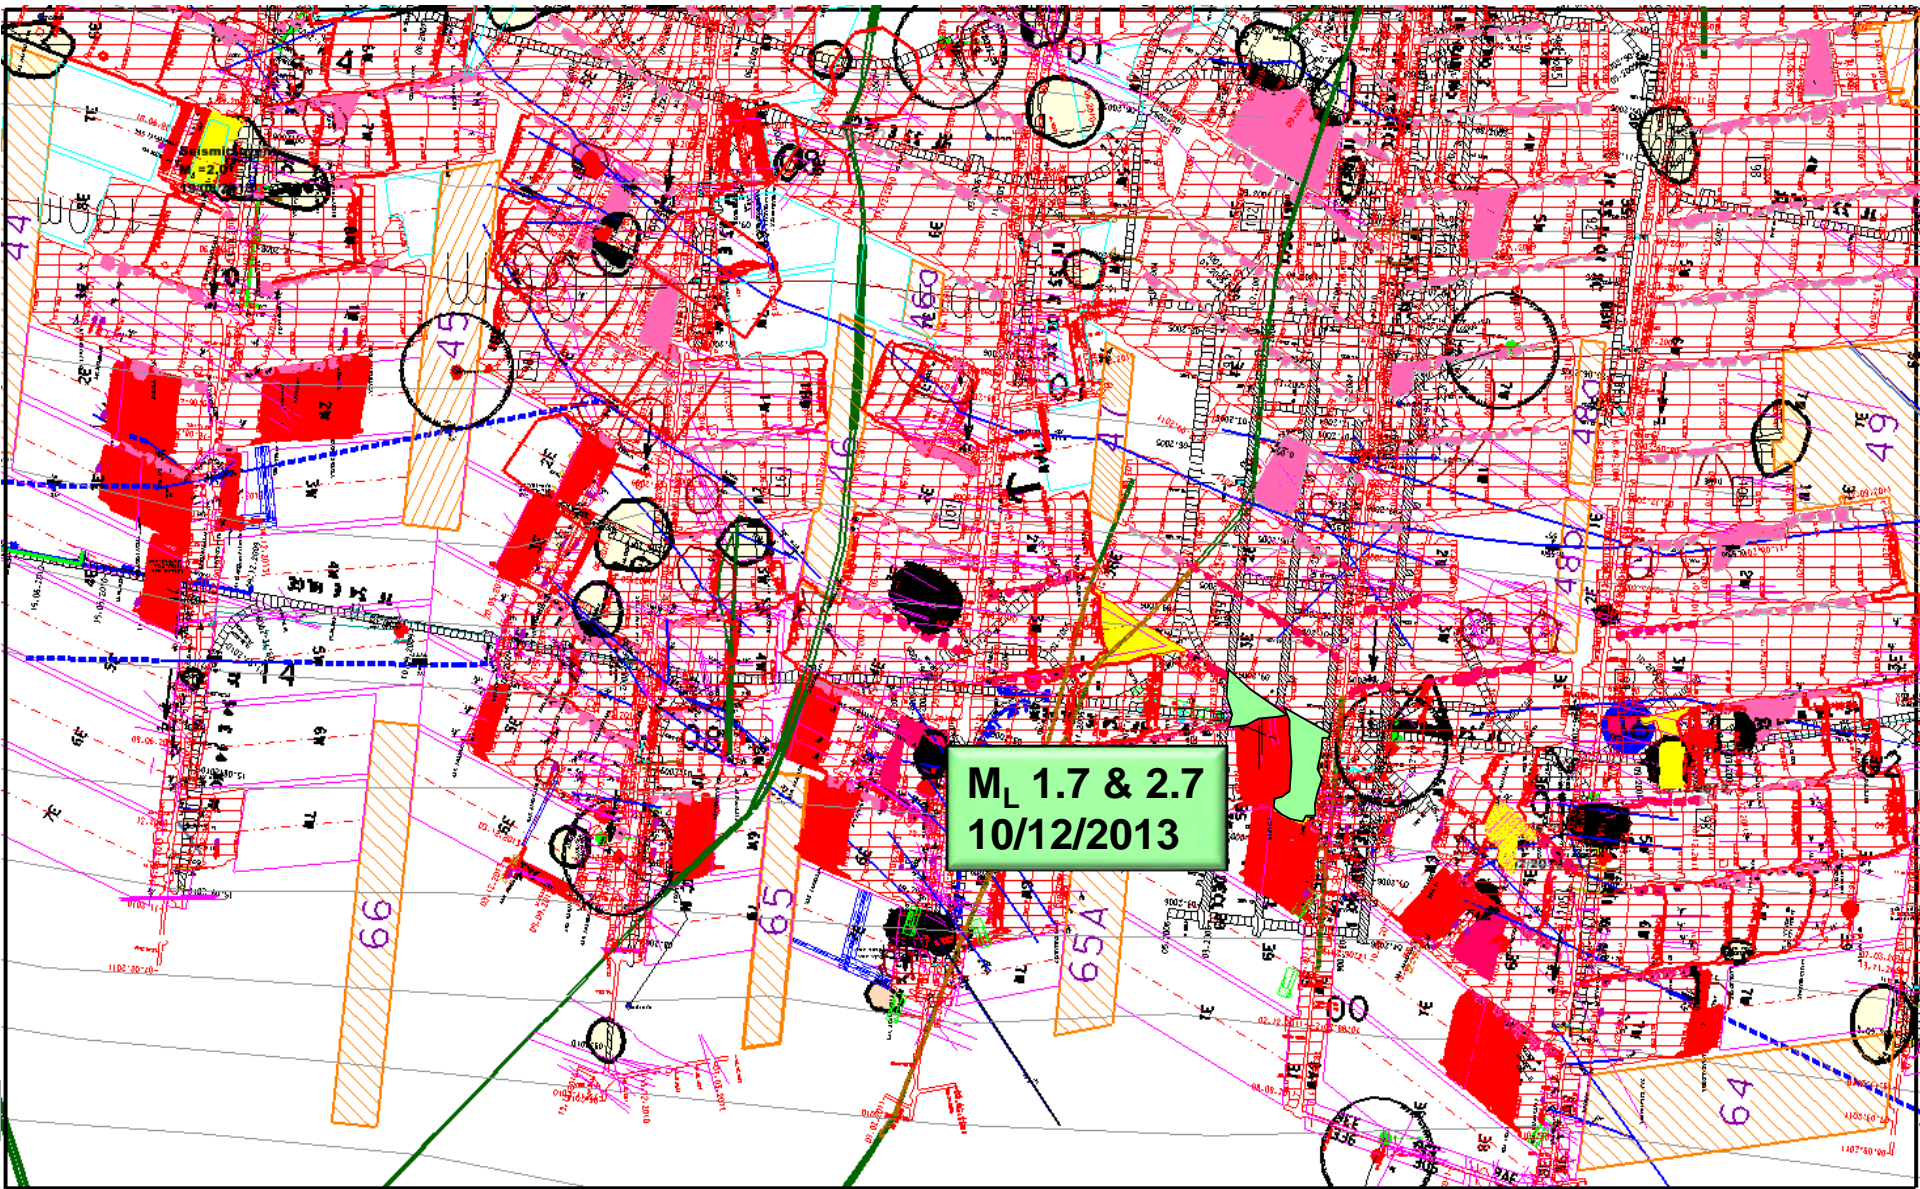
Events 10 December 2013

M_L 1.7 & 2.7
10/12/2013

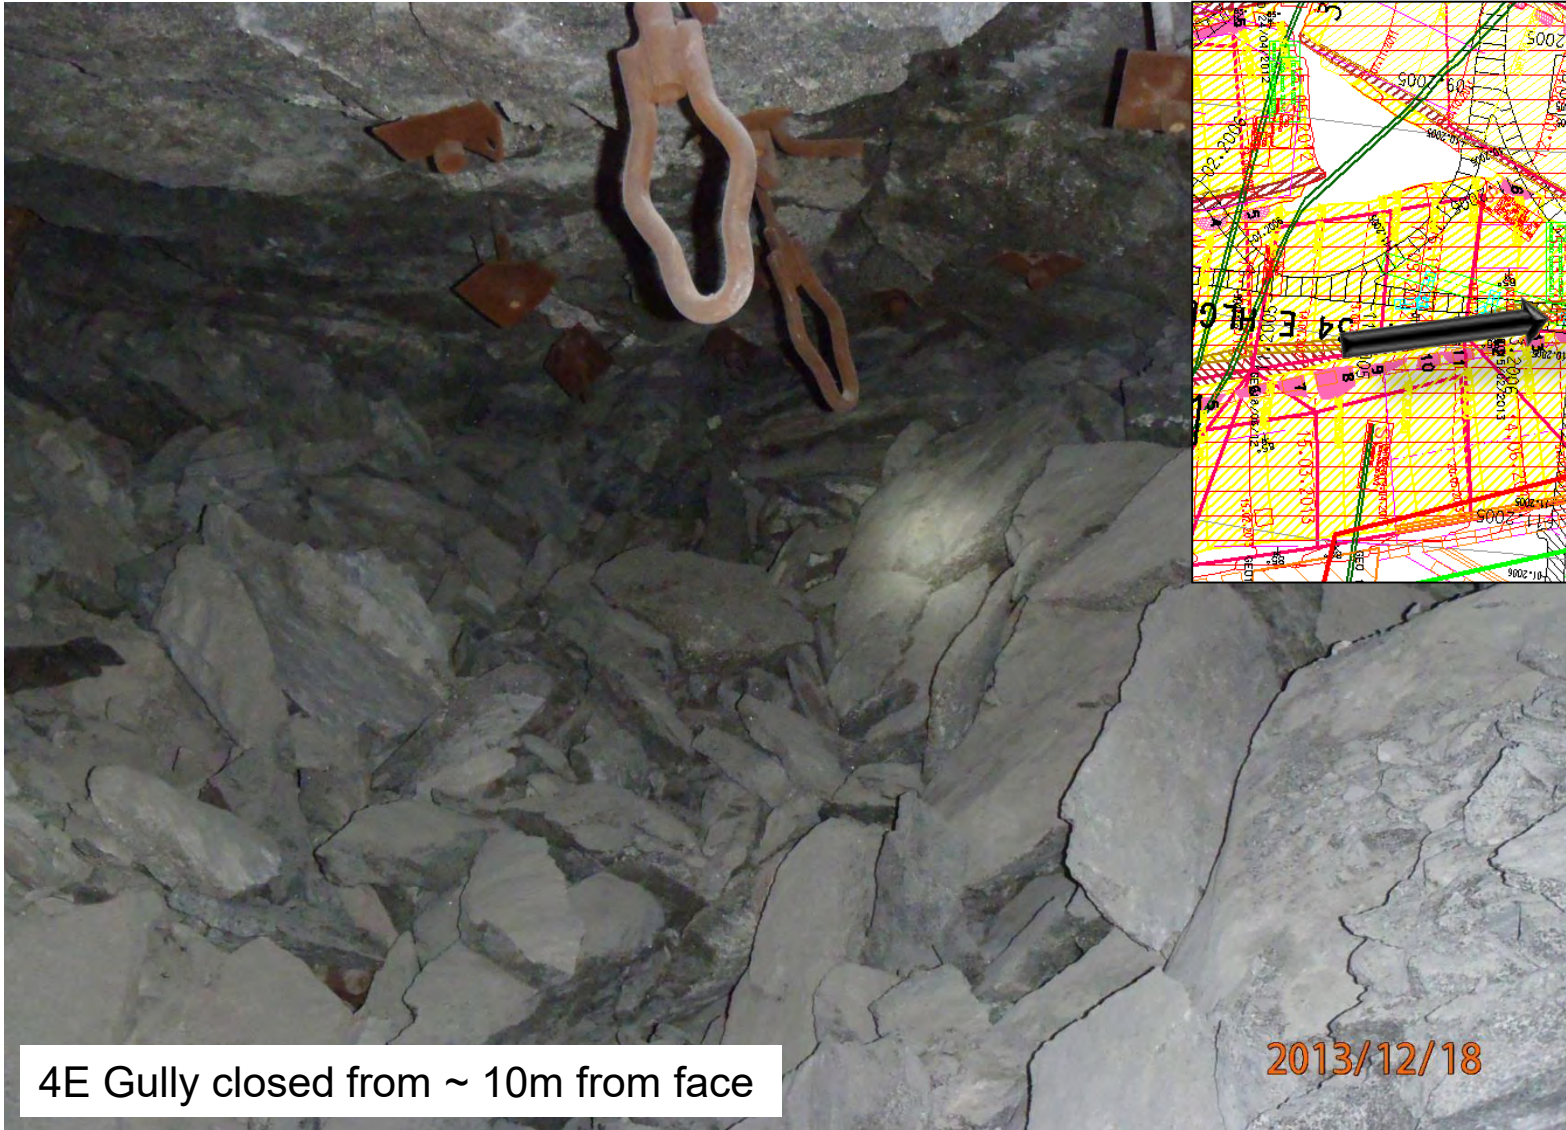
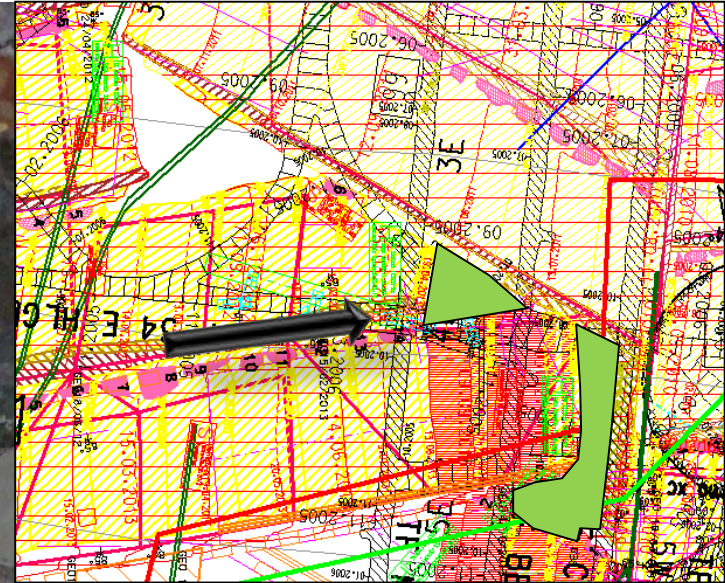
4E Gully closed from ~ 10m from face

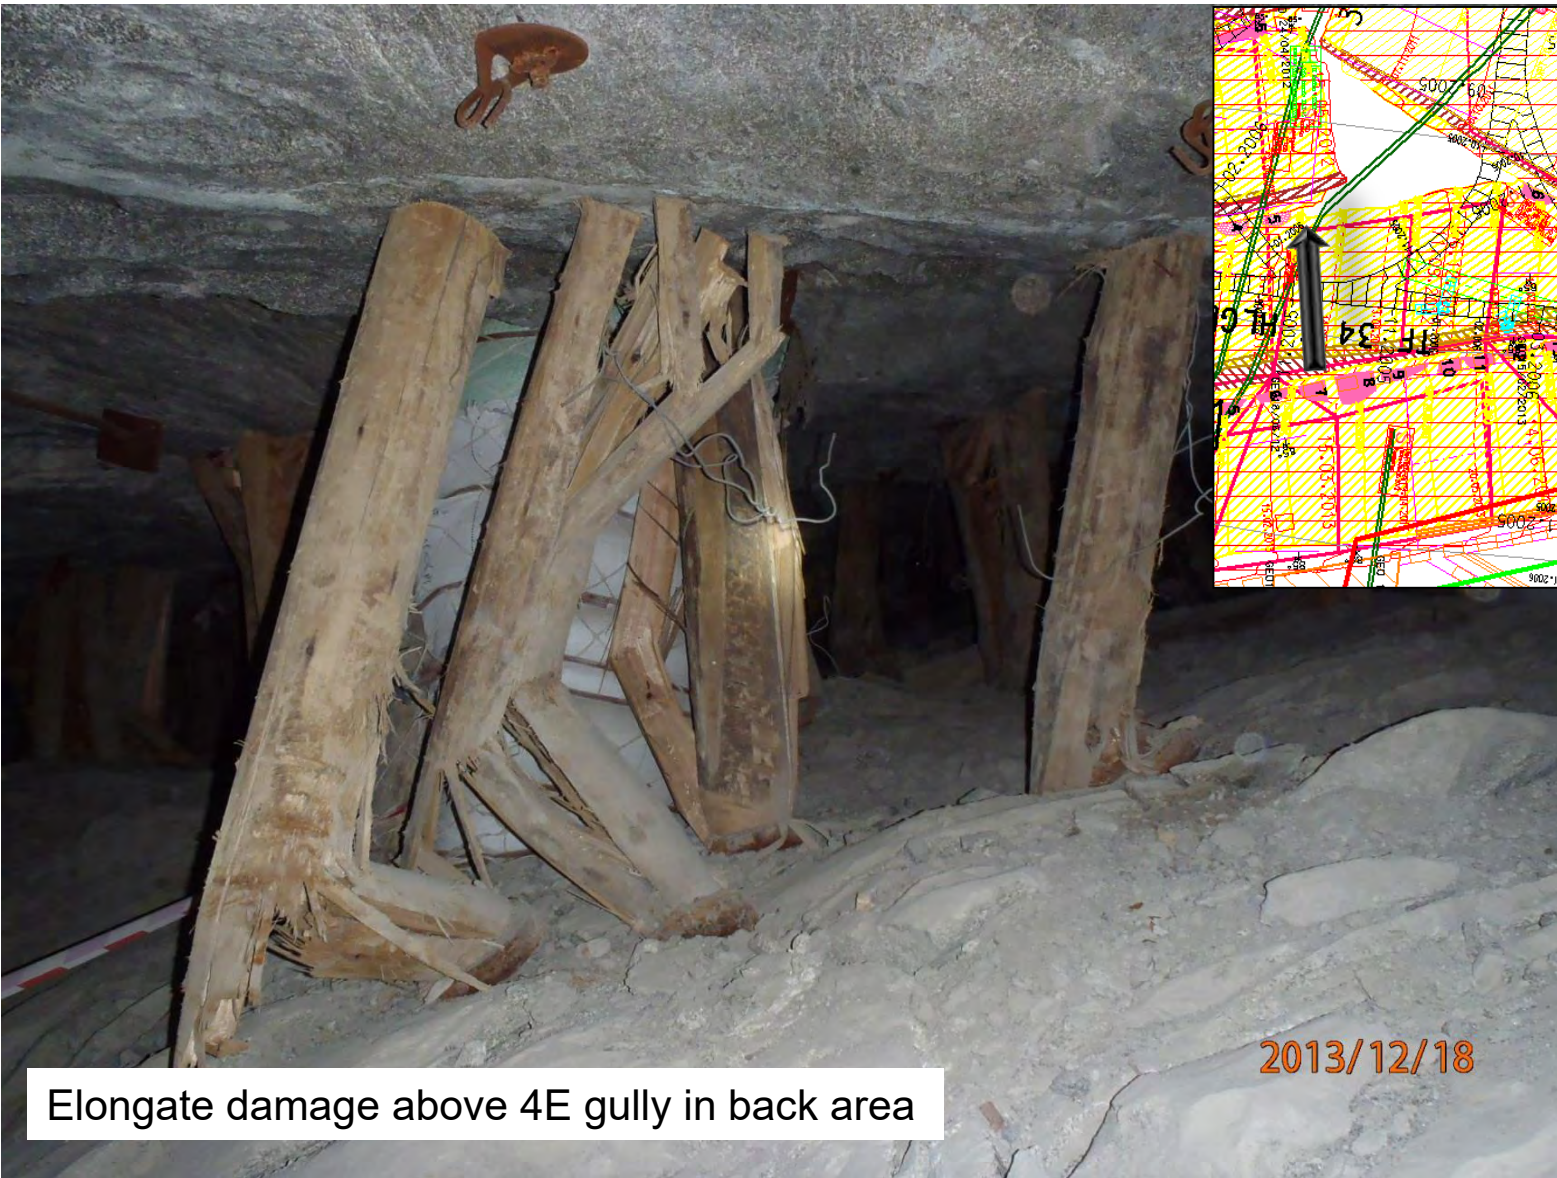
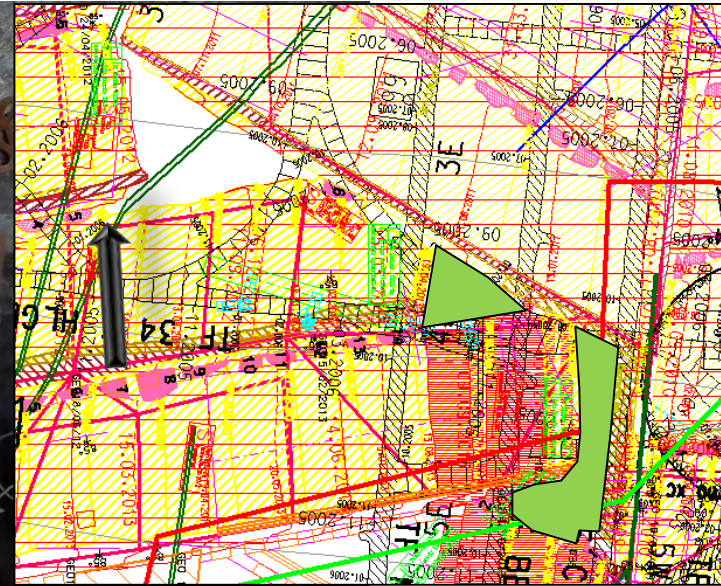
Elongate damage above 4E gully in back area

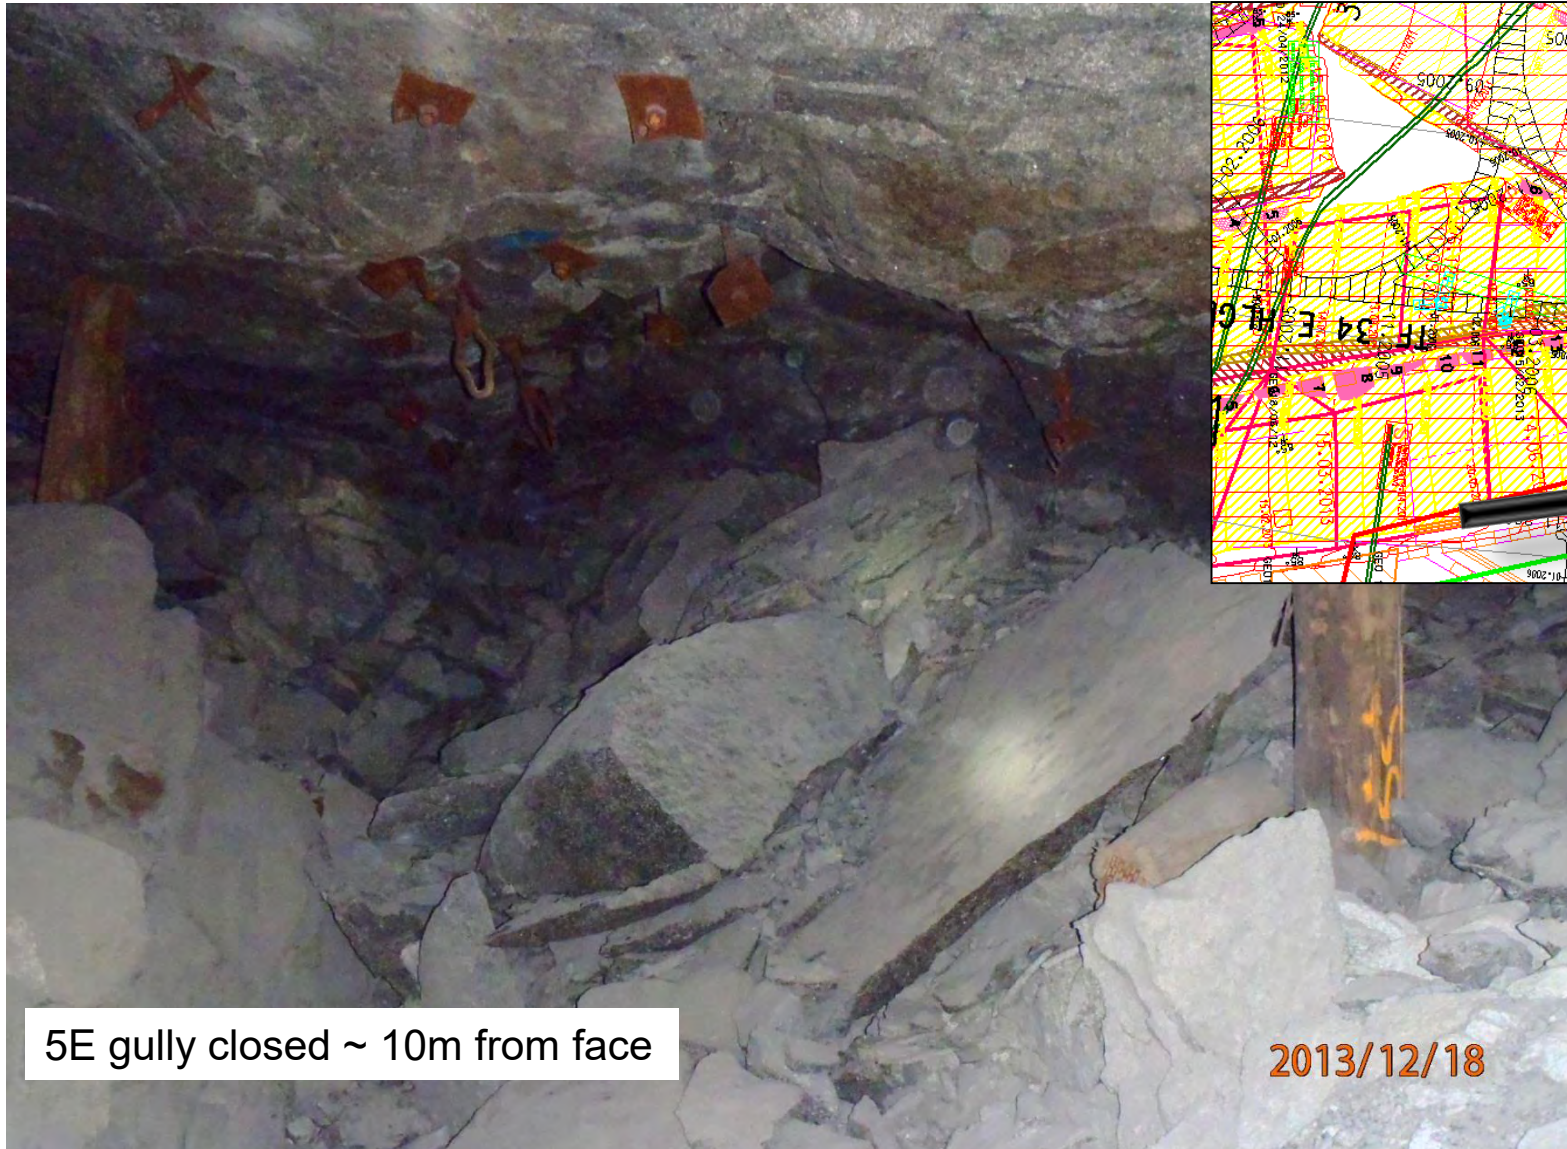
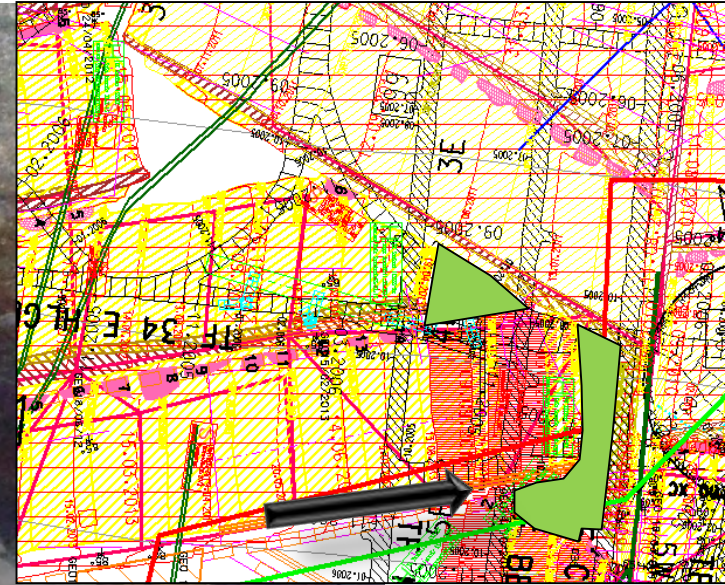
5E gully closed ~ 10m from face

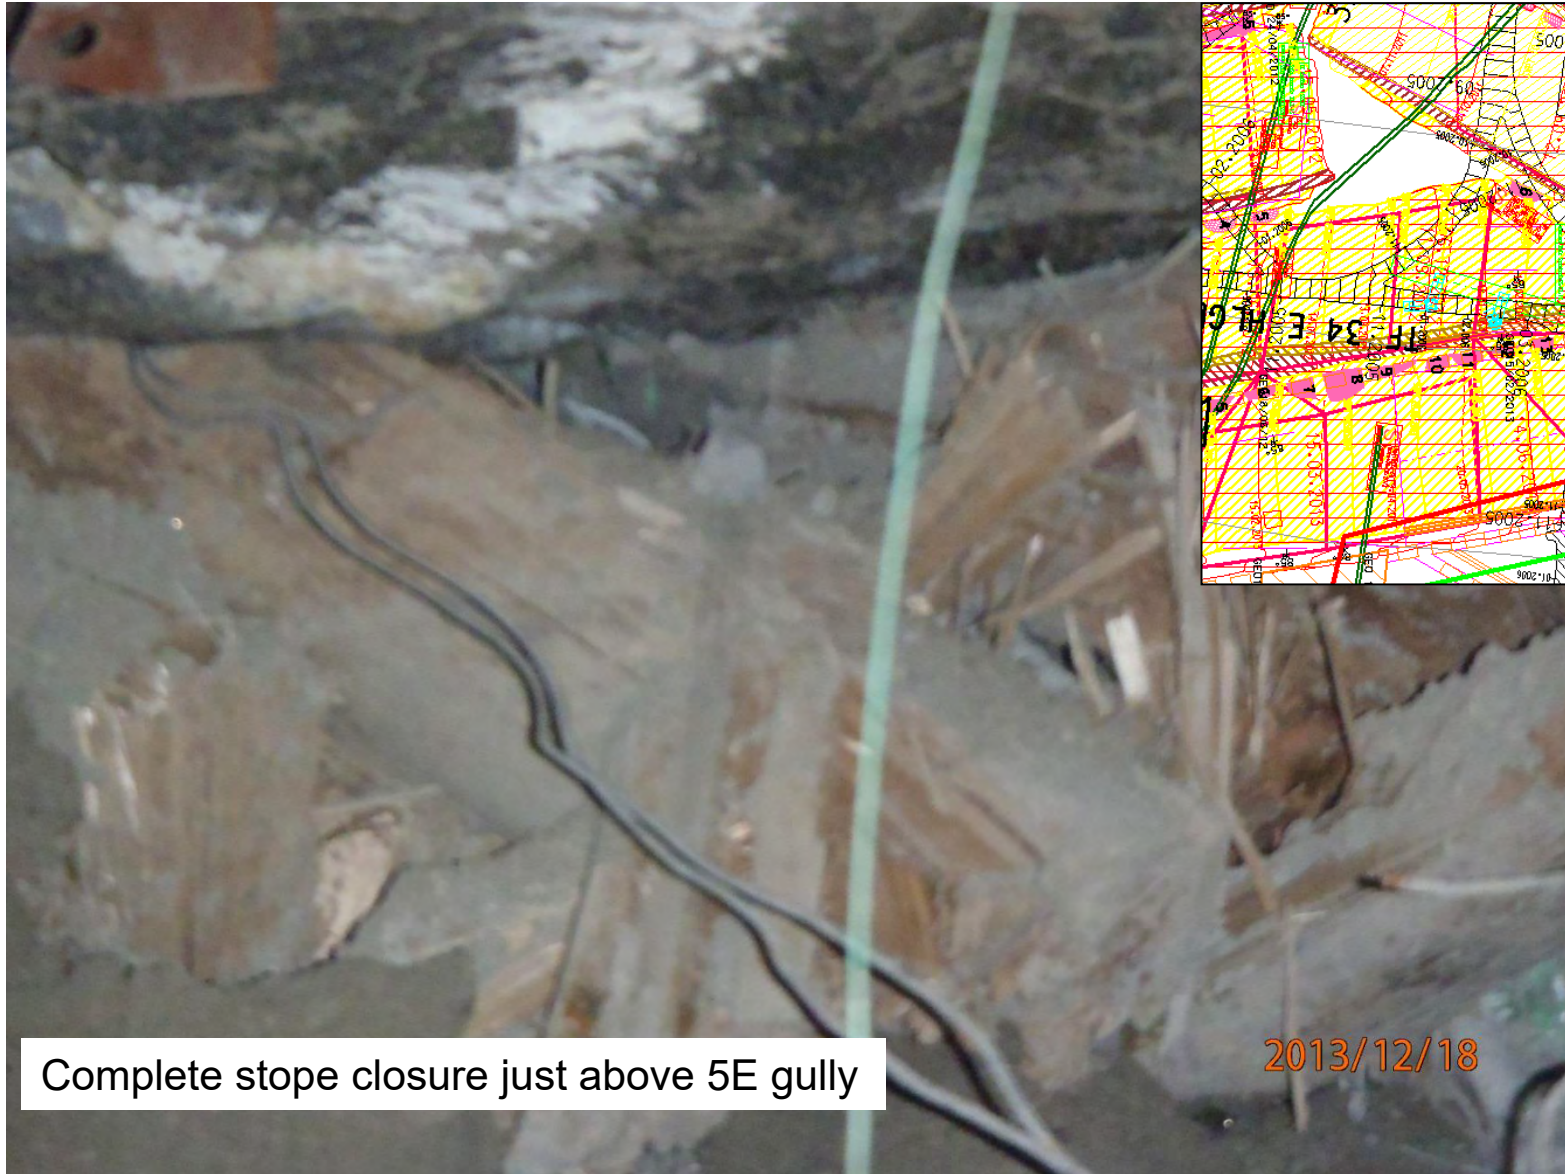
Complete stope closure just above 5E gully
