SA PGM Operations

Kwezi Shaft – Kroondal West

HPI: IOD Investigation

Date of injury: 18 June 2020

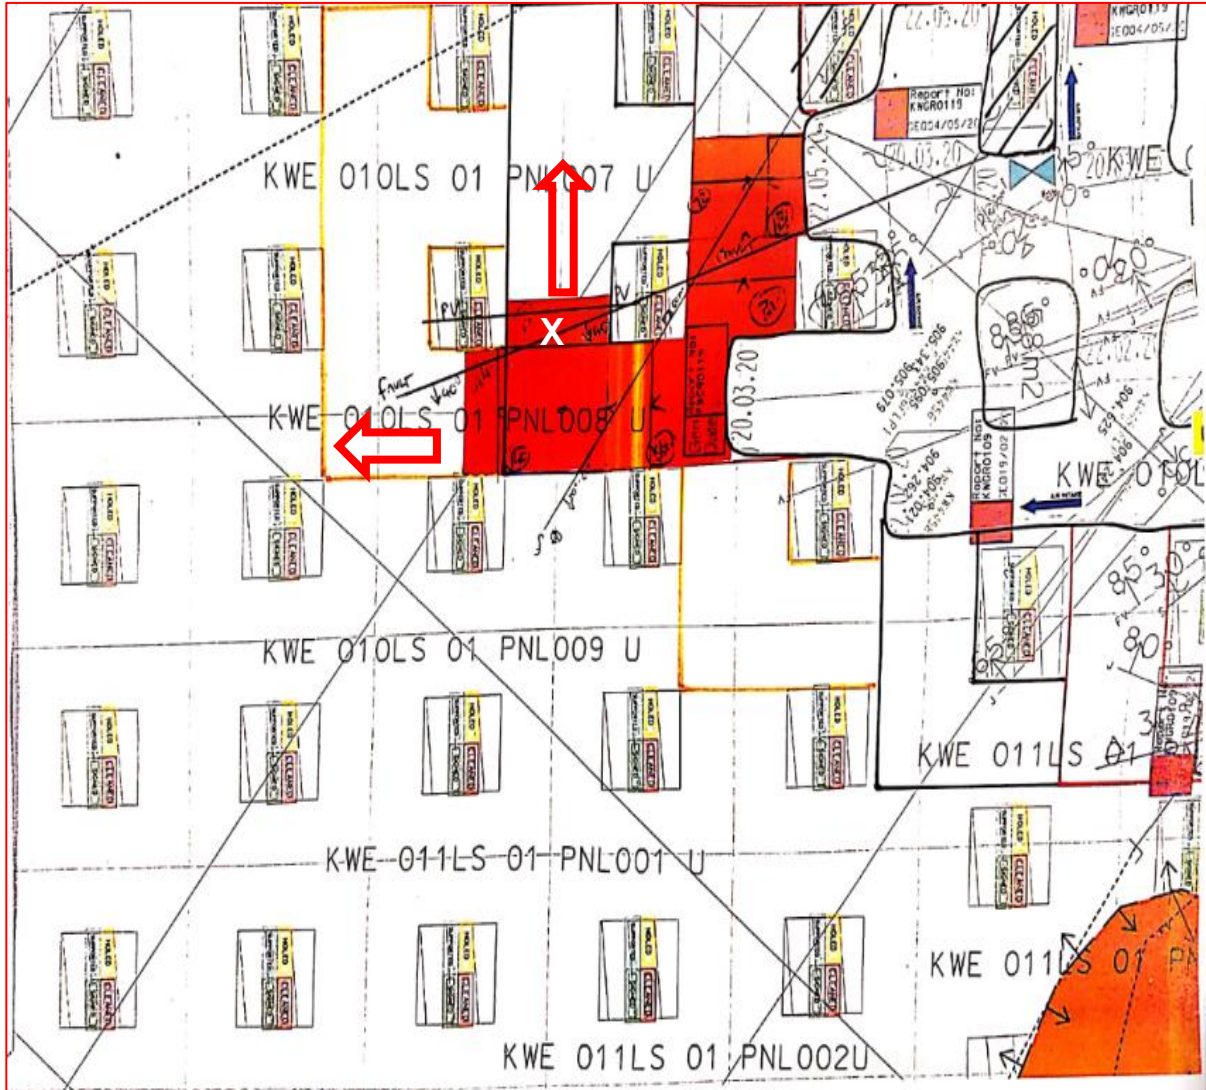
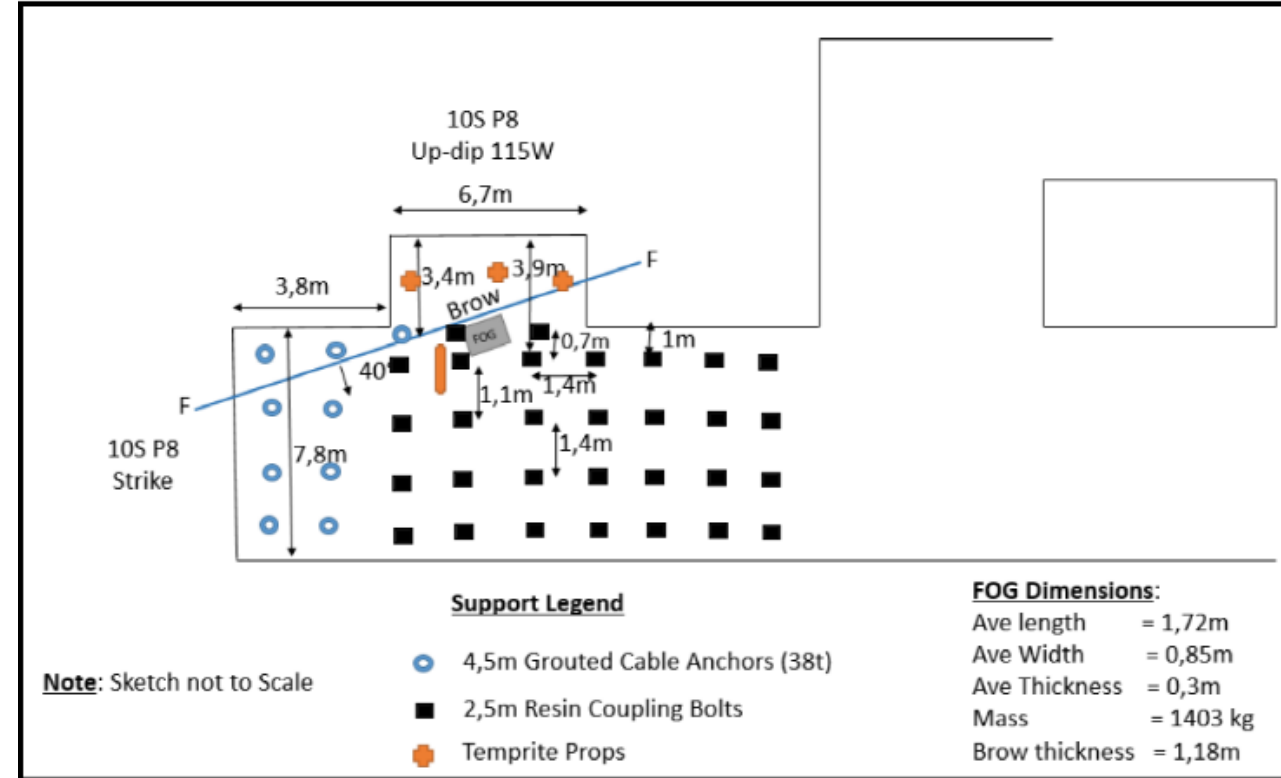
Figure 1 – Plan view of FOG accident, showing the geology and installed support

On 18 June 2020 at approximately 12:10, it was reported that a gravity induced fall of ground (FOG) occurred at 10 South Panel 8, at up-dip 115 West.

The crew was in the process of drilling 4,5m anchor support with a bolter when a FOG, measuring 1,72m x 0,85m x 0,3m, occurred from the side of the brow that was being supported (The up dip was mined from the strong side of the fault).

A brow of 1,18m was created at a flat dipping fault (40°) during the previous blast and the brow was in the process of being supported. The drilling vibrations from the bolter loosened the side of the newly created brow which resulted in the rock, weighing approximately 1403 kg, falling from the brow face. The rock struck the Team Leader, Mr Mosoale who was standing next to the bolter's boom, on his left side. He sustained multiple fractures to his left forearm and left lower leg.

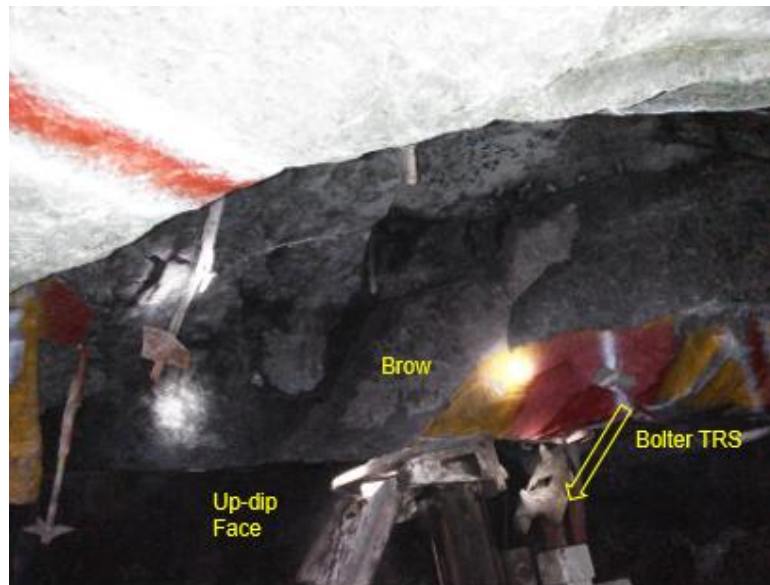
Photo taken from down-dip position looking up-dip towards the brow and up-dip panel face

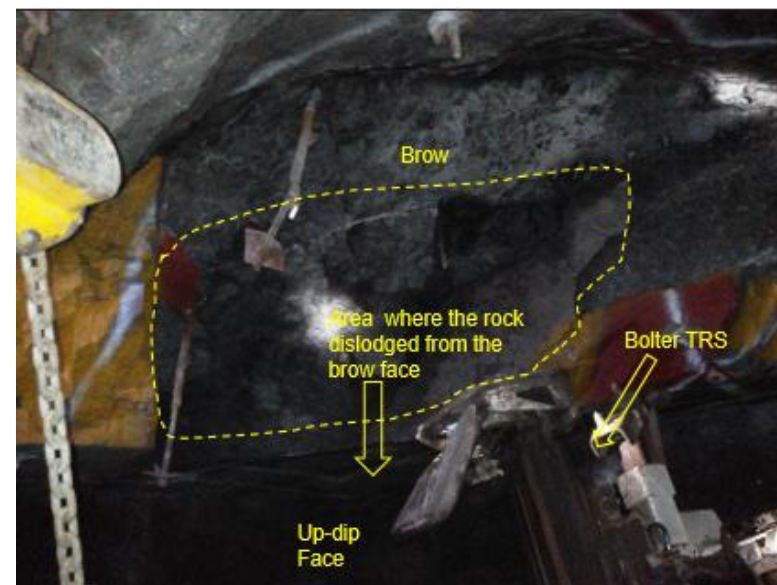
Photo taken from down-dip position showing where the rock dislodged from the brow face

- The predominant mechanism of failure is a slab that fell under the action of gravity, from the brow face.
- The loss of load (5t), supplied by the TRS when the boom was lowered, resulted in the rock to become loose from the brow face where the support hole was drilled, and toppled over causing the FOG injury.
- The main components of this failure are:
 - Brow created on the weak side of the 40° fault
 - Structure: the 40° fault
 - Drilling vibration from bolter loosened the rock, lowering the boom resulted in the rock to dislodge from brow face (load loss from TRS)

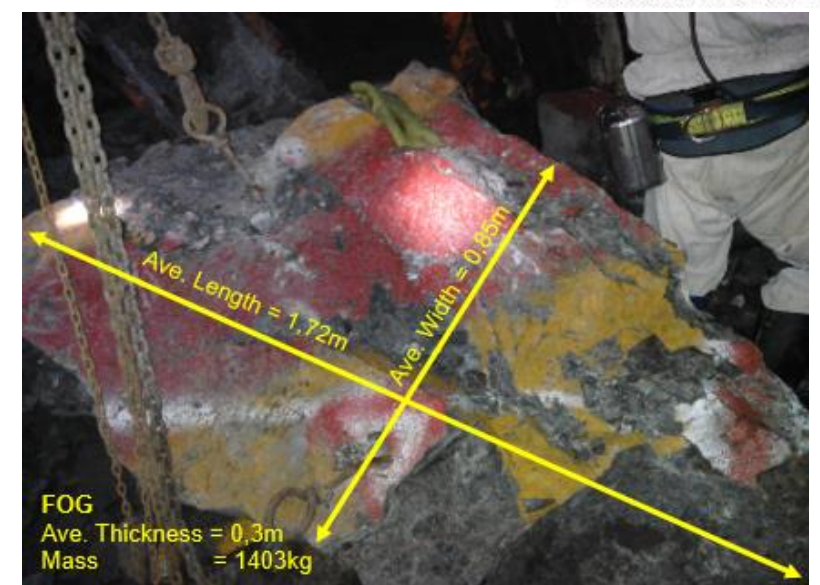
Photo taken of the FOG that struck Mr. Masoale

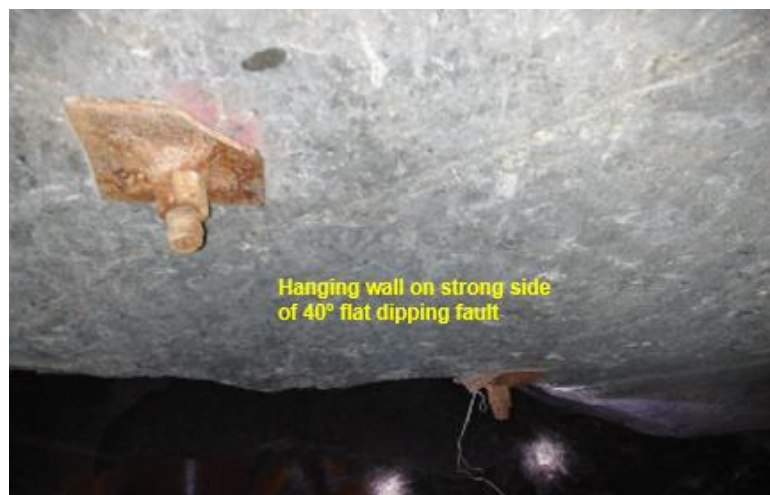
Photo taken of hanging wall & support immediately down-dip of the 40° flat dipping fault – TARP 2 conditions

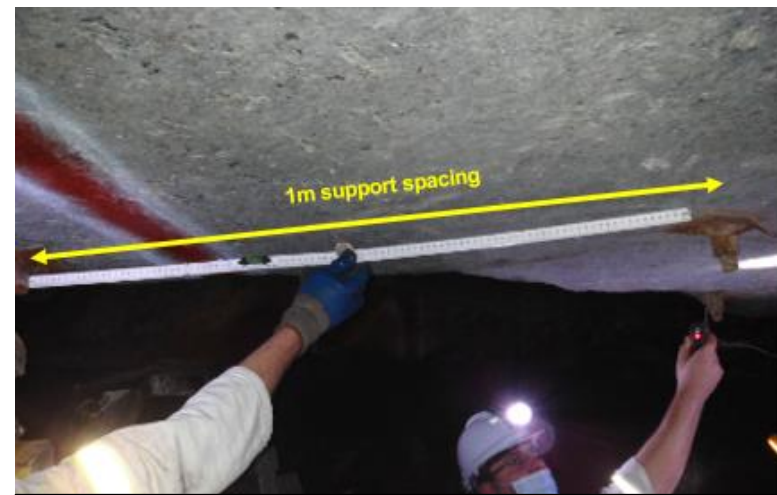
Photo taken of installed support on strong side of 40° flat dipping fault. Spaced 1m x 1,4m and better than standard
