TRIGGER ACTION RESPONSE PLAN (TARP) – FALL OF GROUND (FOG)

Kroondal

Health and safety case study

Trigger Action Response Plan (TARP) – fall of ground (FOG)

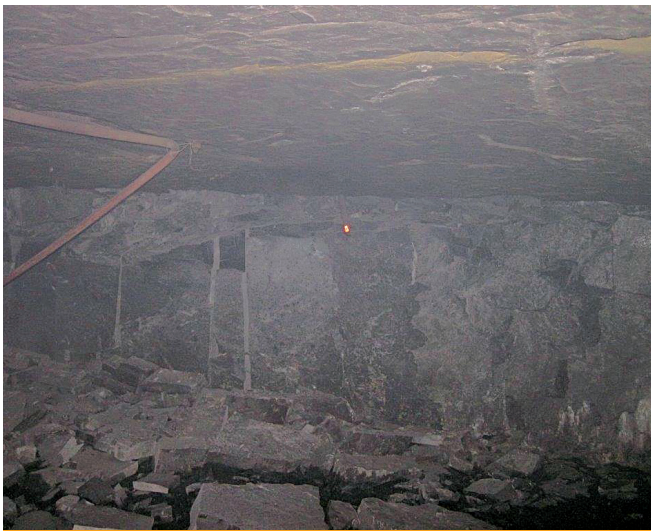
View from front at 13 West

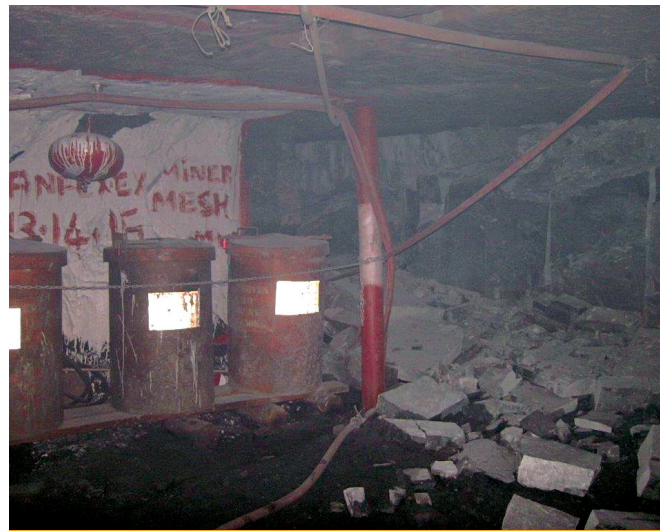
View from 13 West

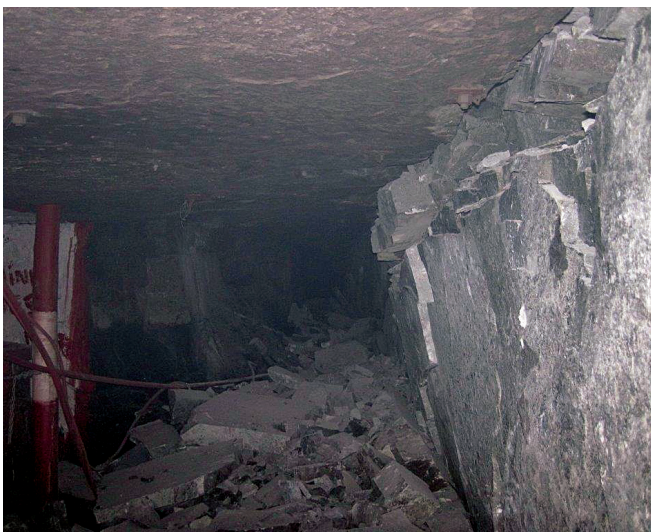
View from South along pillar from 13 West

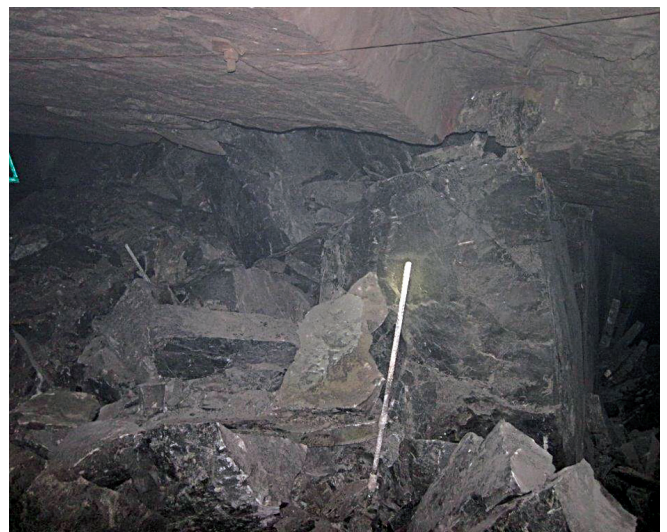
Iron rich ultramafic pegmatoid (IRUP) hanging wall conditions were intersected in the west side of the Marikana B (MKB) section and identified through the application of the mines TARP FOG process. Precautionary measures were put in place following a TARP team visit which included increased support densities and visit frequencies from the advanced Mineral Resources management department (Rock, engineering and geology) prior to the fall. The geologist conducted a routine inspection in the company of the mine manager on 15 March 2016 and identified adverse geotechnical conditions within the face area of the west panels which resulted in a TARP red trigger (horizontal parting with clay filling). No production activities were planned on the day within the affected area which was barricaded at the time of the inspection. The geologist’s findings were immediately escalated to the TARP Red Team as well as to the mine manager.

Top view from 13 West RSE 14 (Damp mud infill on hanging wall)

The mine manager issued a special instruction to stop all work on the western panels and to only work on the eastern side of the section until the TARP Red Team had issued further instructions for the western side. The mine manager conducted early entry examinations with the crew on the morning of 16 March 2016 and noted scaling and falling rocks from the pillar sidewalls at the 13 West panel. He proceeded to barricade all access points to the entire western side of the section and reported the conditions to the mine overseer who was at the waiting area at the time. **While the mining crew was working within the panels of the eastern section, an uncontrolled FOG occurred behind the barricade in panel 13 West at approximately 11:10am. All activities within the section was stopped immediately and the crew withdrew to the waiting area.** The incident was reported to all stakeholders, including nightshift employees. The MKB section crew were stopped from proceeding underground until a geotechnical investigation was conducted.
