## **1.0 FIELD LOGS – FIELD ENGINEER\_AB**

### **1.1 Platinum Mines**

#### **1.1.1 Field Log 1**

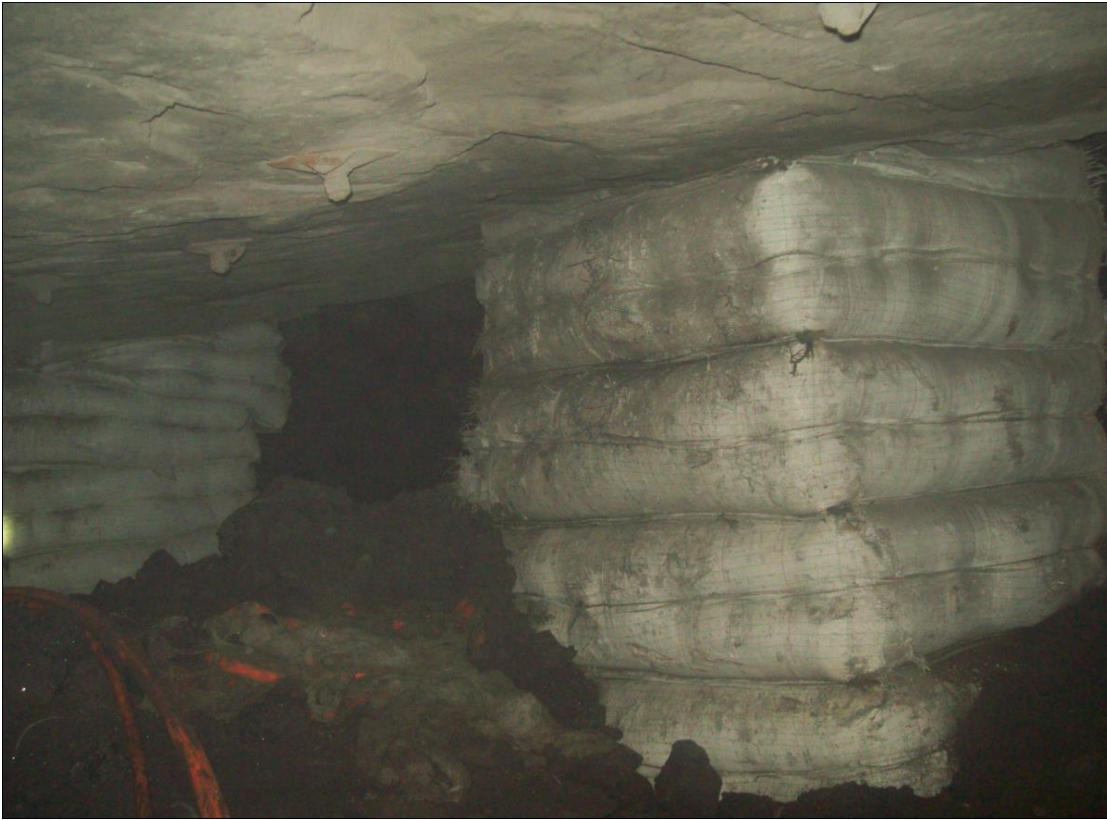
- Mining method is Hybrid (Breast Panel).
- Researchers sat and observed meeting at waiting place.
- RDOs and other crew members left early into the stope to continue with EE despite us asking to accompany them.
- When researchers got to the face, it was being drilled already.
- It is unlikely that entry exam and barring was done thoroughly. Possibly it was rushed as the crew was rushing to prepare to blast. Smooth HW also is a reason for the lack of examination, sounding and barring.

*Figure 1: Smooth HW conditions*

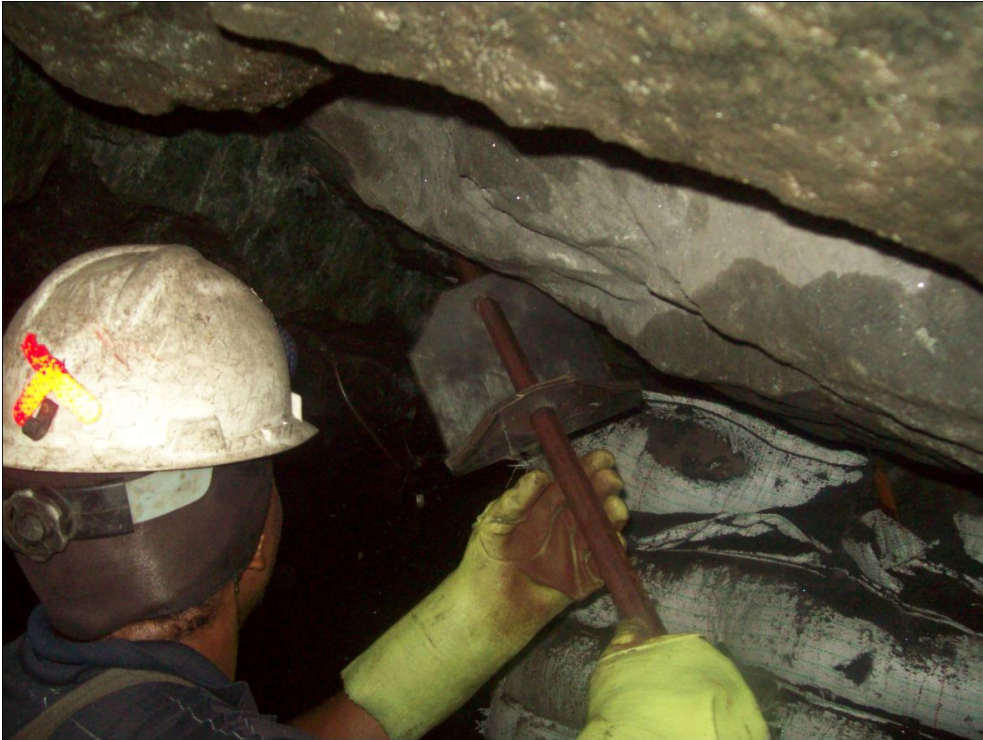
- Another concern is that even by visual examination, researchers could identify areas that could be barred that had been missed. These areas were highlighted.
- The final concern is the positioning of the gaskets. Pictures were taken to illustrate the problem. Sometimes the pinch bar is not held where the gasket is placed (hands are not placed behind gaskets).

*Figure 2: Barrer's hands not positioned behind/ in gasket*

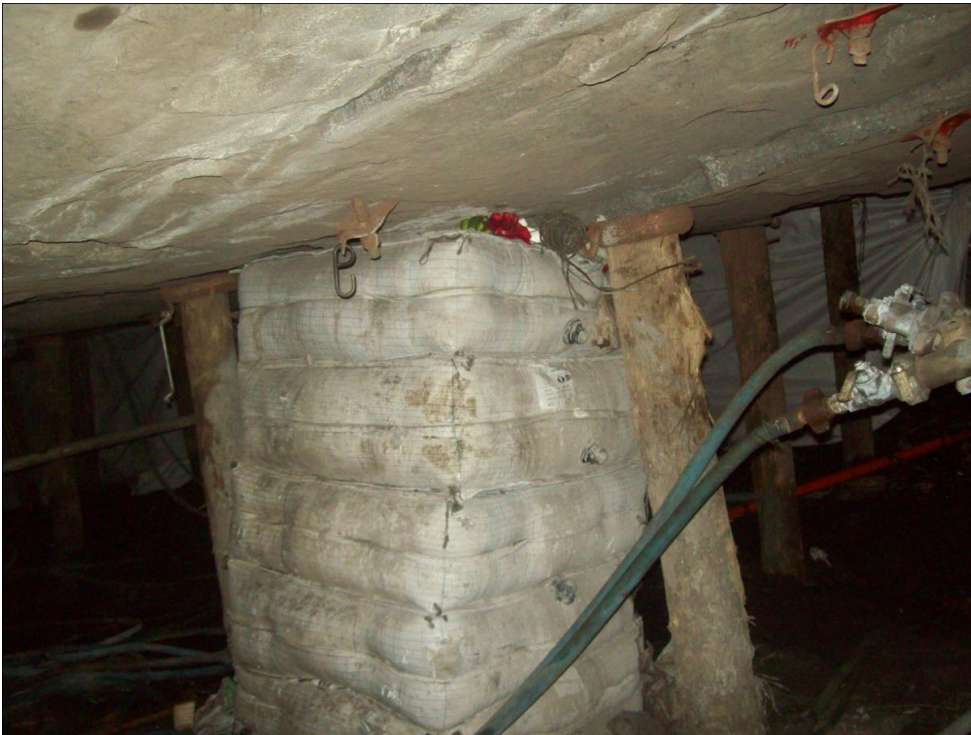
*Figure 4: Good HW condition in training centre*

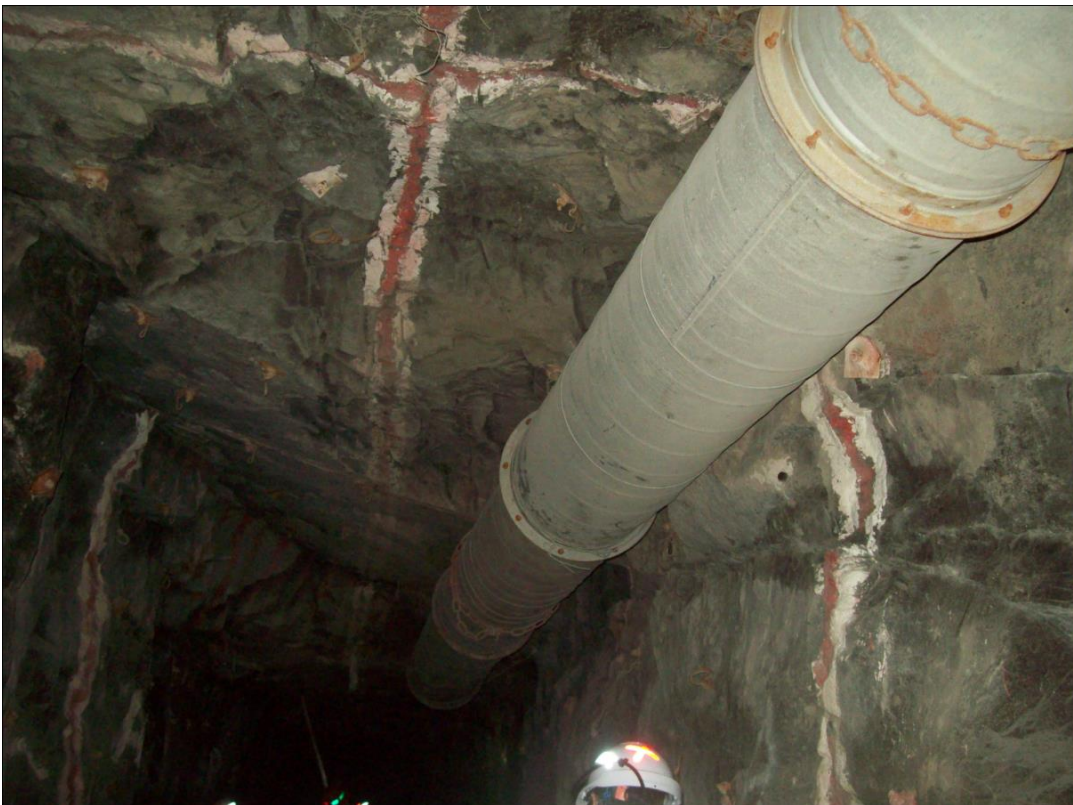
- Accompanied by SCO.
- Very basic EE was observed. Only sounding of HW occurred. No rocks were actually barred down. Not much attention was being paid to hearing the sound when sounding.

Figure 5: Condition of XC

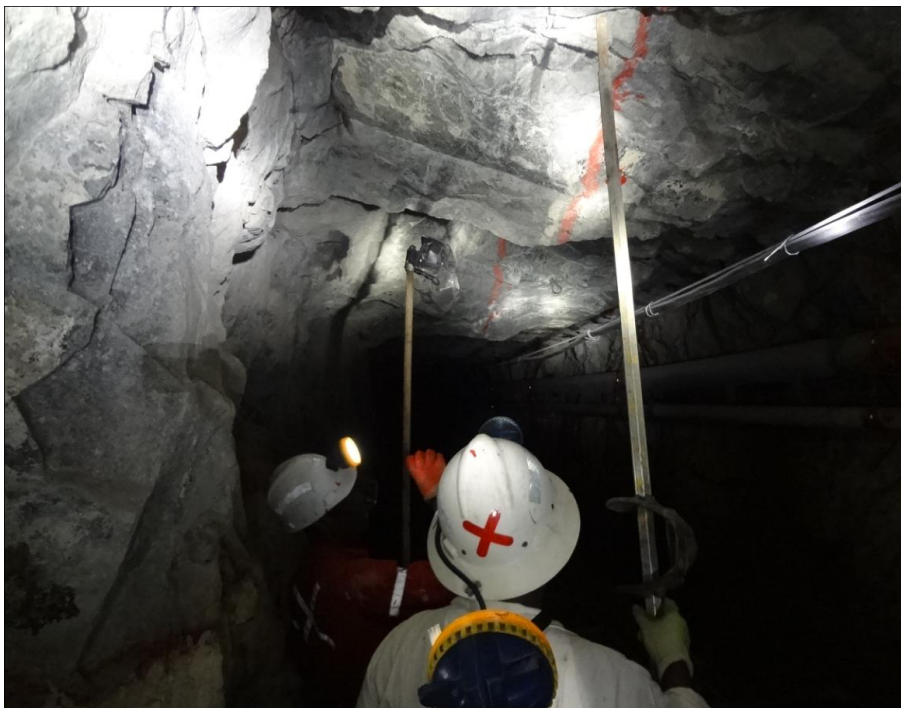
Figure 7: XC Sidewall and HW condition

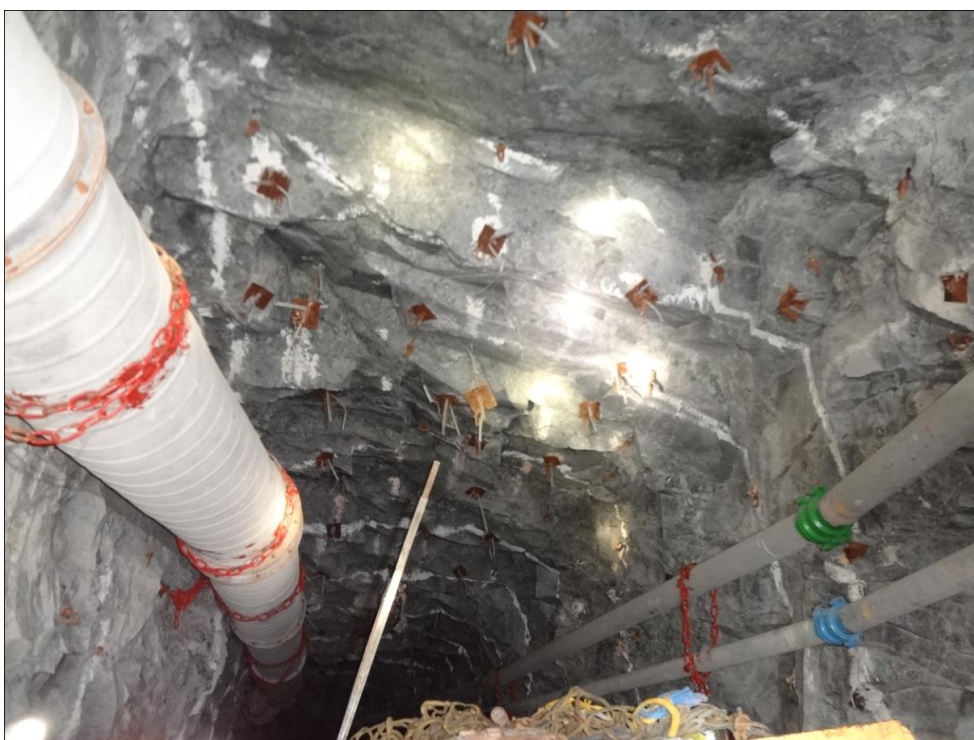
Figure 8: Support density due to faults and dykes

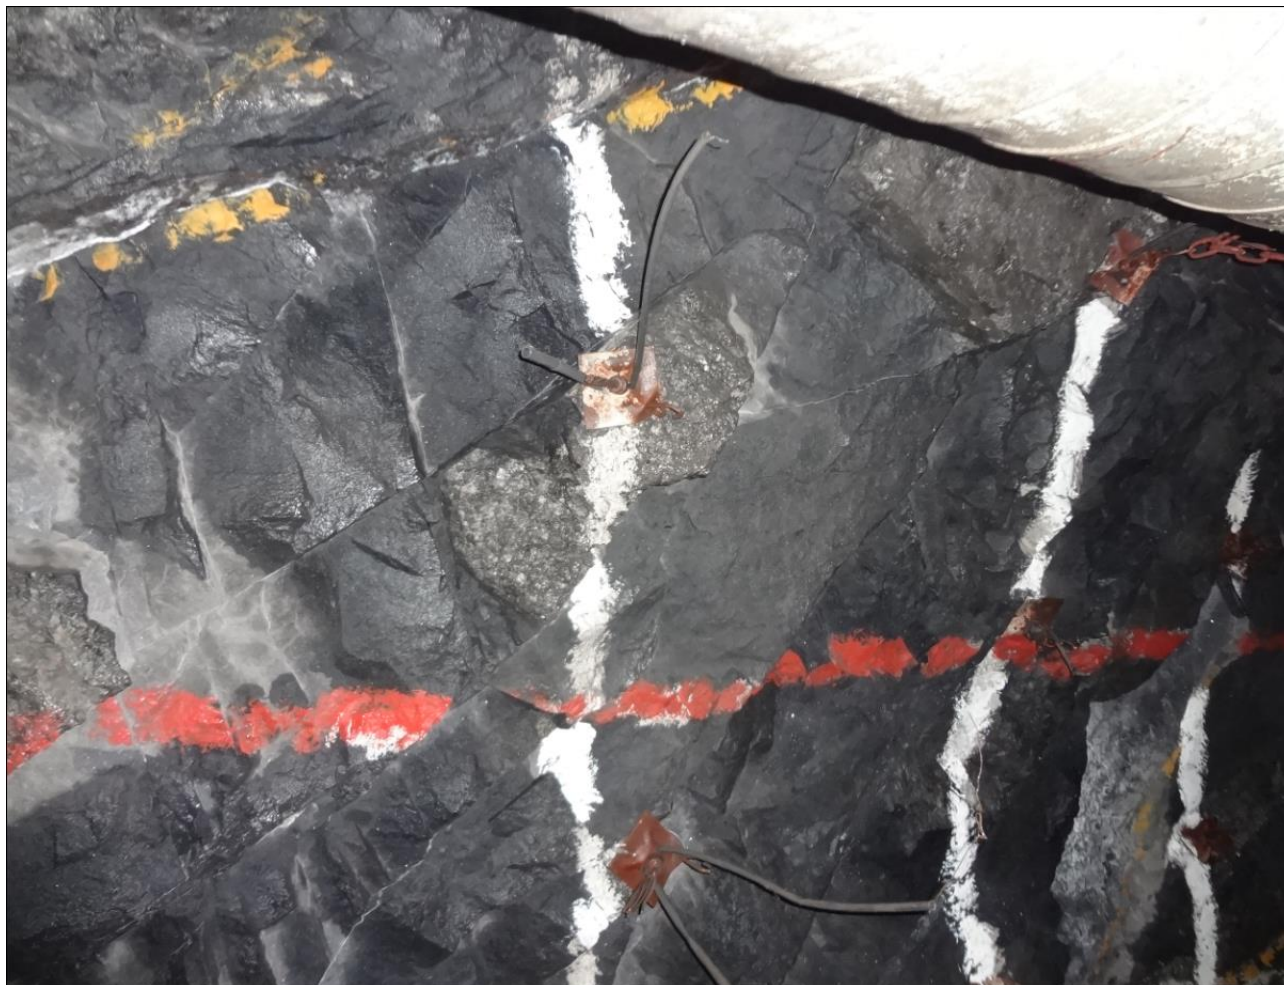
*Figure 9: Jointing in Sidewall of Pyroxenite*

- Ground condition has deteriorated close to the Reef intersection but support is installed to standard – TC's 1m apart.
- Early entry examination and barring was done thoroughly and to standard. Once or twice, the individual forgot to place his hand behind the gasket. He was reminded of this.
- Sidewalls were barred.
- Watering down and testing /sounding was done thoroughly.
- Safe declaration book was signed after completion.
- Team supervisor talked and encouraged and reminded people about what to do (Comp A by miner appointed).
- One 1.8m long steel pinch bar had a bent tip and was old.
- Production personnel advised of a preferred orange gaskets that looks like a glove almost.
- 5m remote release slings were available at the working place store as well as plenty 3m aluminium pinch bars.
- Faults and other geological features were clearly demarcated (with yellow paint).

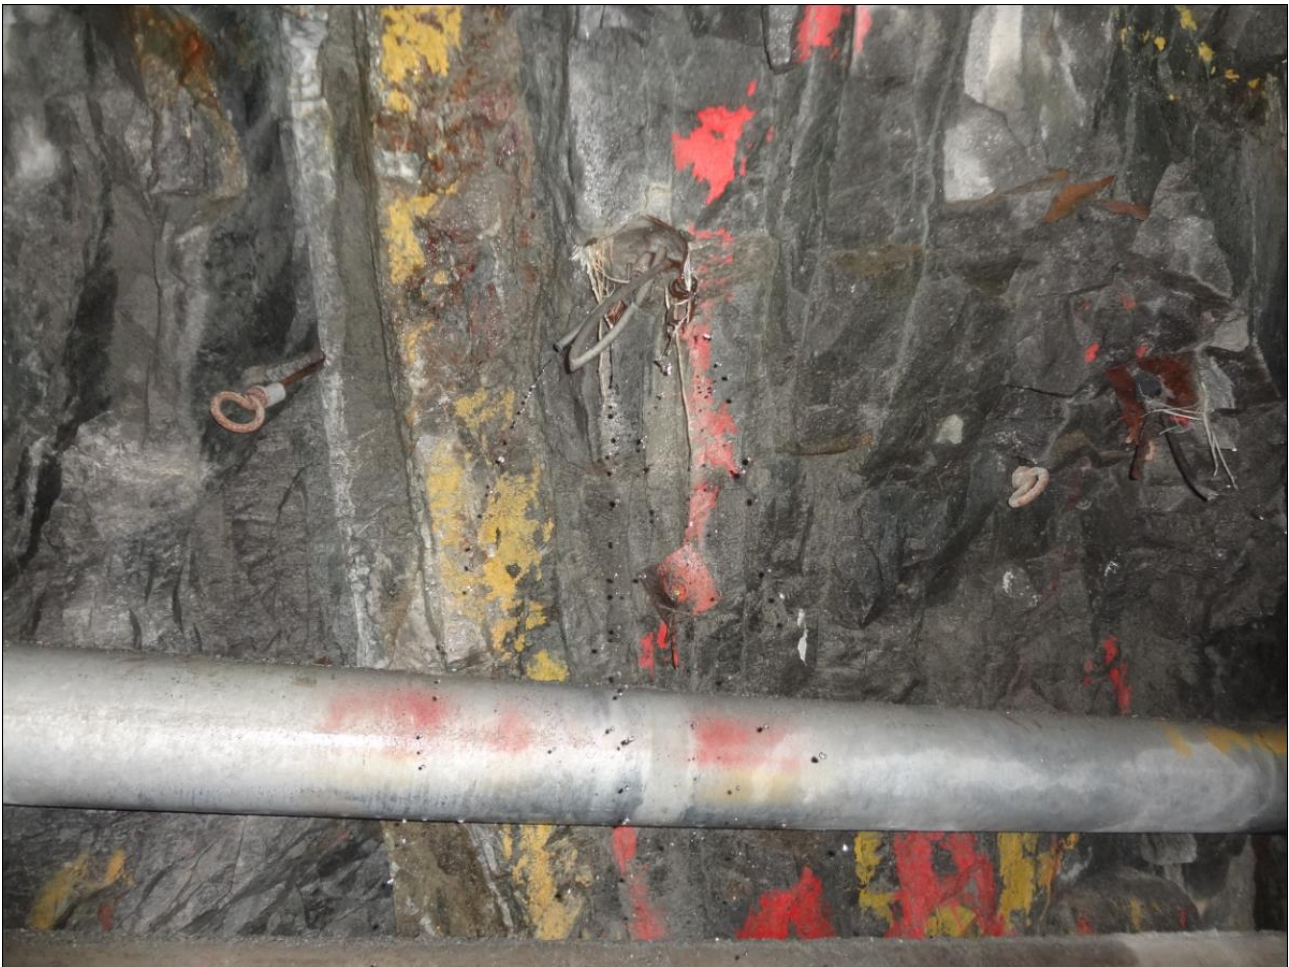
*Figure 10: Fault demarcation - Note the fissure flow through anchor - not grouted well*

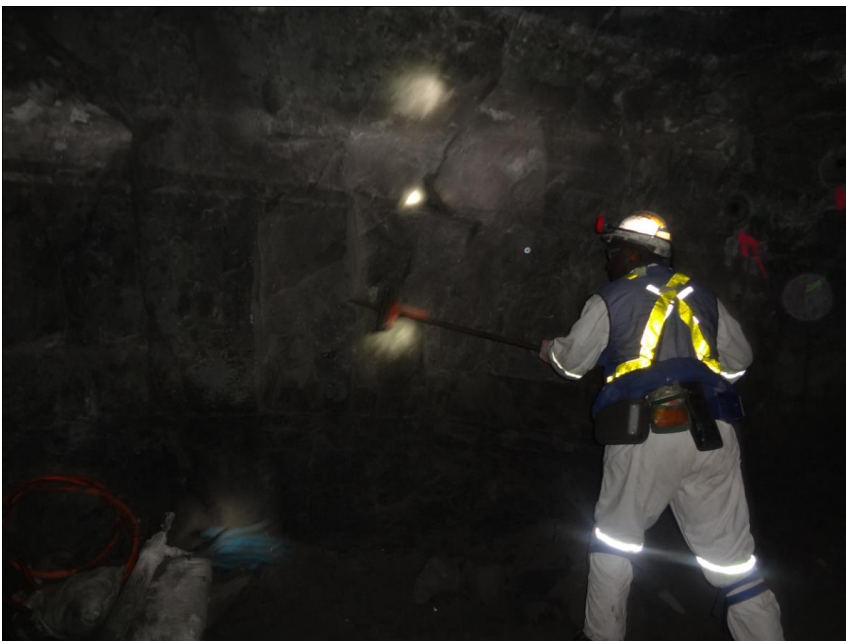
*Figure 11: Barring of pillar sides*

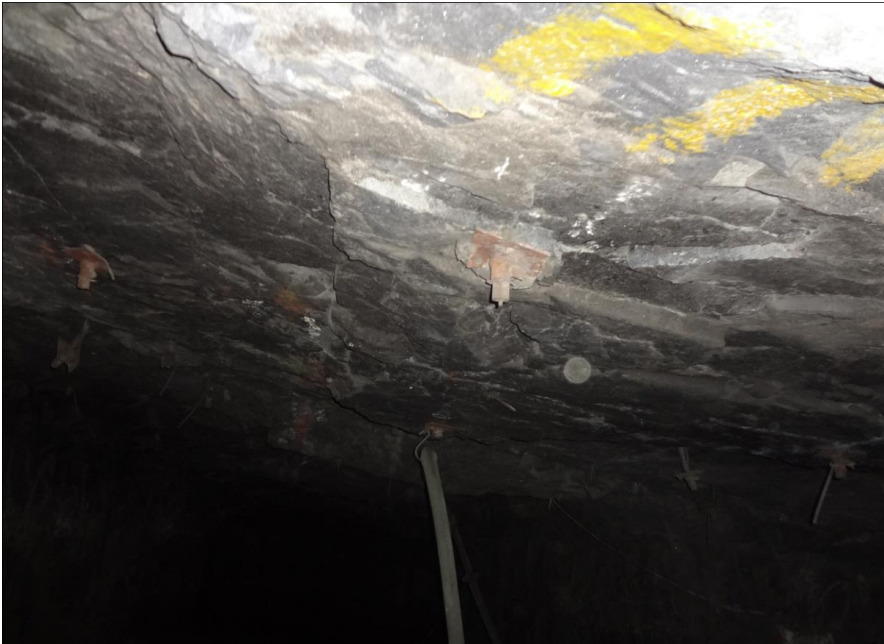
Figure 12: Relatively smooth HW

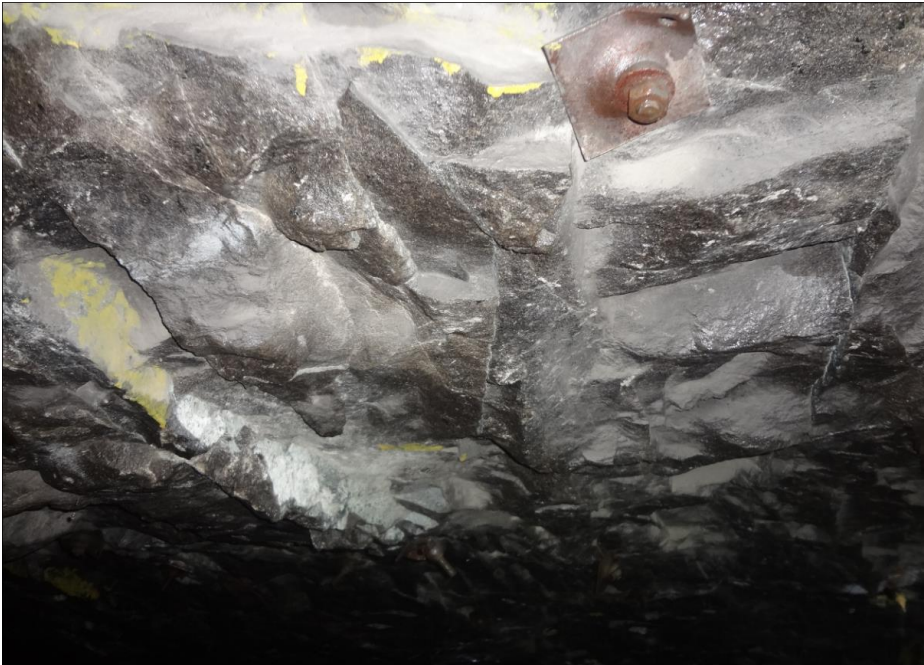
- First panel was comprehensively inspected, however the second was not thoroughly completed due to the presence of "stof". Miner indicated they would declare panel safe for machinery, then clean and then bar.

*Figure 15: HW condition*

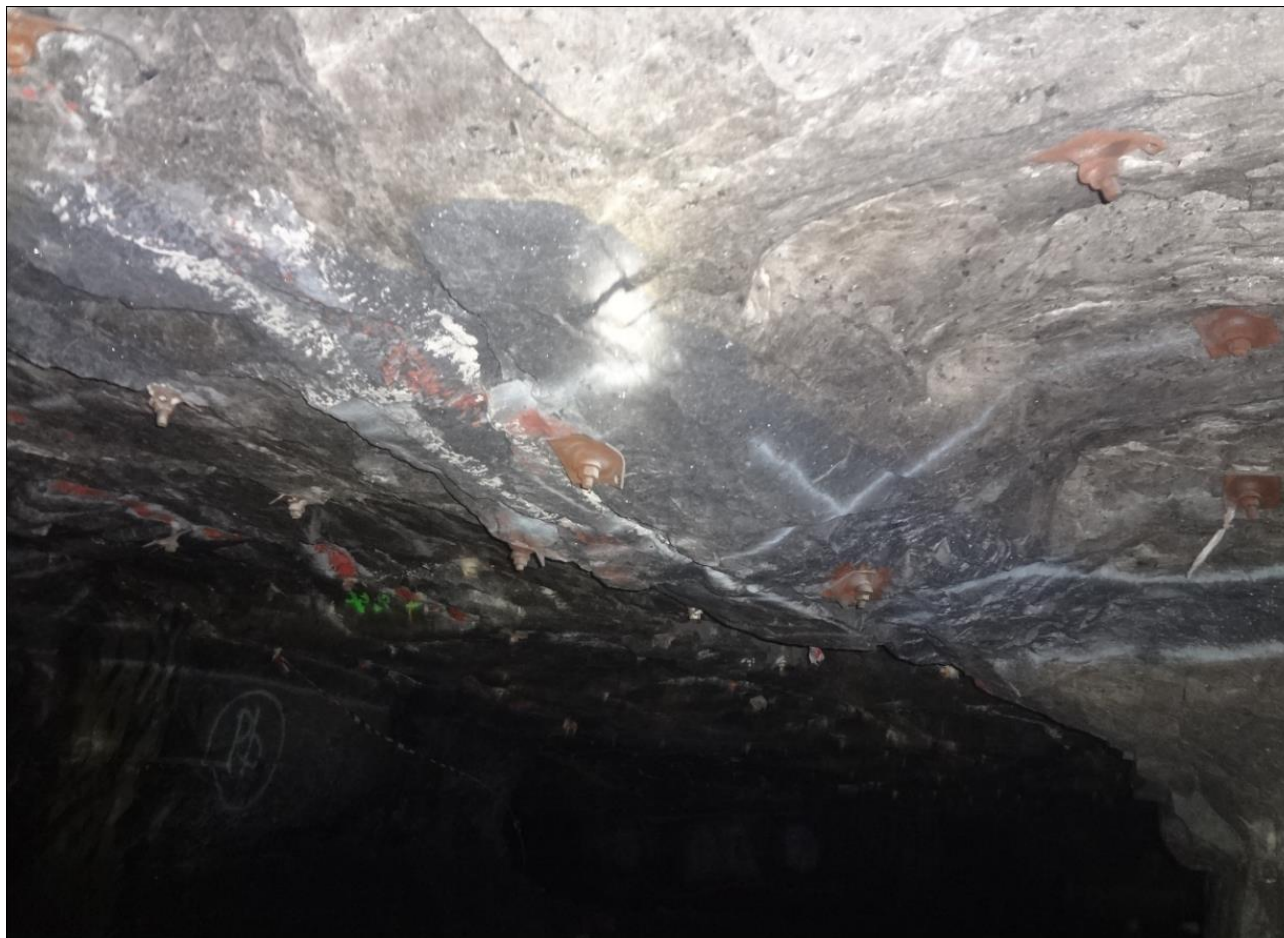
*Figure 19: HW Pyroxenite*

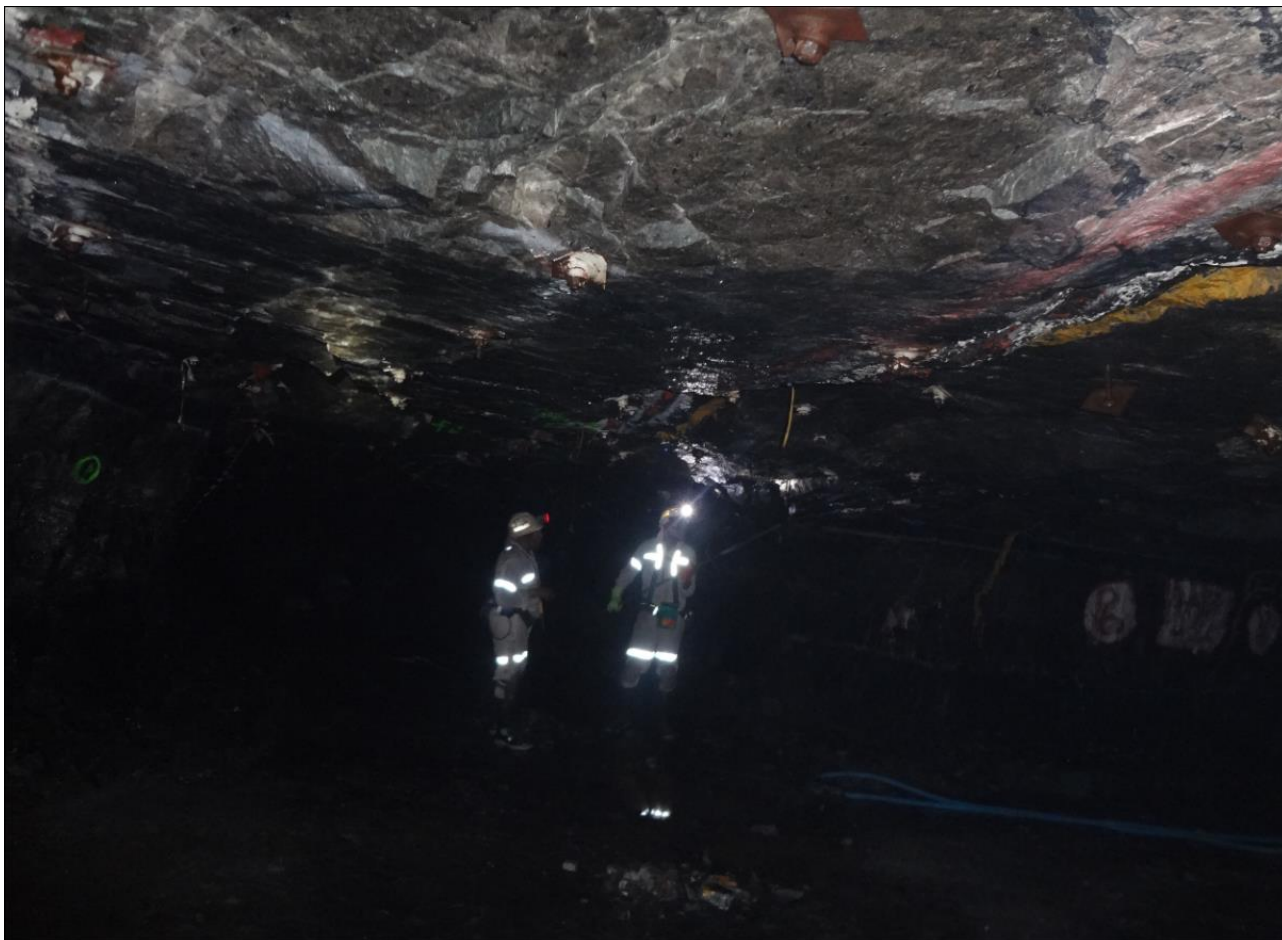
- Accompanied by strata control officer.
- Blocky HW conditions.
- Miner had already entered with his people when the researcher got to the waiting place.
- He had declared many of his panels “loading panels”. Thus he did not do EE in them.
- He suggested completing panel 1 while I observed; after loading a small amount of “stof”.
- Excuses were given for not barring/ not doing EE or watering down. All poor and incorrect ways of thinking showed. E.g. reason for not watering down was that small rocks would be dislodged. Laziness was apparent.
- Observed personnel barring at the face before it was examined.
- Miner began washing from the second split and too far into the panel and he was aggressive at times.
- **When barring began:**
- It was done from the wrong side often.
- Miner was positioned in front of the barrer i.e. closer to the face and even caused an obstruction at times.

*Figure 20: Proximity of miner to barrer (on the right)*

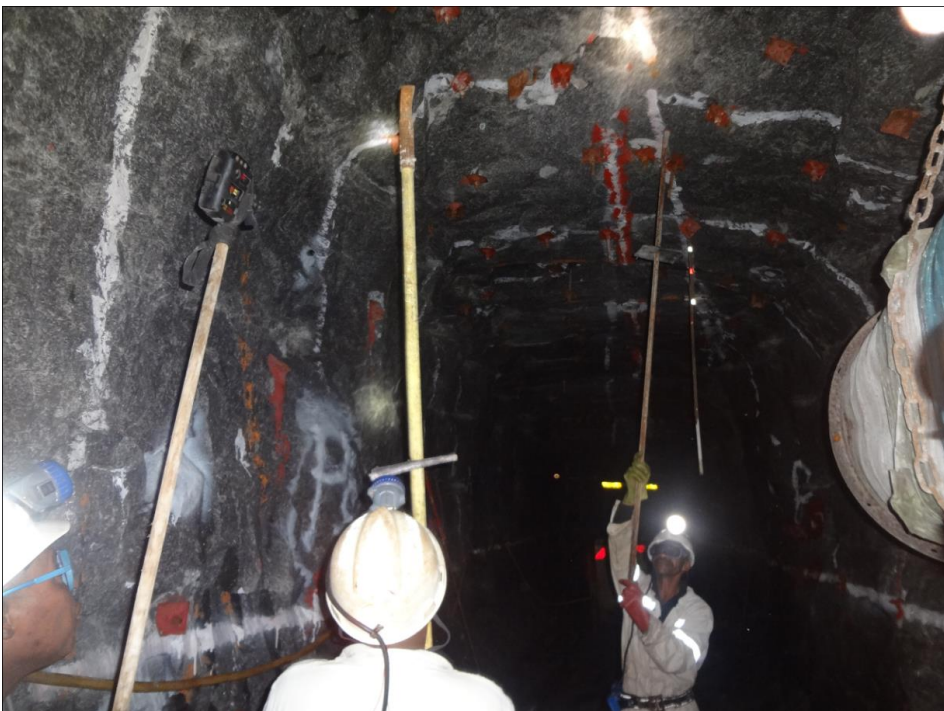
*Figure 22: Incorrect positioning directly under the rock being barred, and note the position of the gasket*

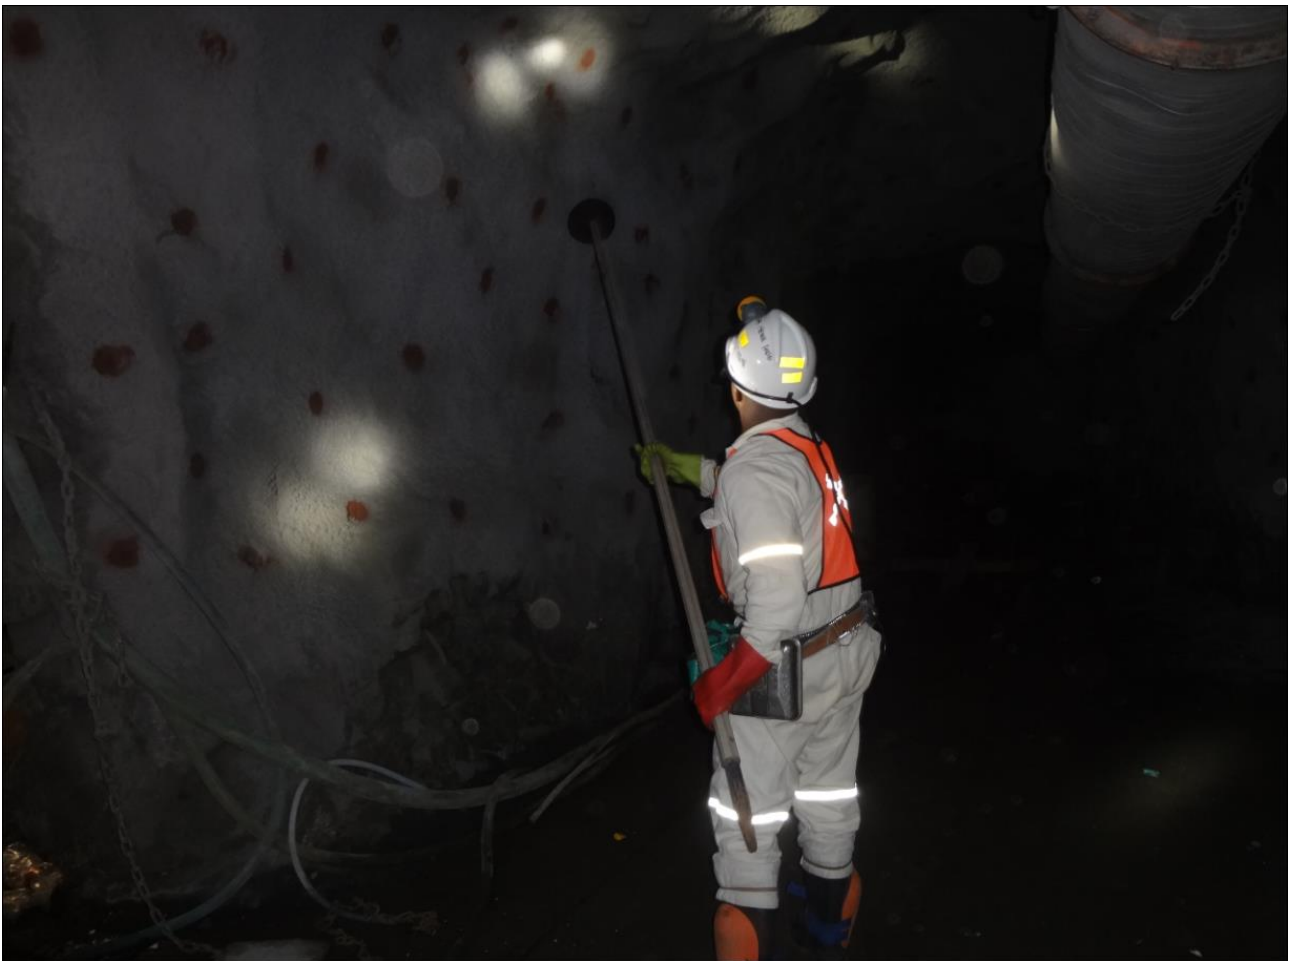
*Figure 23: Inadequate barring training where trainees 'demonstrate' barring in a shotcreted area rather than actually barring*

- Observed training centre crew conducting barring training in-stope and in development. EE was completed to standard in-stope, but the development training was lacking i.e. there was no proper area to practice.
- Interview conducted with entire crew at the waiting place and surveys completed.

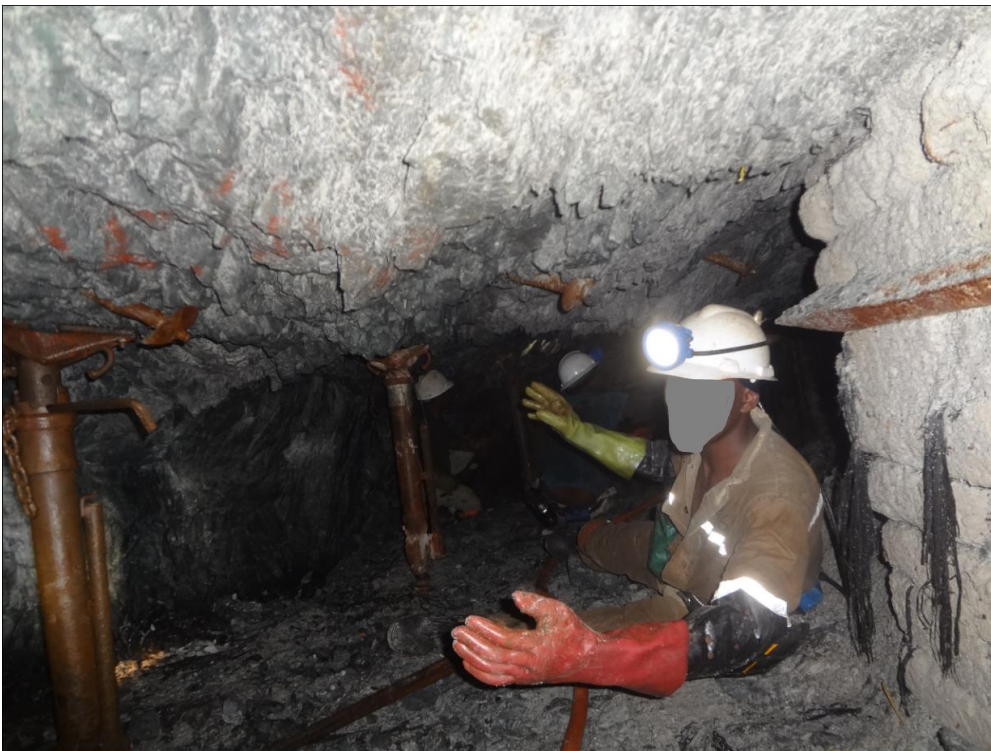
*Figure 24: Confinement in-stope due to accumulations of ore*

- Insufficient tramming to get 'stof' out due to a German box being used in the area.
- Accumulation of ore increase temperatures in-stope.
- All access ways are confined.
- Not enough labourers in crew to install support.
- Many sockets evident on face.

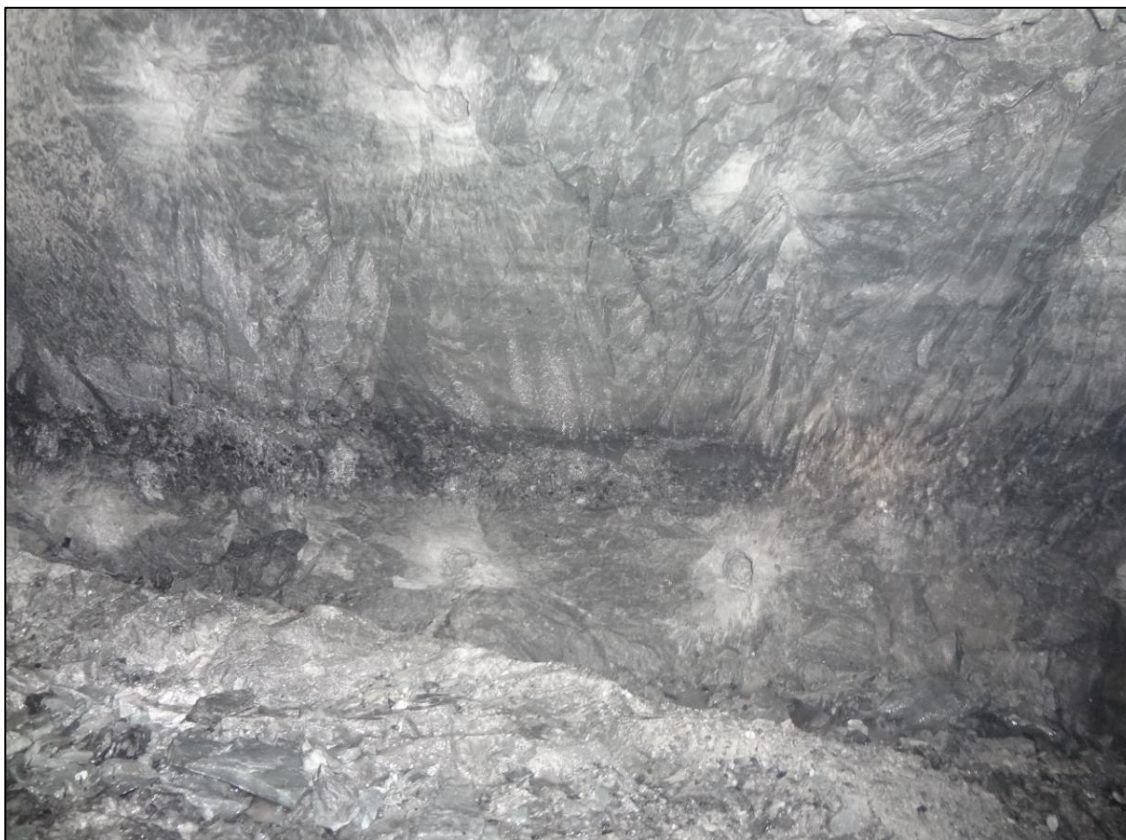
*Figure 25: Multiple sockets on the face*

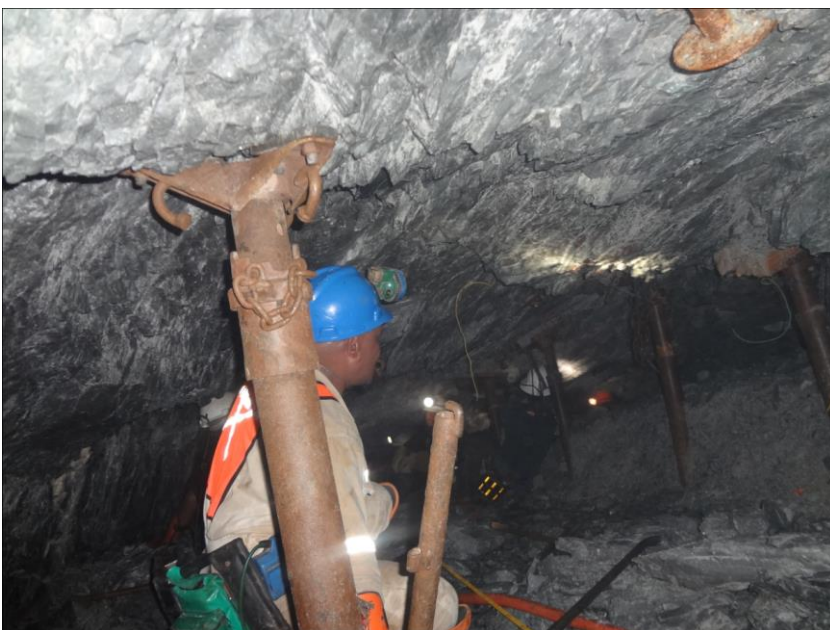
- No preconditioning holes drilled contributing to poorly fractured HW conditions.

*Figure 26: Poor HW condition*

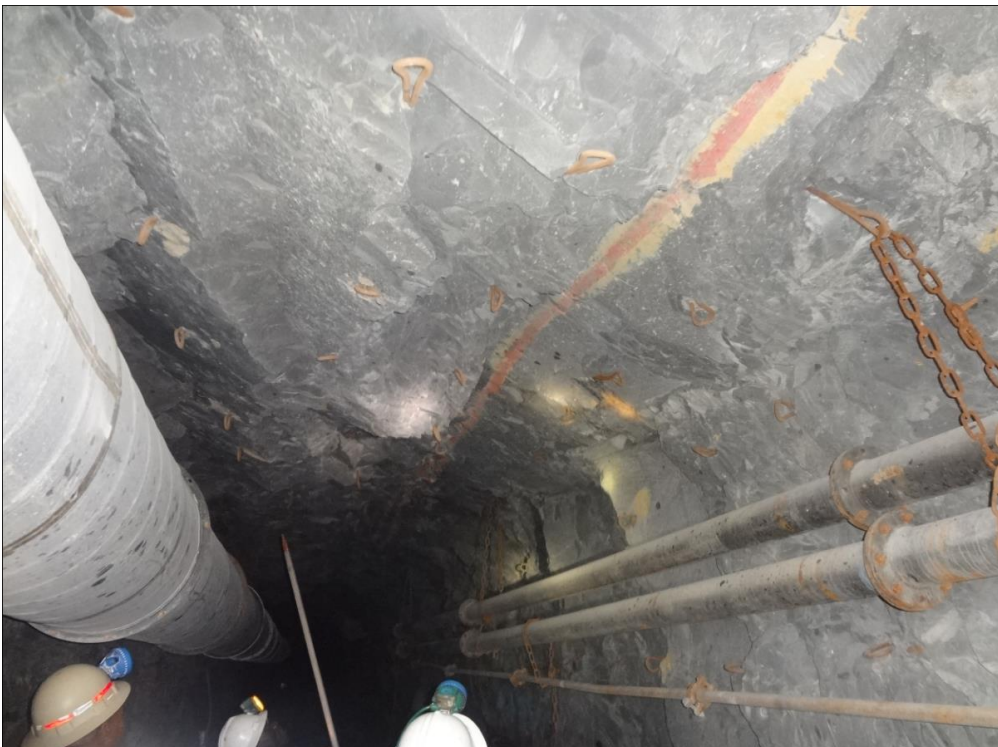
- Very poor ground conditions observed. Highly faulted area with dykes contributing to extremely fractured HW conditions.

*Figure 27: HW in tunnel*

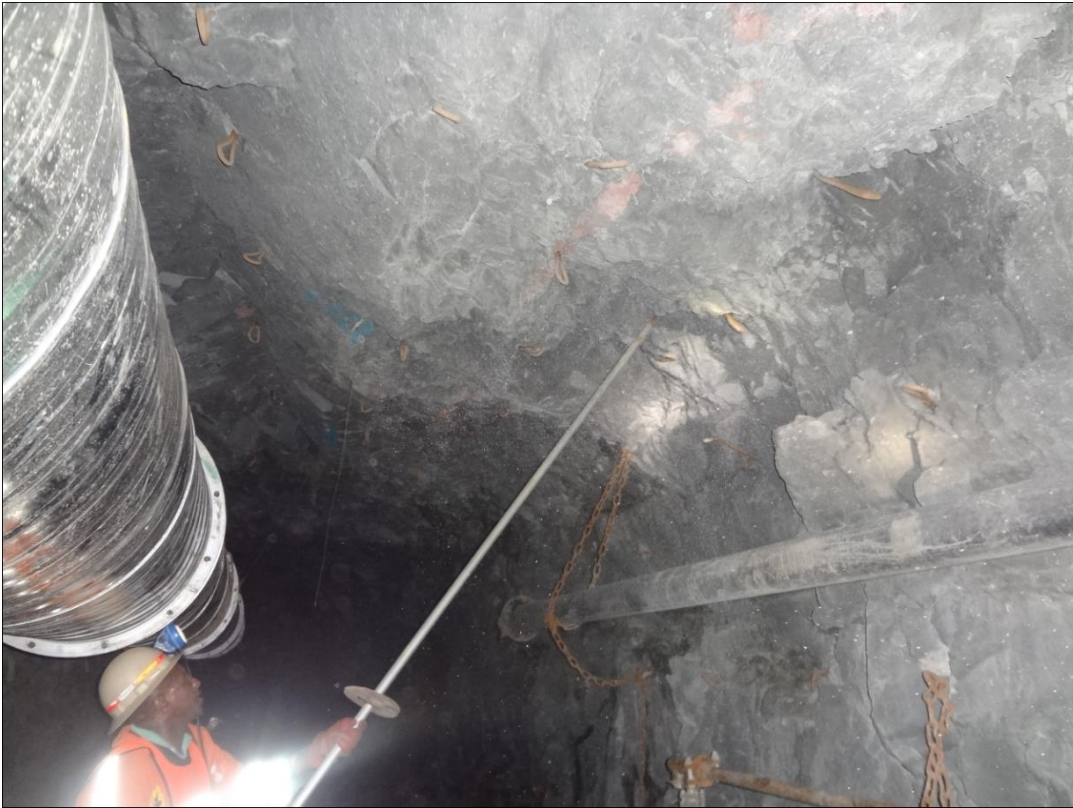
- MOSH EE was completed well with the following observations:
- Watering down.
- Visual inspection as well as sounding.
- Pinch bars in good condition.
- Gaskets used and hands were placed behind.
- Sidewalls were less inspected than the HW and this was concerning as there was an overhanging (LHS) sidewall.

*Figure 28: Barring in the development end*

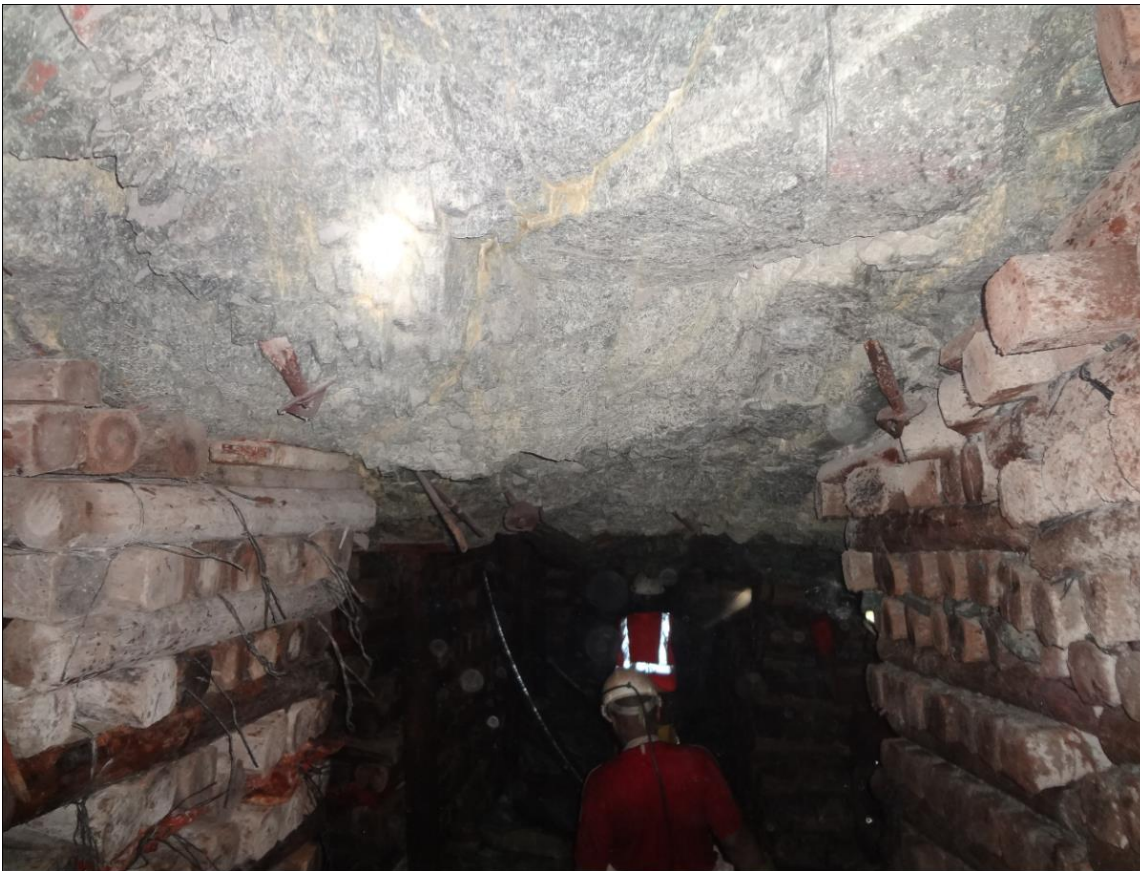
Figure 29: Fractured HW Quartzite

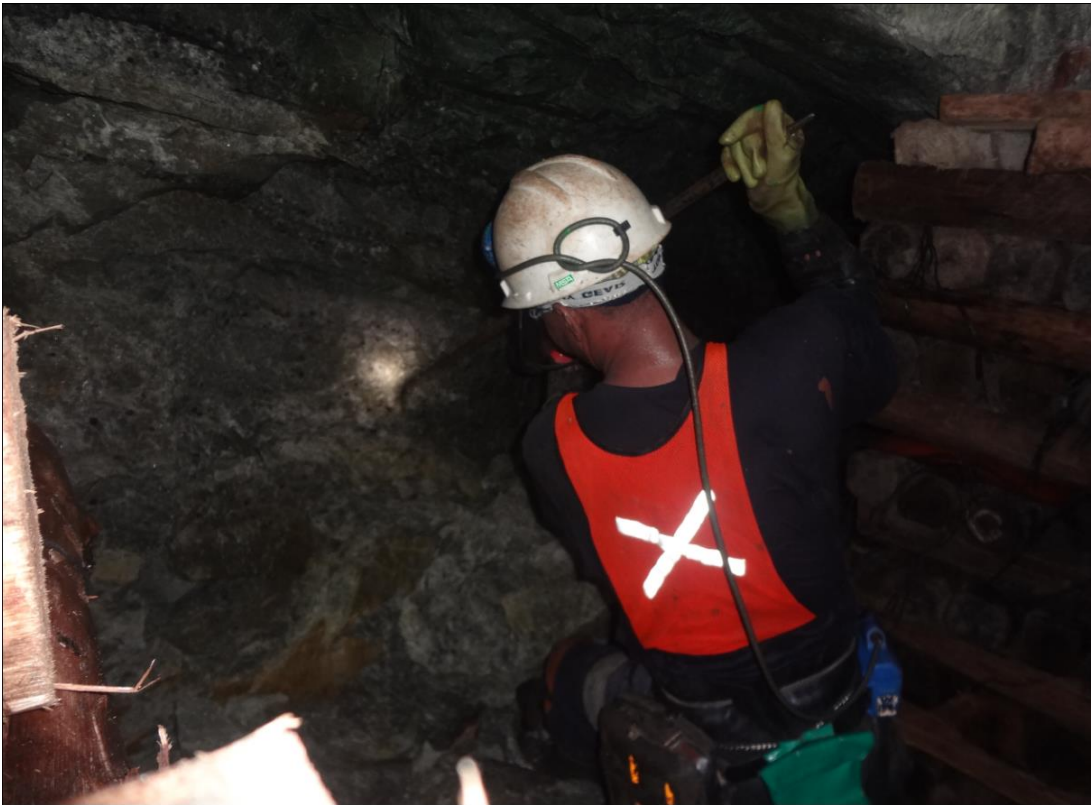
- Gaskets were not observed on some pinch bars.
- People were positioned too close to where rocks would fall when barred i.e. they were confined and down dip (no escape routes were identified).

Figure 30: Positioning of barrer

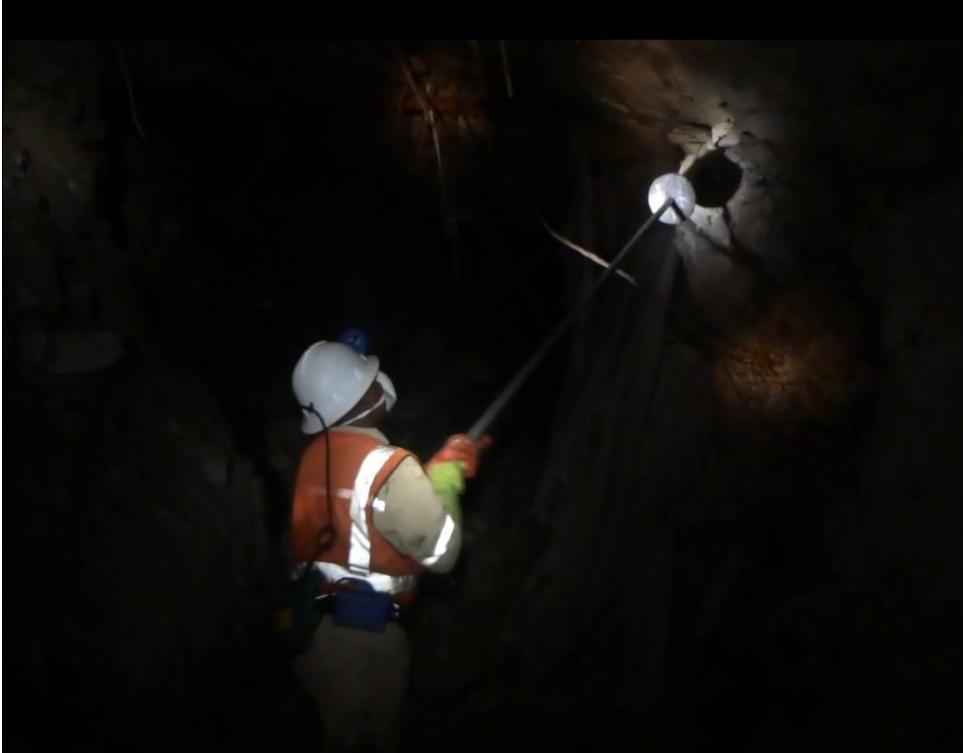
- Positioning at all times was not good.
- Watering down and barring did not take place in the best sequenced manner.
- Gaskets being loose and incorrect positioning of gaskets are a problem as a gasket was observed almost falling off the pinch bar.

*Figure 32: Incorrect Position of Gasket*

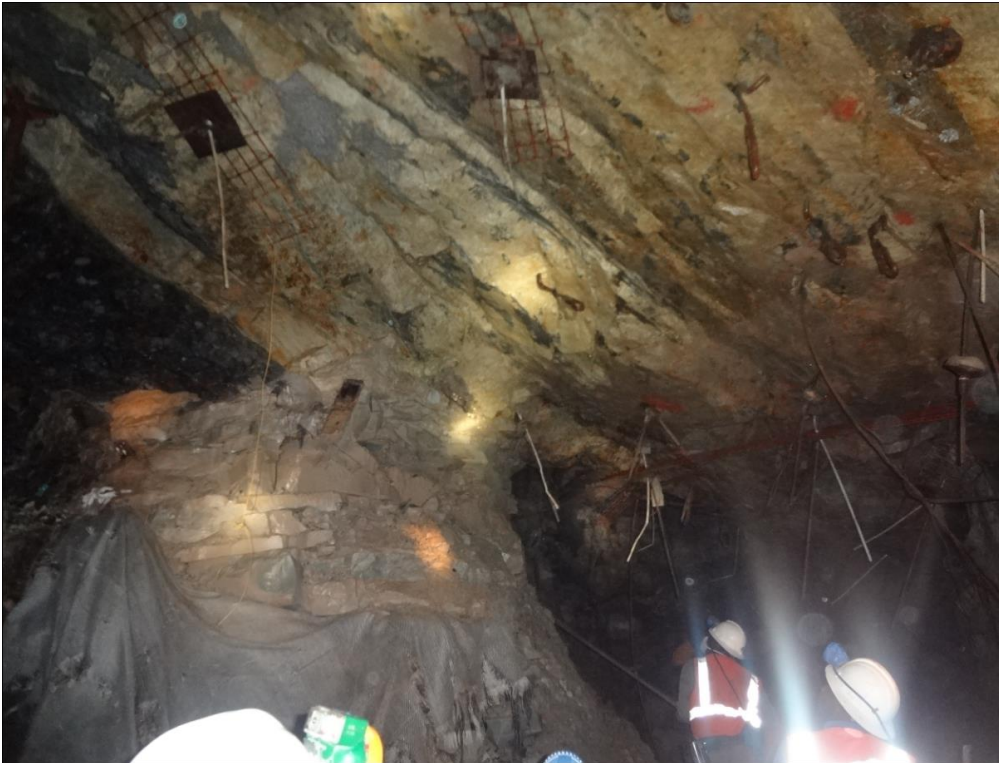
- Pinch bars used were new and sharp.
- Barring of backfill is hazardous as it is friable and causes mud in-stope when exposed to water. It was observed that the barrers took cognisance of these considerations.

*Figure 33: Exposed Backfill bags and poor HW condition*

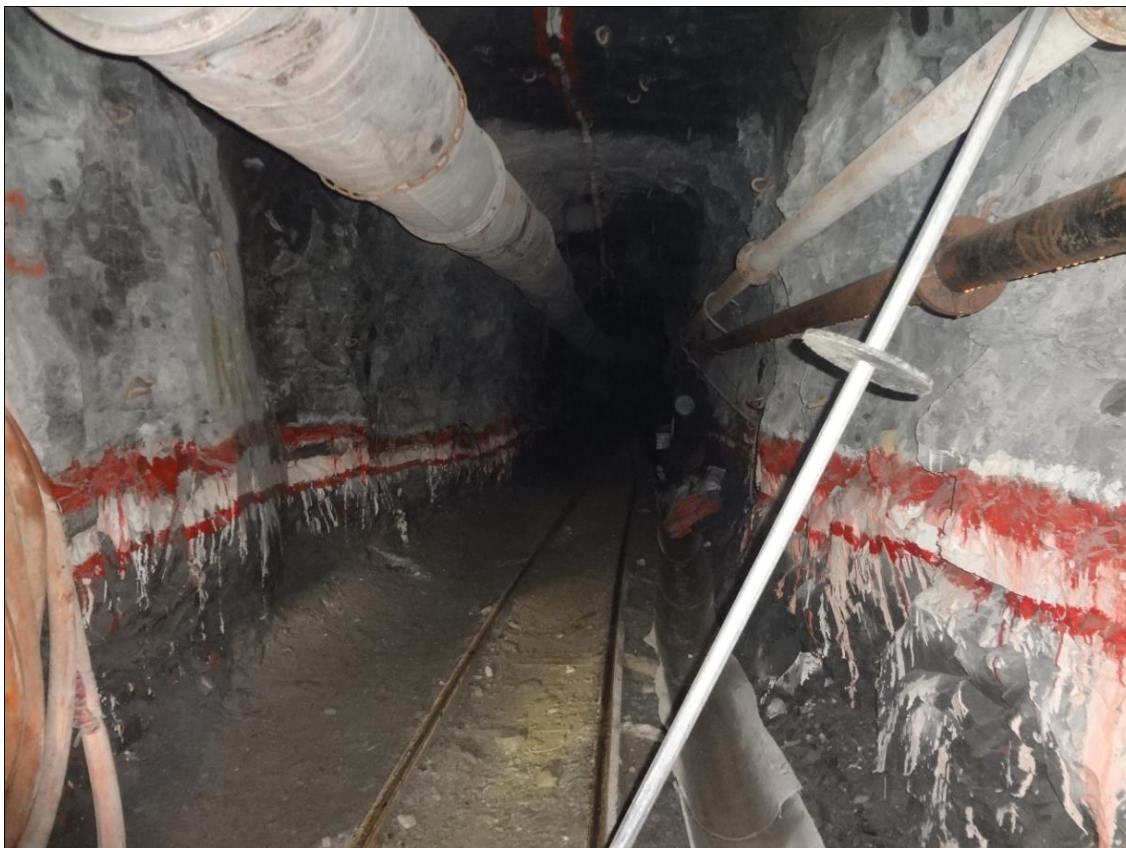
- Crew entered without a miner (as the miner was paraded) and EE was not conducted. People were already working at the face.
- When the miner did conduct EE when he arrived, the following was observed:
- Visual examination was done from XC breakaway but more focus was placed on HW rather than including the sidewalls as well.

*Figure 34: Sidewall and Hanging Wall condition*
