## **1.0 FIELD LOGS – FIELD ENGINEER\_AB**

### **1.1 Platinum Mines**

#### **1.1.1 Field Log 1**

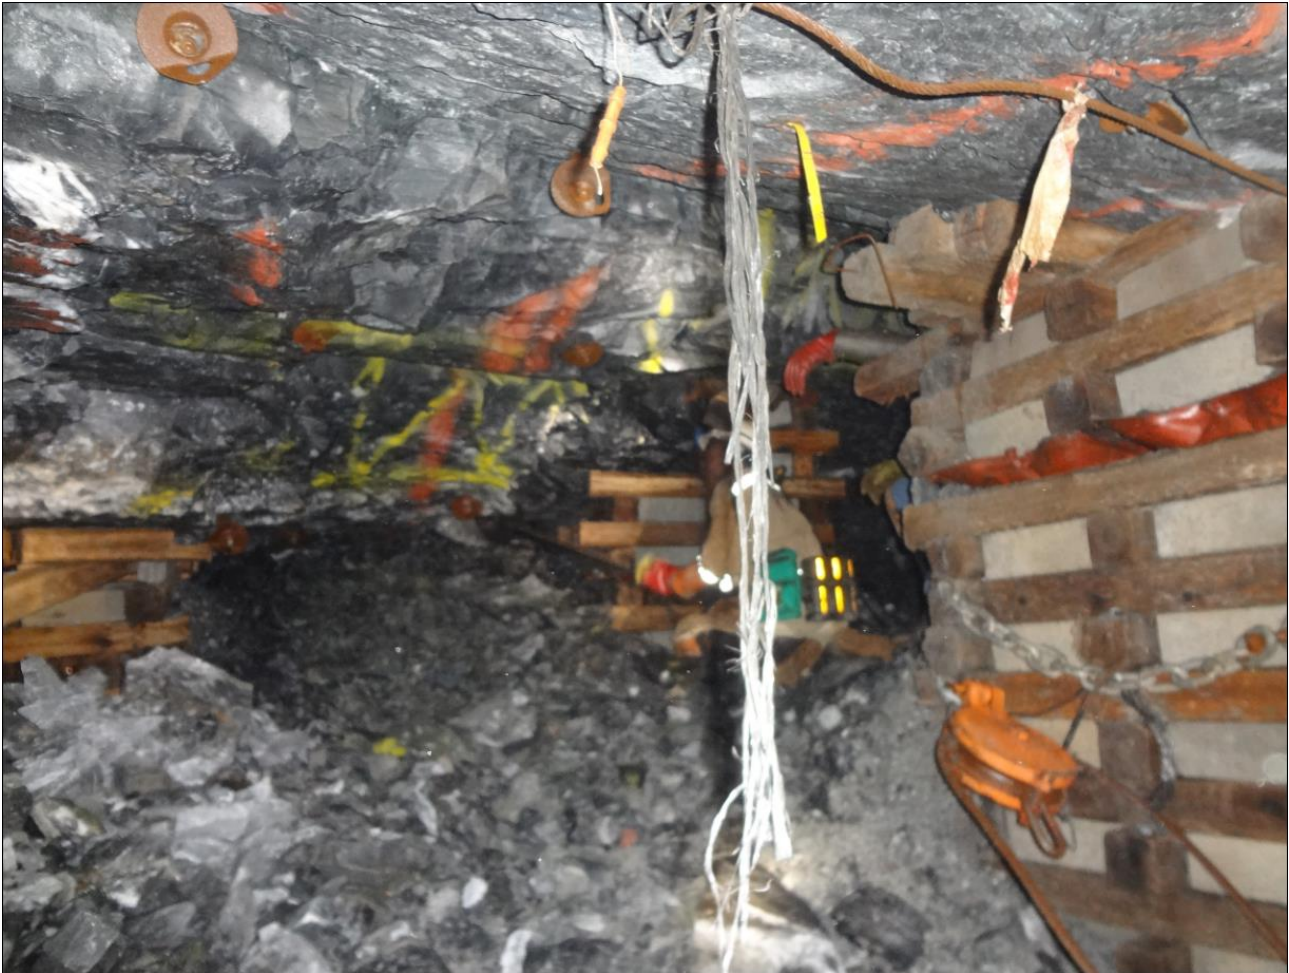
*Figure 35: Fractured WAF hanging wall*

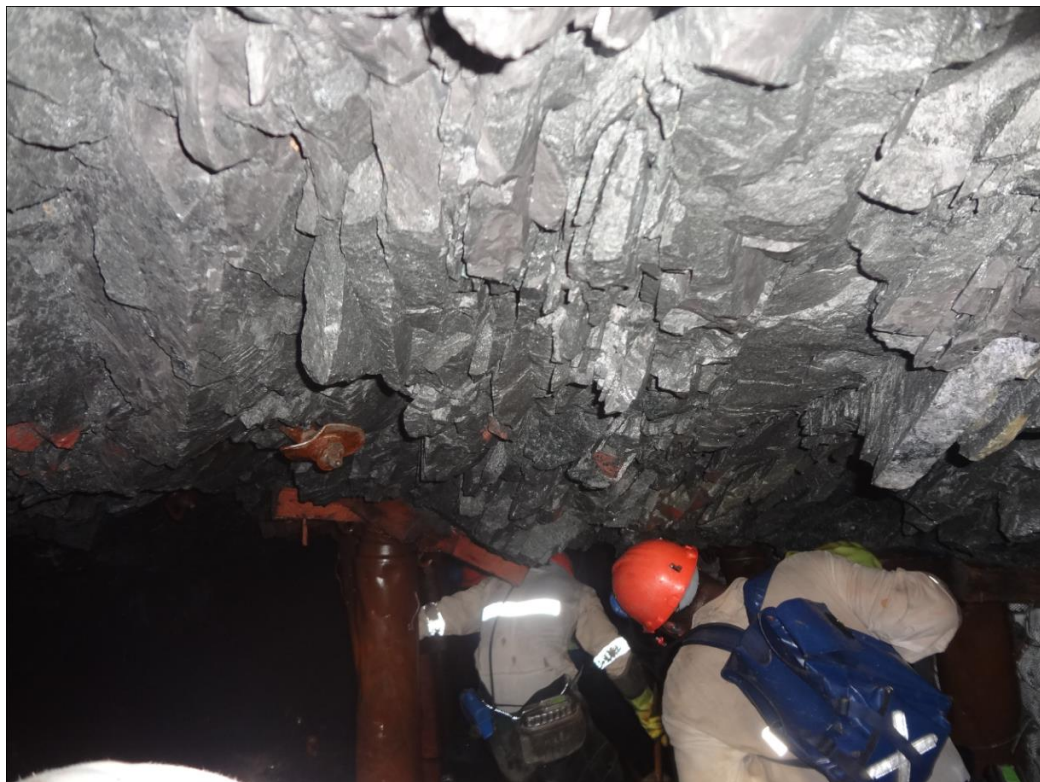
*Figure 36: Steeply dipping joints and stress induced fracturing in the HW*

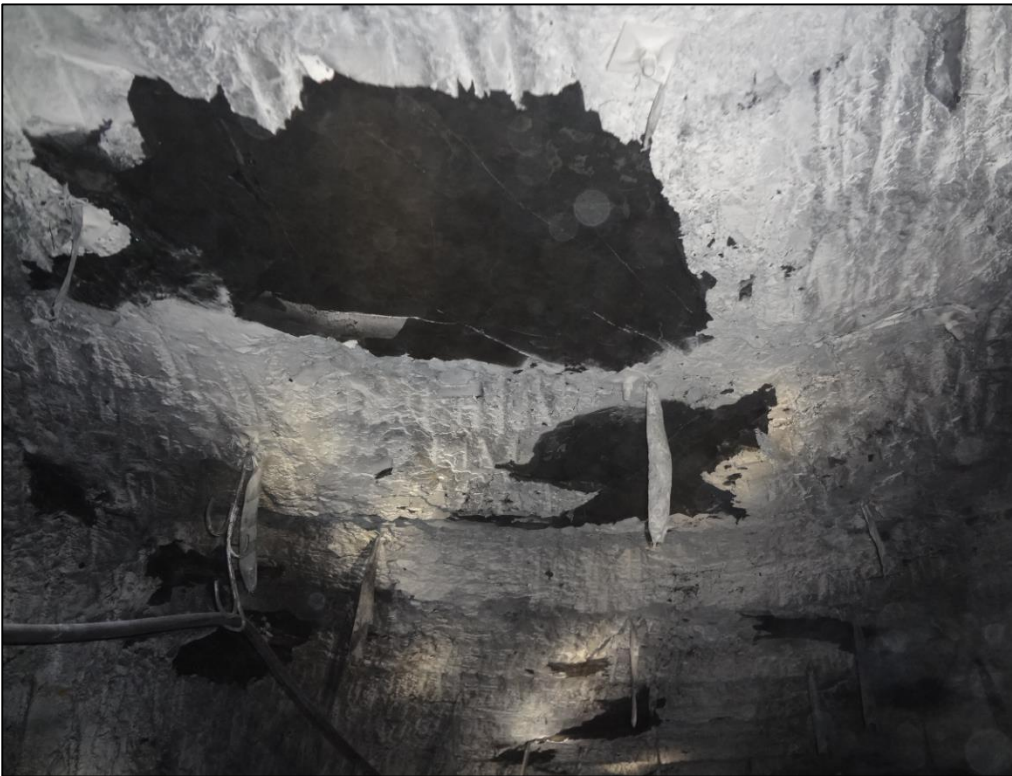
- Accompanied by the shift boss.
- Observed sounding and barring with very poor roof conditions due to the presence of many dykes.

*Figure 39: Poor Roof conditions*

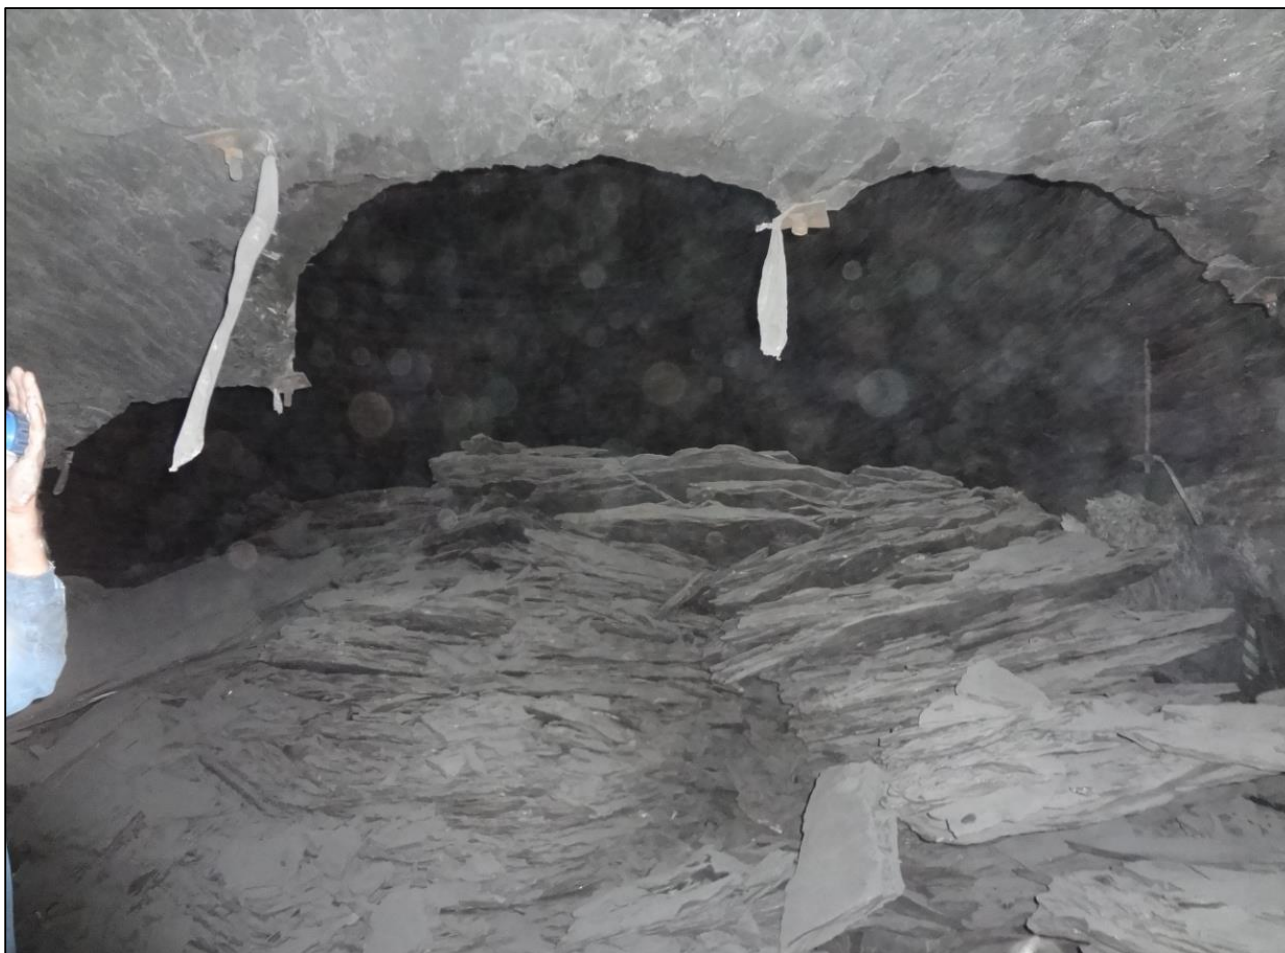
Figure 44: Another view of the large FOG

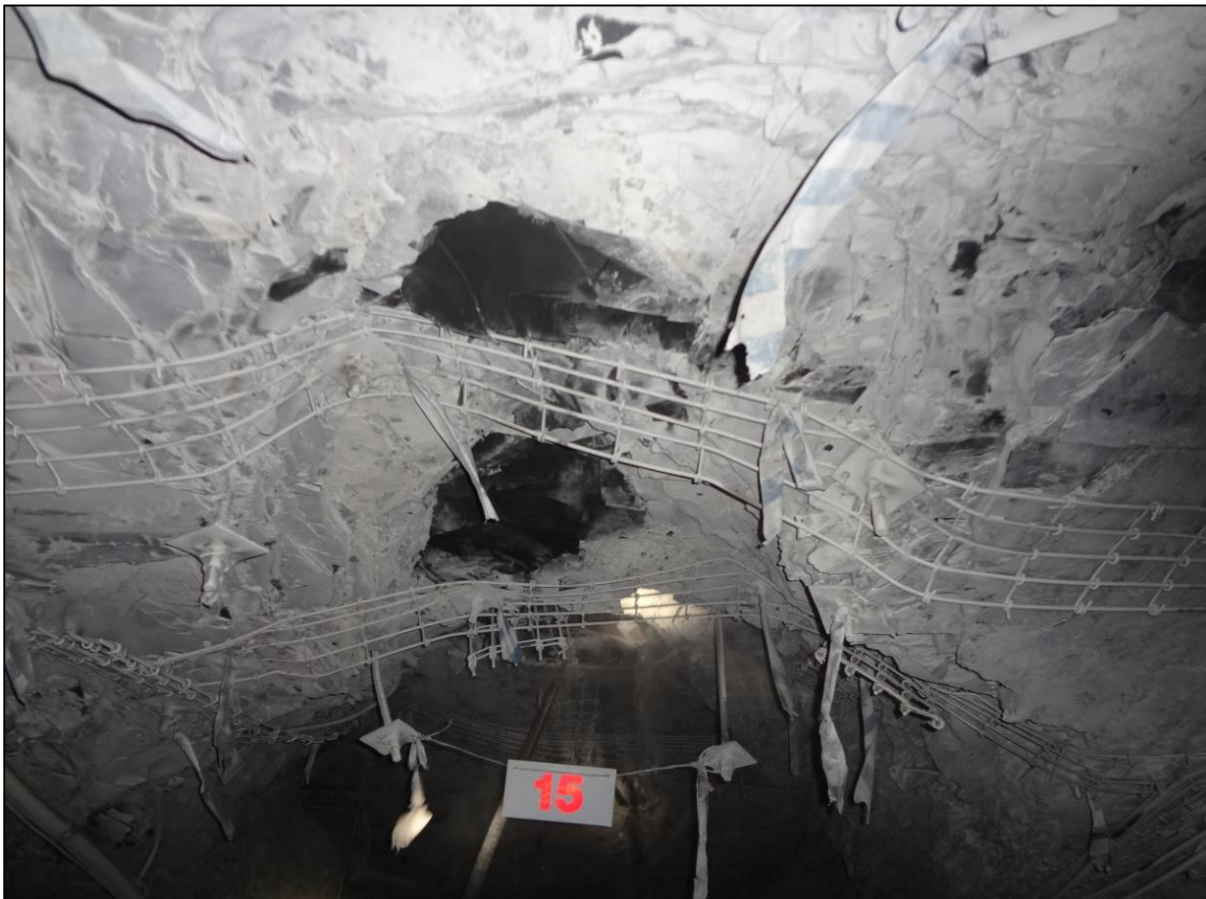
- Accompanied by the shift boss.
- Better roof condition were observed in this section than working area 1 due to there being less geological complexity in this section, most notably, less dykes.
- Barring and sounding was not done thoroughly.
- People did not want to assist with barring and sounding.
- Sticksides appear to be scaling at parts, especially the corners (pictures were taken).

*Figure 45: Roof in the outbye section*

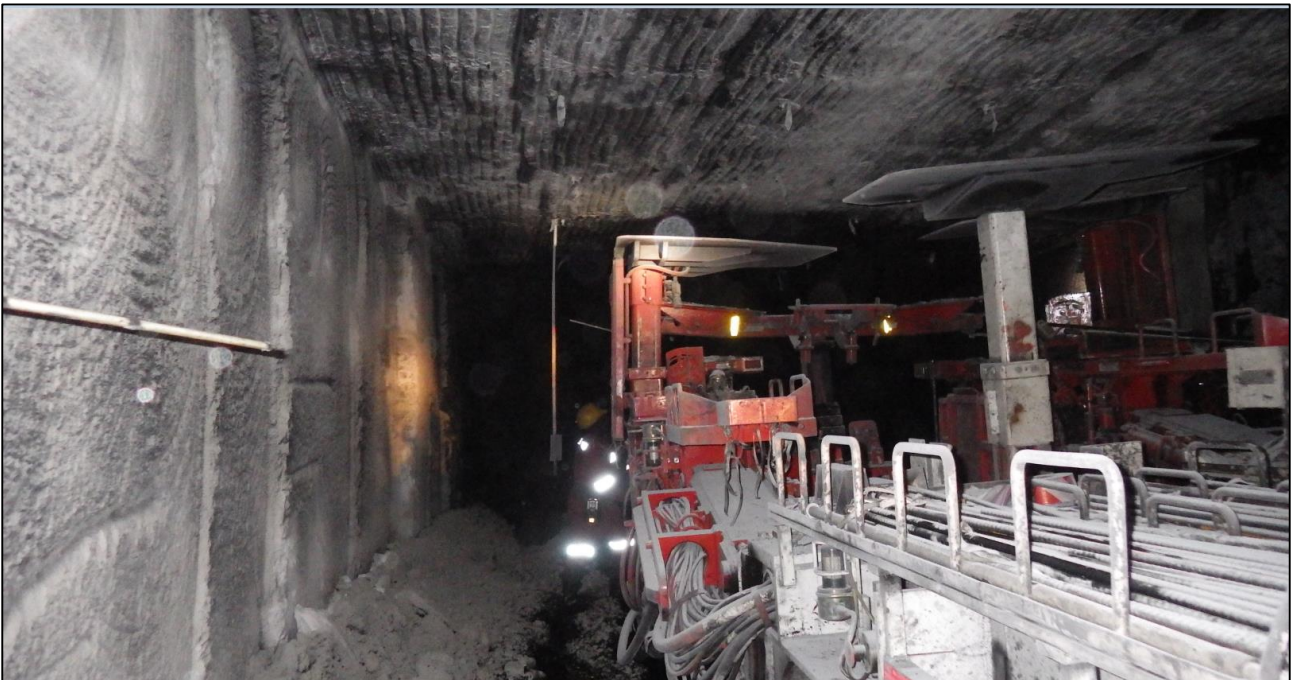
*Figure 46: Good Roof conditions and good pillar cutting*

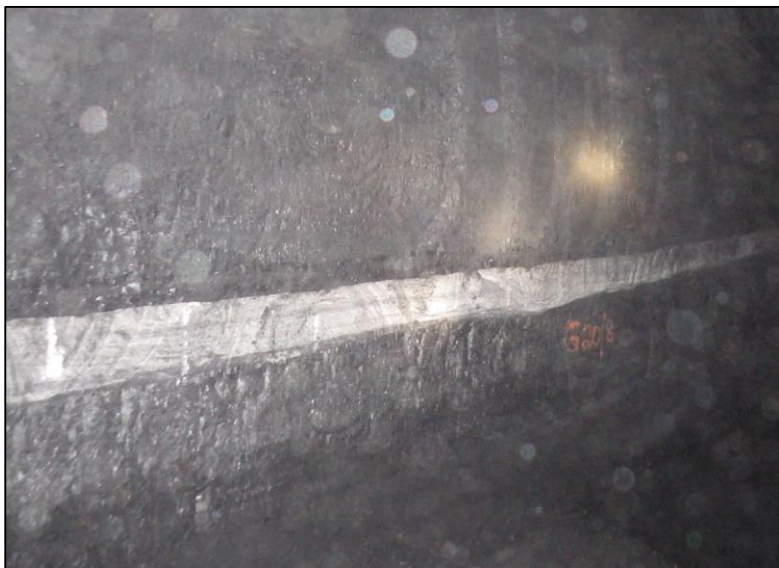
- Roof strata highly laminated with a thick in-seam parting being observed. Seam 1.39m thick from floor up to parting. Face was mining in an area with burnt coal and a predicted zone of poor roof conditions was noted on a plan.

Figure 49: In-seam parting

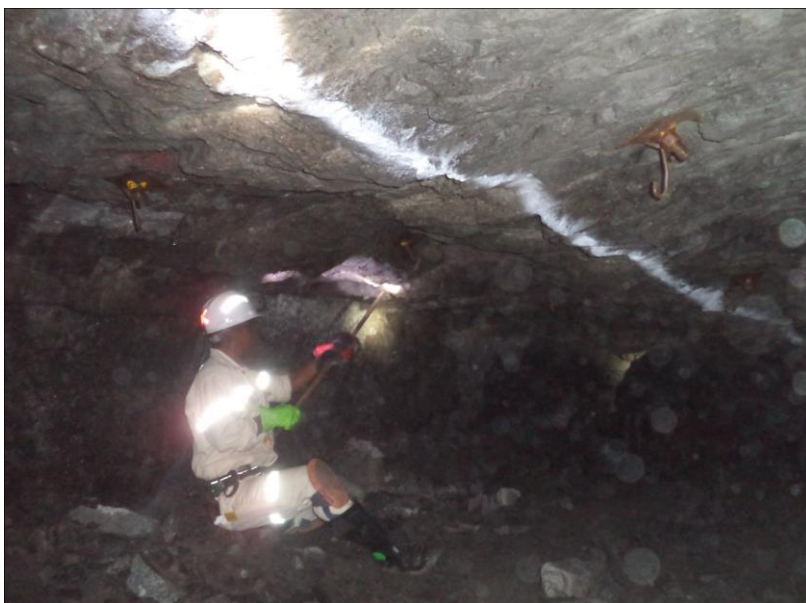
- Observed barring during entry examination.
- Positioning whilst barring wasn't always good. Pinch bars were blunt but were still used.

*Figure 65: Incorrect stance- positioning and footing. Kneeling would have been preferred to sitting*

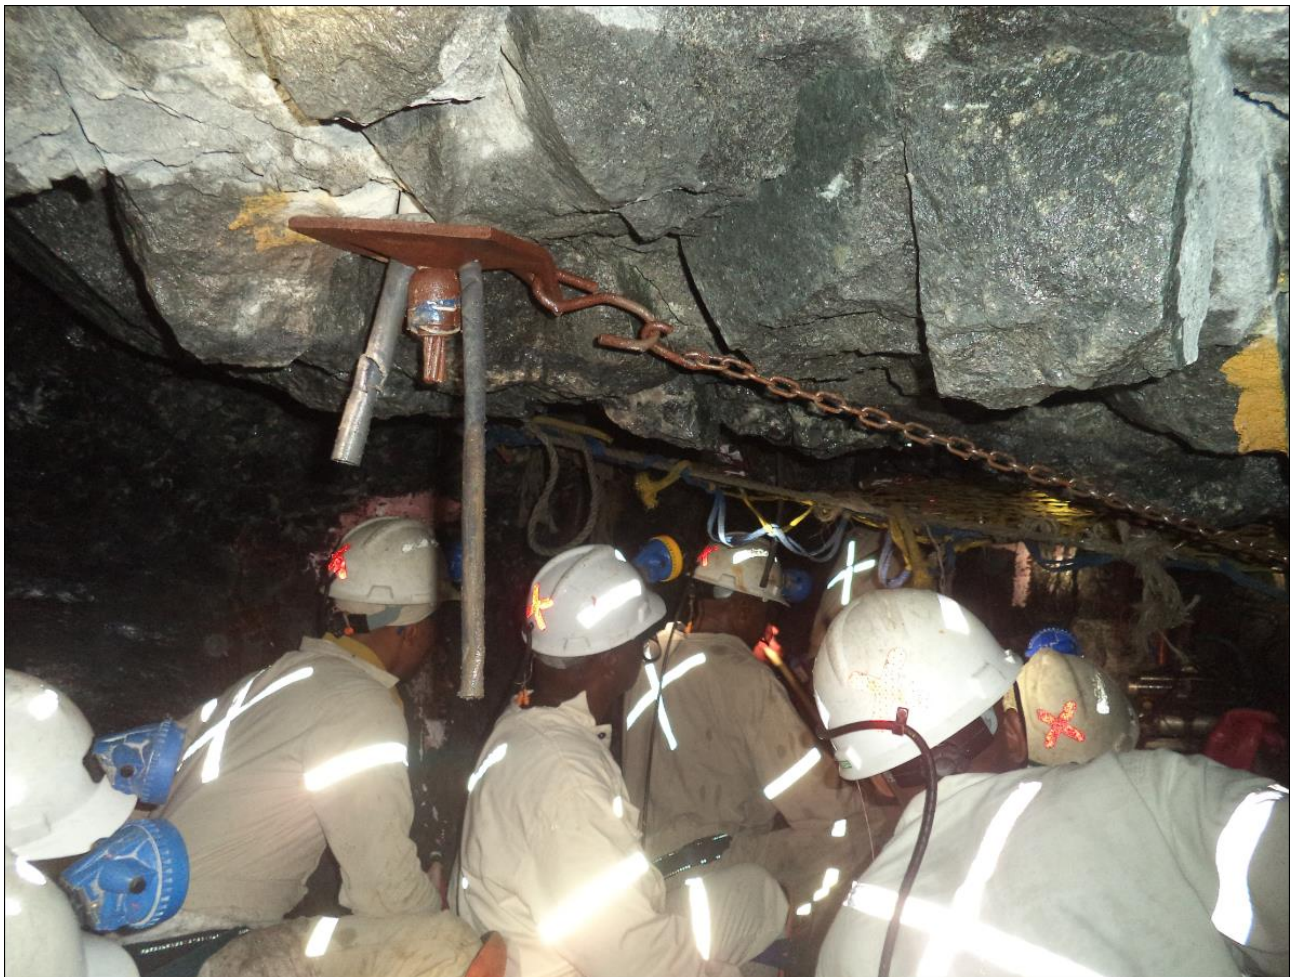
- Accompanying person: Strata control officer
- Barrage observed along the travelling way. No warning of persons down dip. People have no consideration for the barring rules. Some bystanders too close to barrer.
- Observed barring in the stope. Barring through the net in places.
- When barrers look back they tend to bar behind them from the down-dip position.
- Hanging wall, blocky.

*Figure 68: Blocky HW conditions*

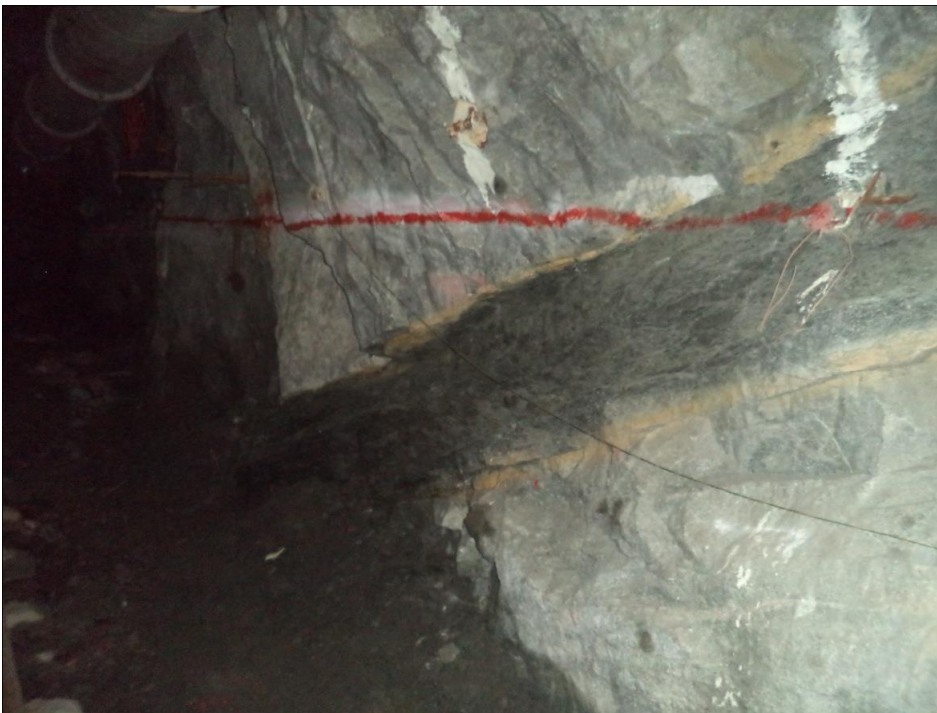
*Figure 69: Dyke in Sidewall*

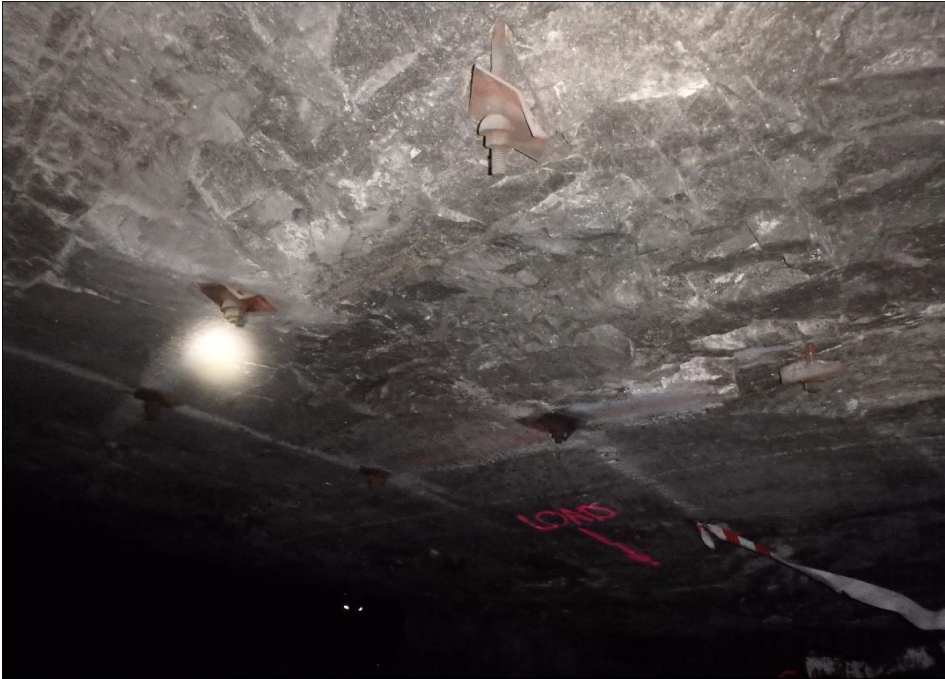
- Barrer positioning was not always good. No watering down prior to barring.
- Blocky conditions. Persistent closely spaced discontinuity sets perpendicular to the hanging wall cross-cutting the set oriented parallel to the hanging wall. Macro scale discontinuity shape is wavy resulting in variable block sizes.

Figure 72: Blocky HW conditions

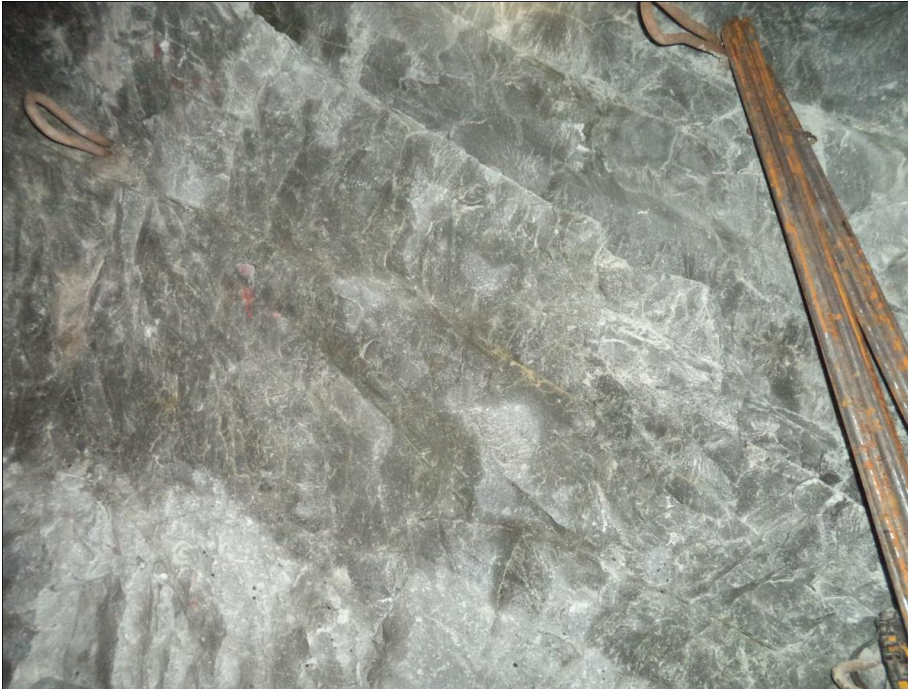
*Figure 75: Jointing in Sidewall*

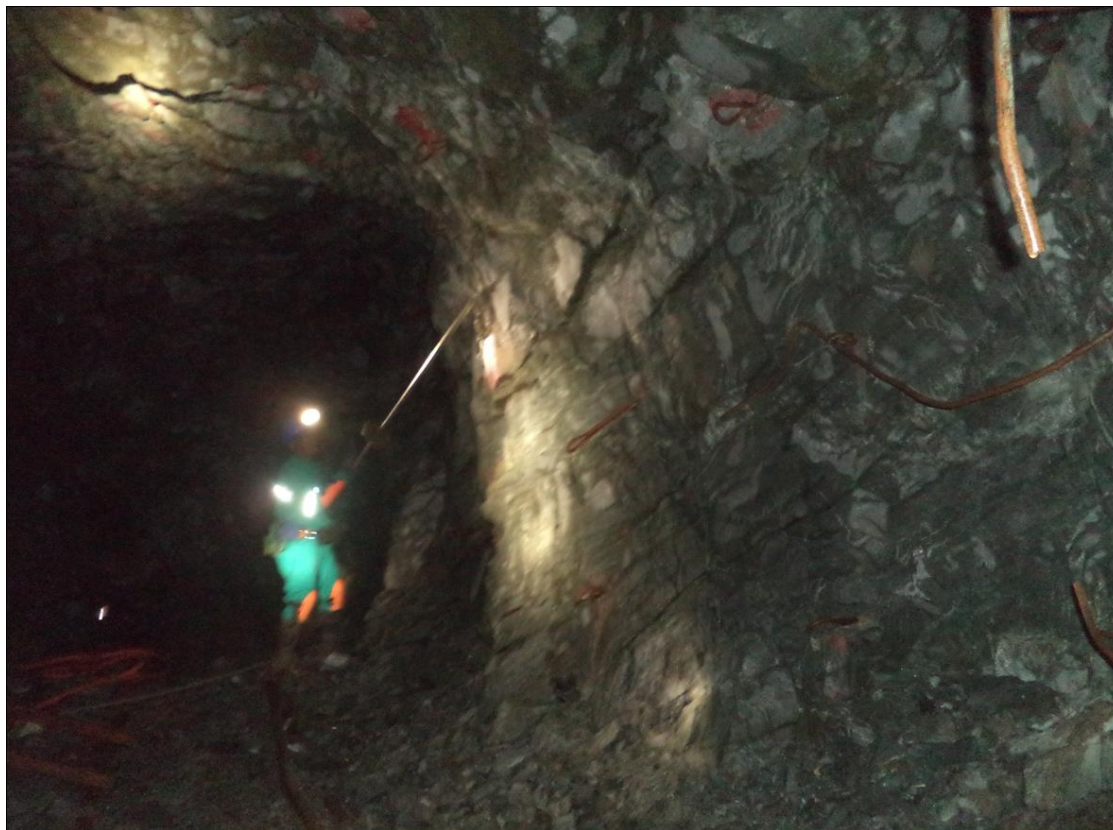
- Only safety reps carried out barring. This is apparently their job and the other crew members would not bar. Crew members do not like spending lots of time barring, only the safety reps would bar.
- The crew was not pleased with me asking the safety rep to bar unsafe areas because they felt I was wasting their time.
- Observed good barring practice from the safety reps.
- Barring is difficult practice in these very high development ends.

*Figure 76: Barring in high excavations*

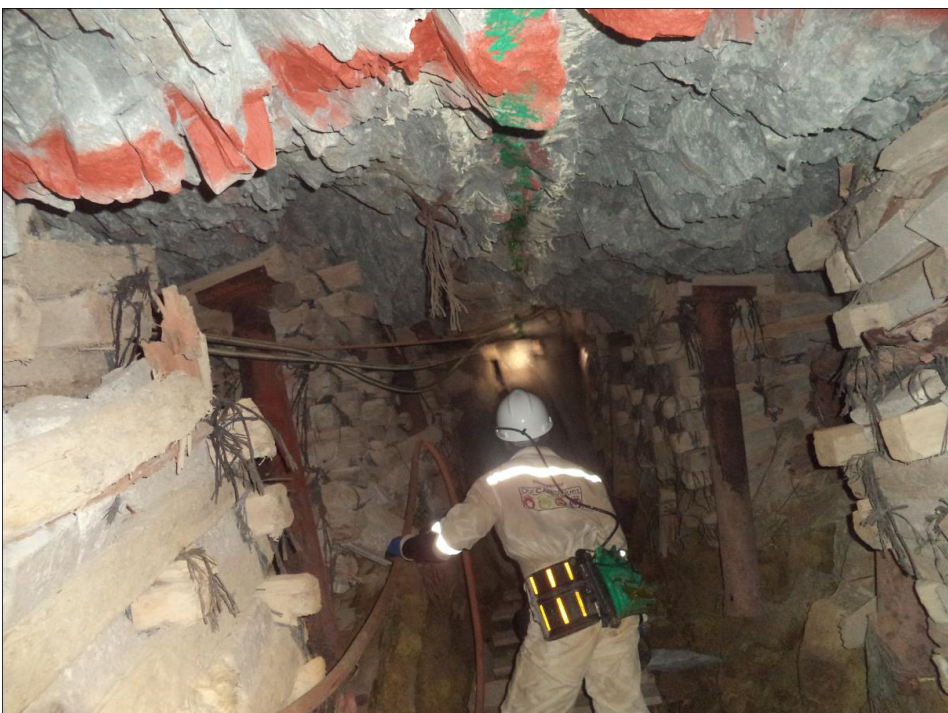
Figure 78: Steeply dipping joints in HW

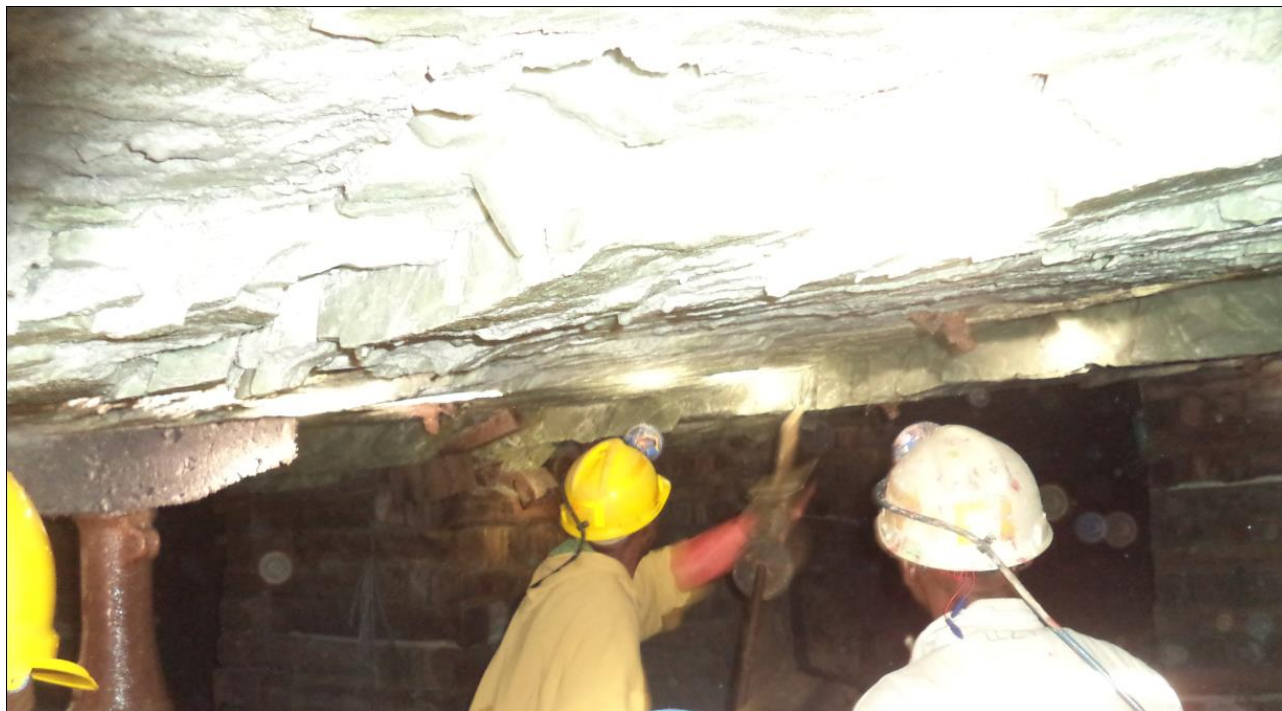
Figure 82: Laminated HW (Quartzite)

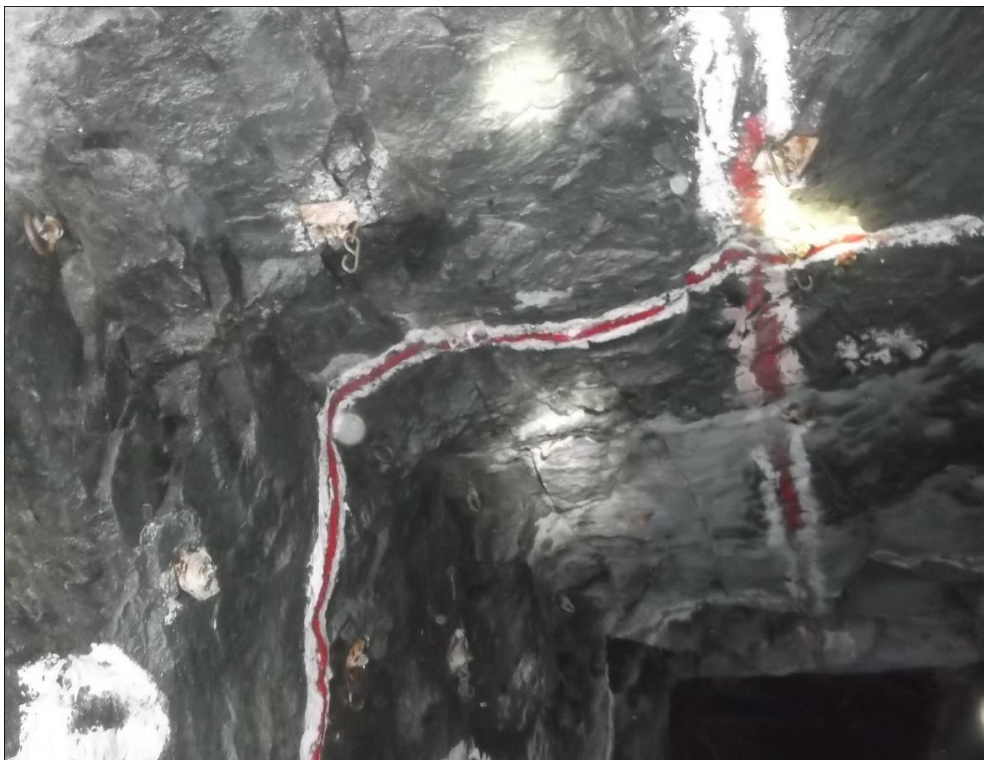
*Figure 84: Jointed HW condition*

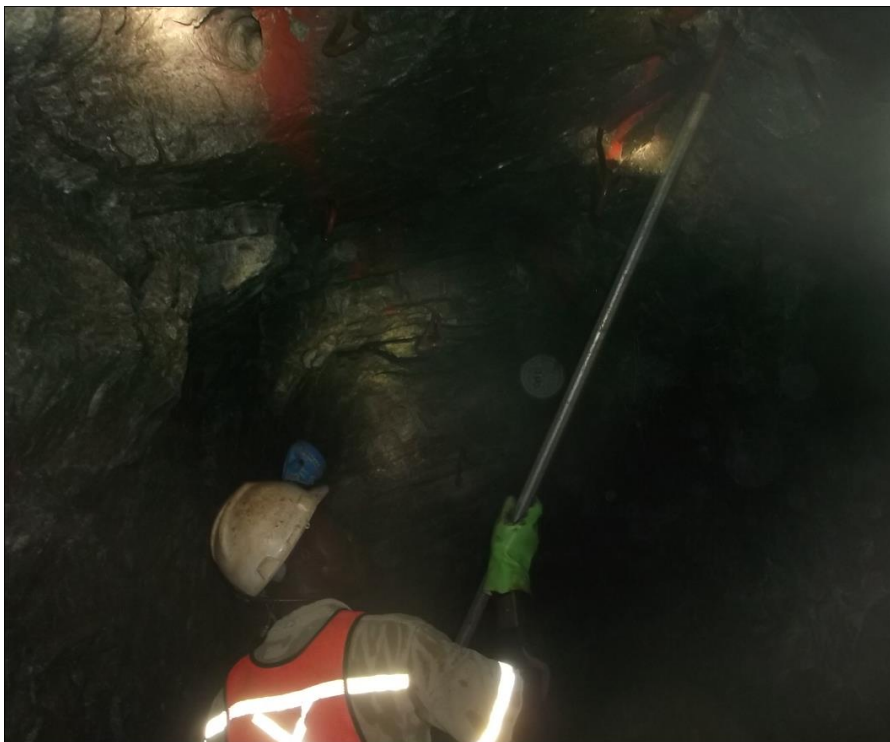
*Figure 89: Barring in stope. No gasket on pinch bar*

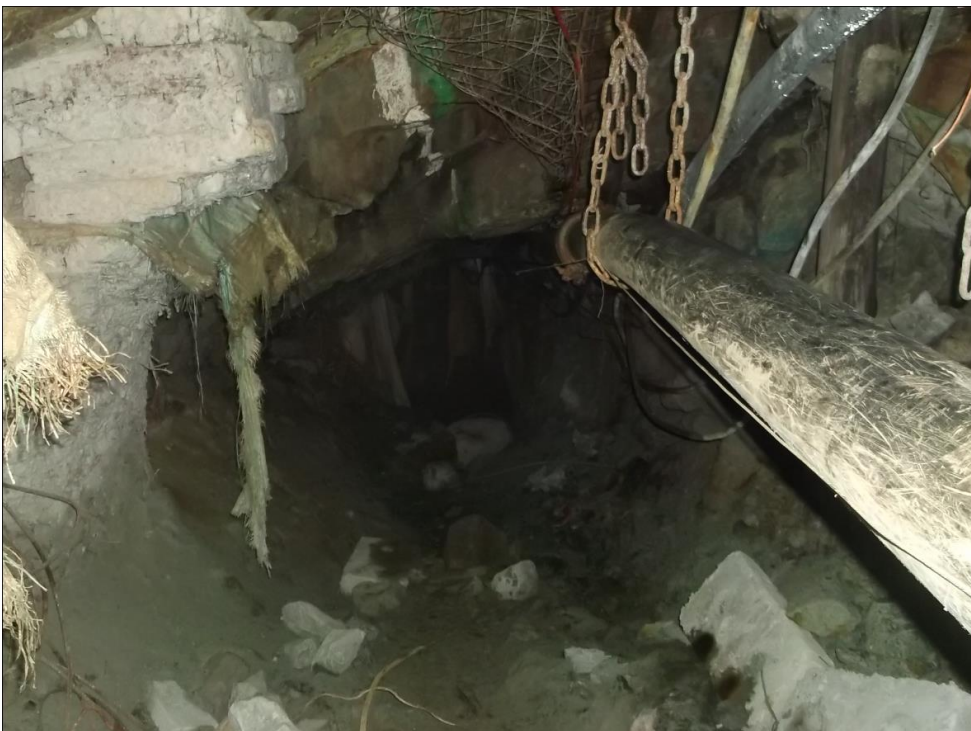
*Figure 91: Poor housekeeping in gully area*

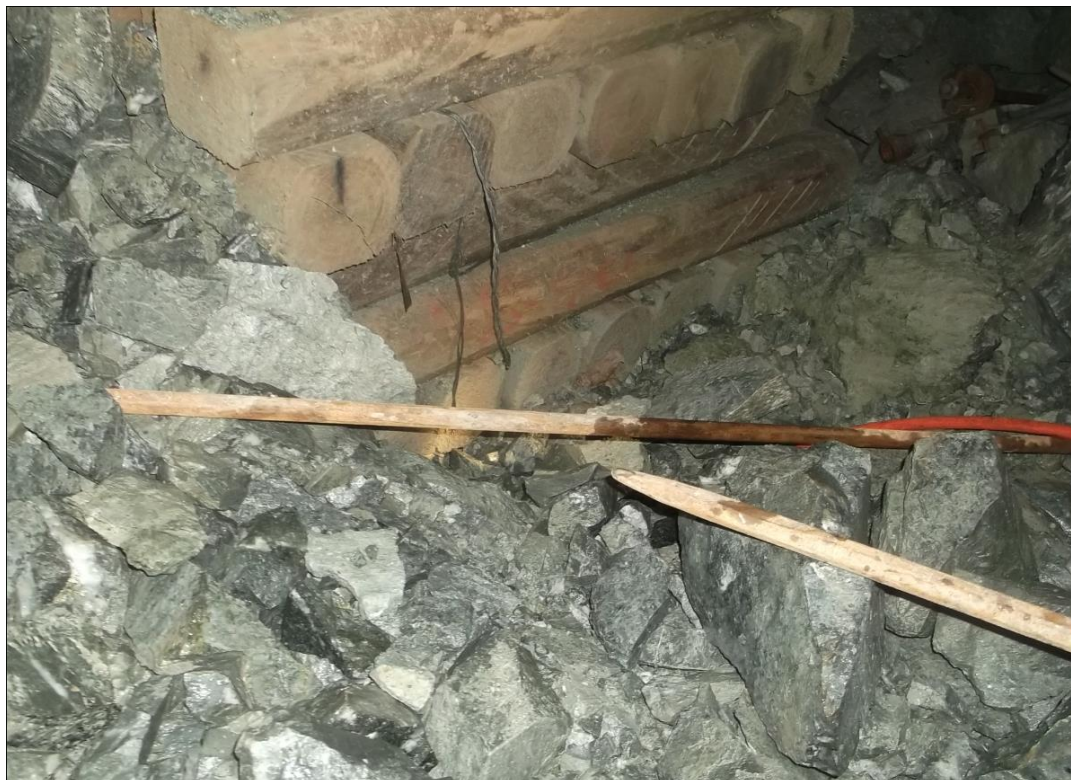
*Figure 93: Old, rusted and blunt pinch bars without gaskets*

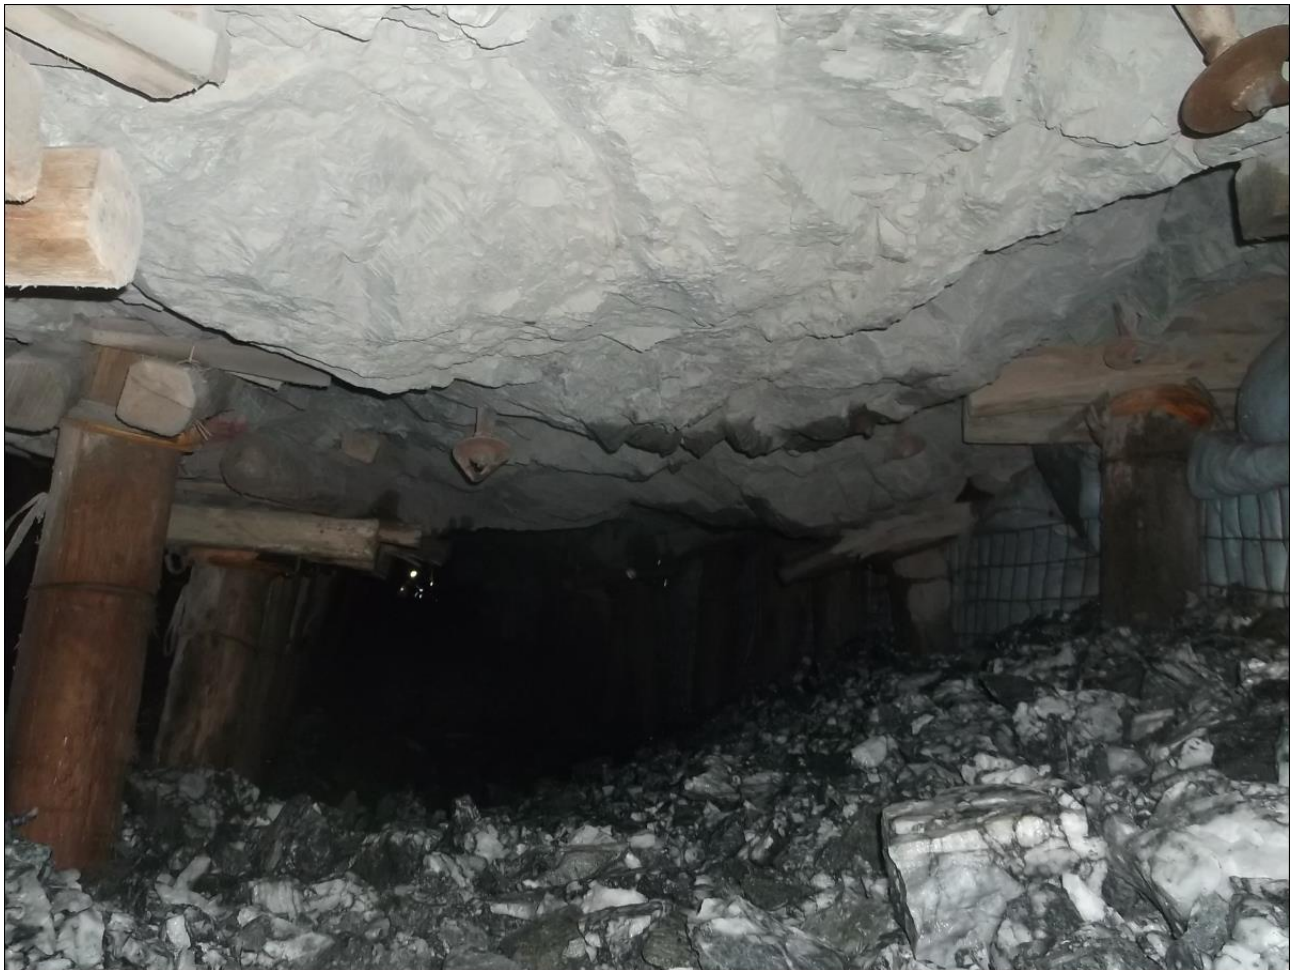
*Figure 94: Lava HW with excessive accumulations of ore in-stope*
