Bambanani Shaft - Entry Examination and Making Safe

*Date: 14th May 2021
Presented at: South African Mine
Industry MOSH Day of Learning
Presented by: Willem Gouws*

Loss of life Accident

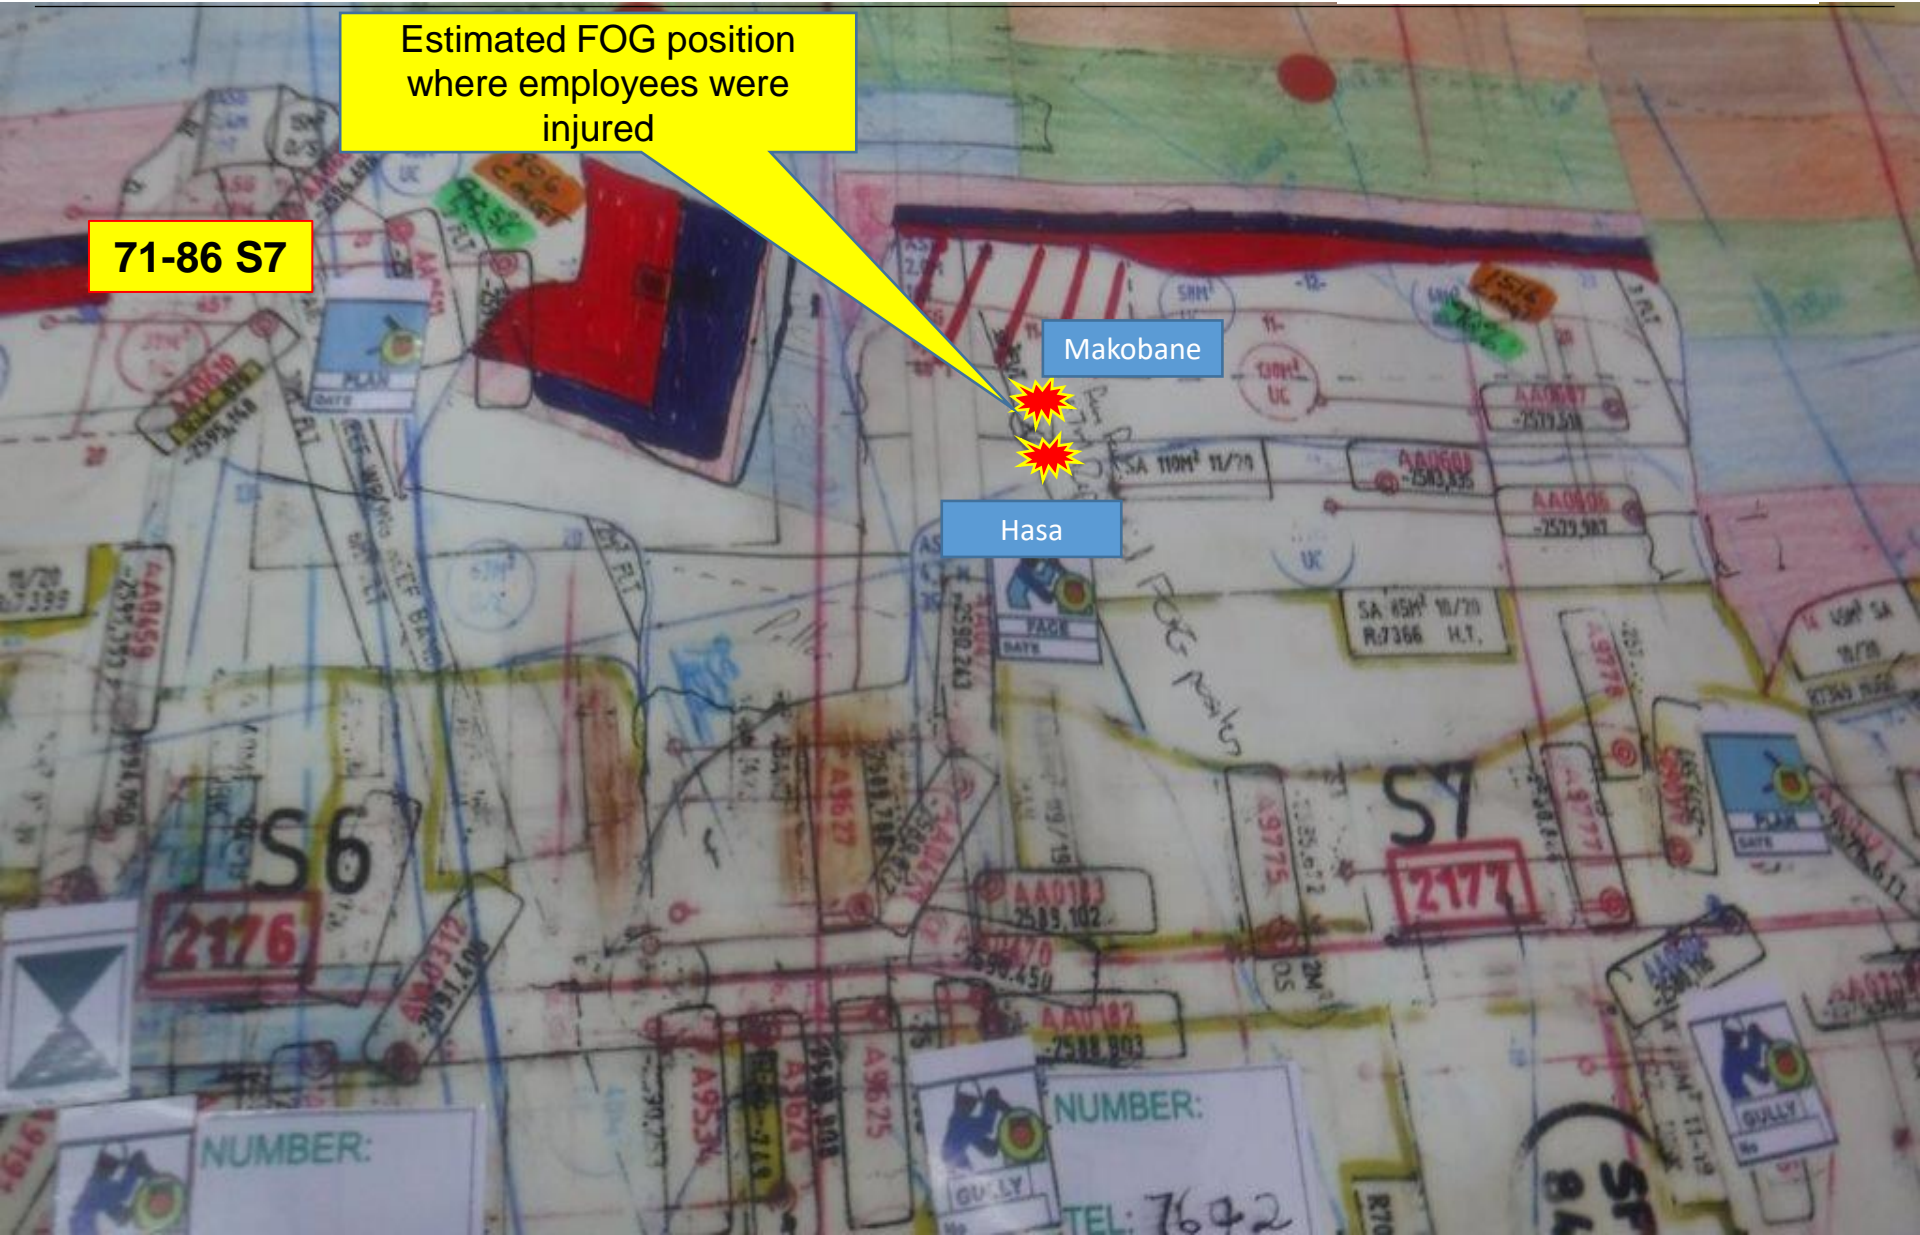
Photos Scene of Accident 71-86 S7

Estimated FOG position where employees were injured

71-86 S7

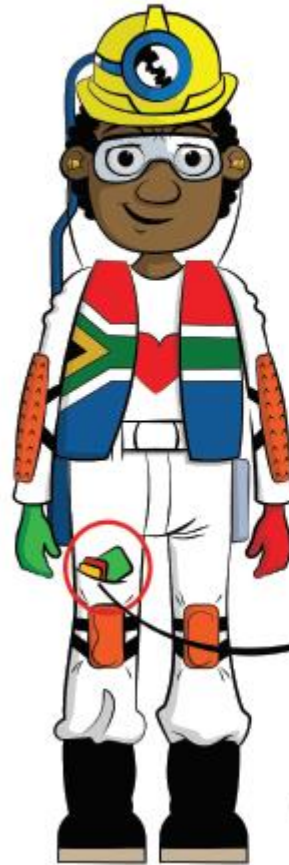
- S STOP**
& think about the people, area & tools
- L LOOK**
for potential hazards and understand energies
- A ASSESS**
if controls are in place and effective
- M MANAGE**
deviation & correct
(see green, orange and red card)

SAFE	BE CAREFUL	UNSAFE

TEAM PROCEED with operations as normal	ACTION REQUIRED only proceed with operations if safe	STOP & BARRICADE do not enter or proceed
