**LEADING PRACTICE IN-STOPE PERMANENT MESH SUPPORT CASE  
STUDY CASE STUDY AT MASIMONG MINE**

**LEADING PRACTICE  
CASE STUDY**

Permanent in-stope netting

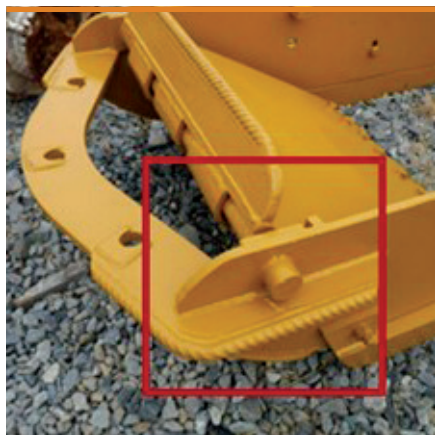
Changes made to the scraper and drilling machine to install netting in low stoping widths.

- Permanent mesh initially introduced in areas with stoping widths >1.5m in order to avoid scraper damage. Scrapers were modified in order to eliminate sharp corners and hooking onto nets. Modified scrapers allowed for cleaning in areas with low stoping width (>1.2m).
- The removal of S-Hooks from washers reduced incidents of the tendons and nets being pulled out by the scraper. Tendon support must be installed at the correct angle and spacing in order for netting to become effective and to prevent any sagging, drill rigs were modified.

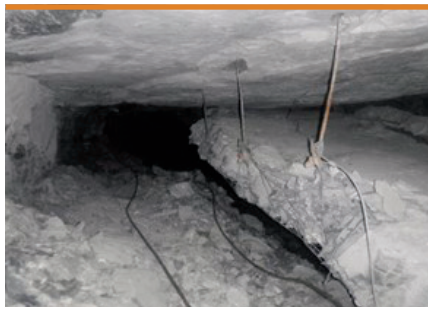
Raise line 1810 S13A centre gully hanging wall was supported with permanent mesh and tendons. Subsequent to the initial breast ledge blast, a significant FOG of 72 tonnes was suspended by the permanent mesh.

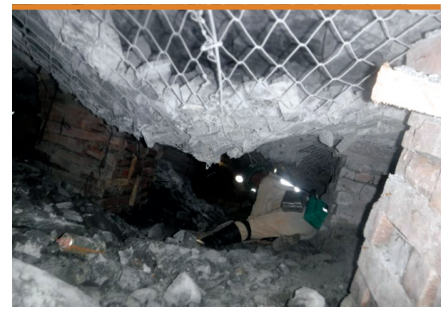
Permanent in-stope steel net arresting a seismic induced FOG following a magnitude 2.4 event at 1810 S12 E17 UD3 on 24 May 2022.

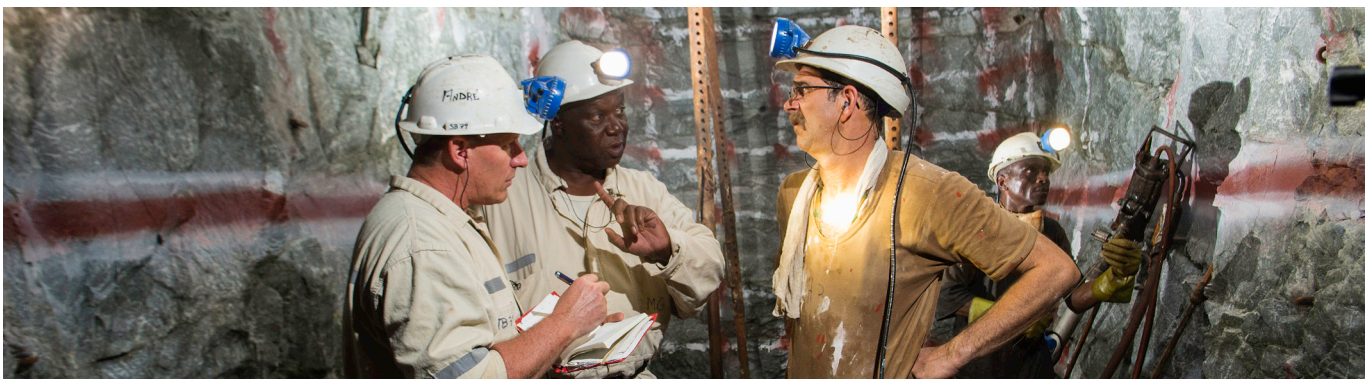
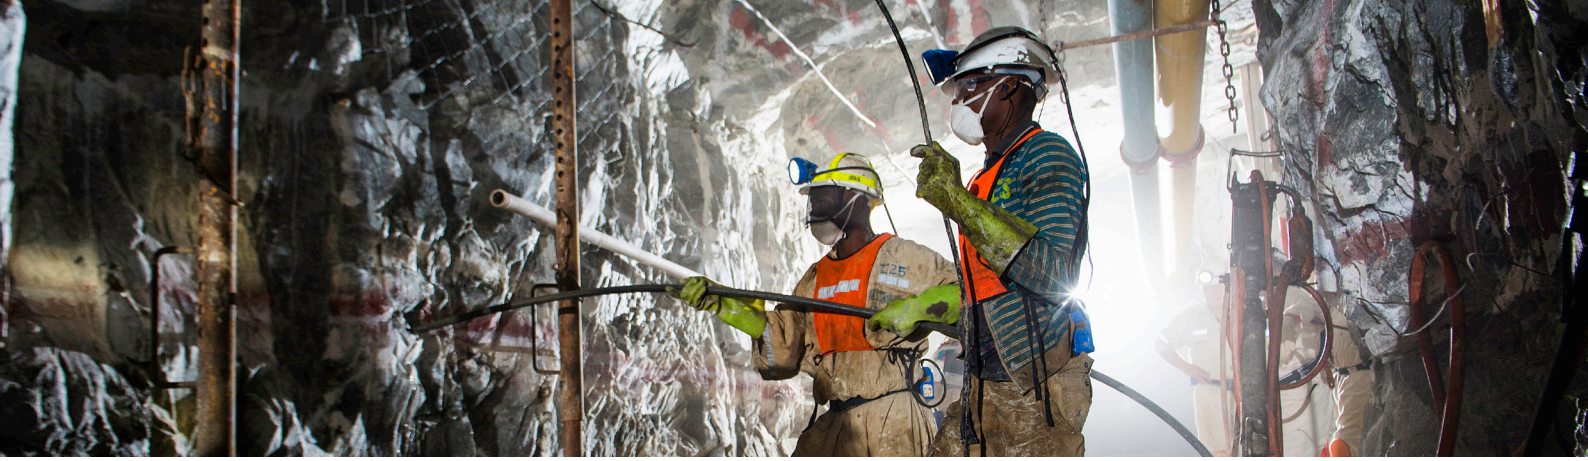
**A schematic illustrating the installation of the permanent in-stope netting**  
(section view - not to scale):
