## **1.0 FIELD LOGS – FIELD ENGINEER\_AB**

### **1.1 Platinum Mines**

#### **1.1.1 Field Log 1**

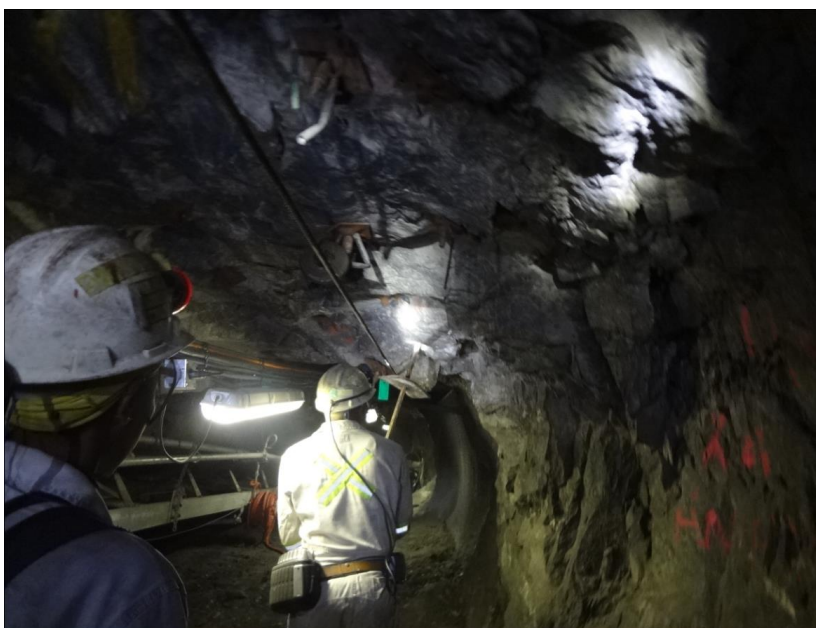
*Figure 14: Barring at conveyor belt area*

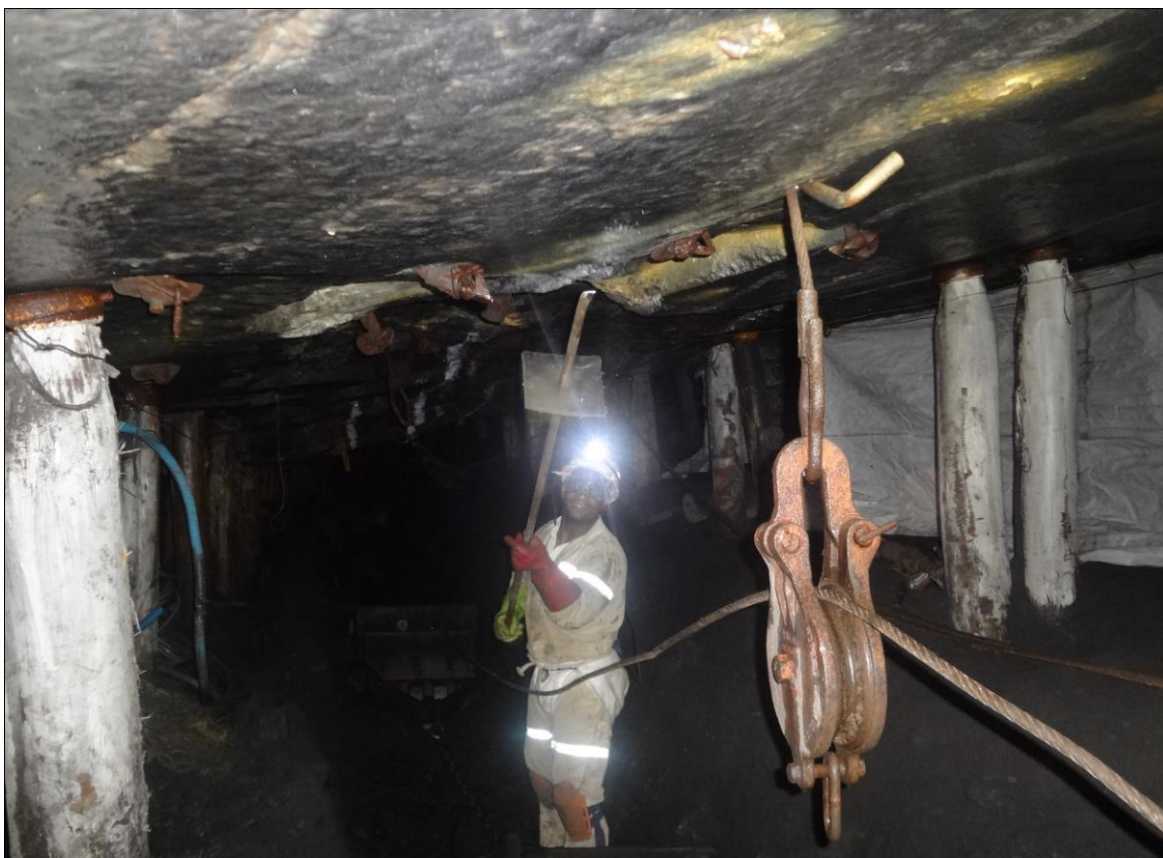
- Reef being mined is UG2 with HW Pyroxenite.
- Accompanied by SCO.
- Awaited the fixing of a water pipe in the centre gully before EE began.
- The entire crew participated in the barring survey together. The crew was responsive and enthusiastic but I was not convinced that barring is done daily and to standard by this crew.
- Barring was completed to standard.

Figure 21: Barring in strike gully

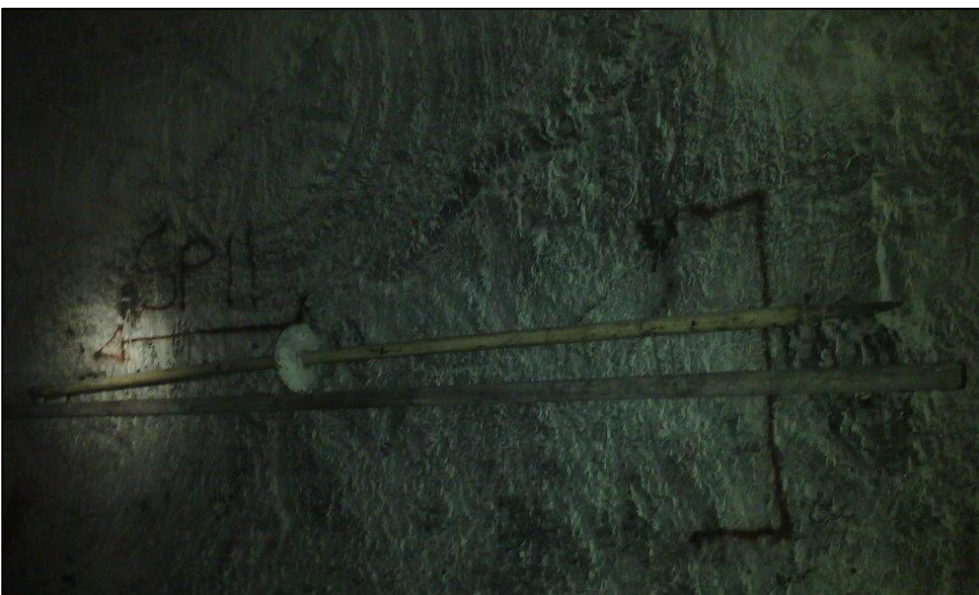
Figure 38: More barring equipment in section

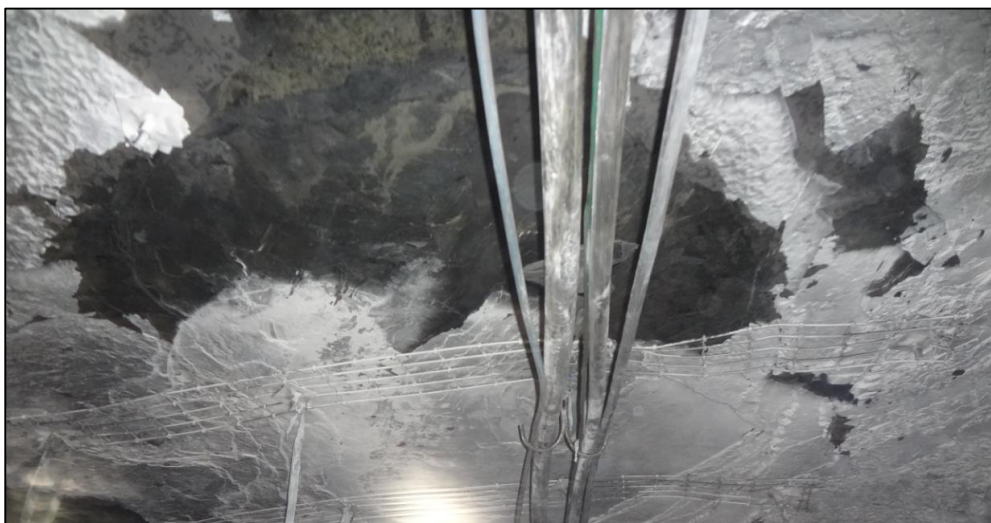
*Figure 41: Areas of the roof where barring was completed*

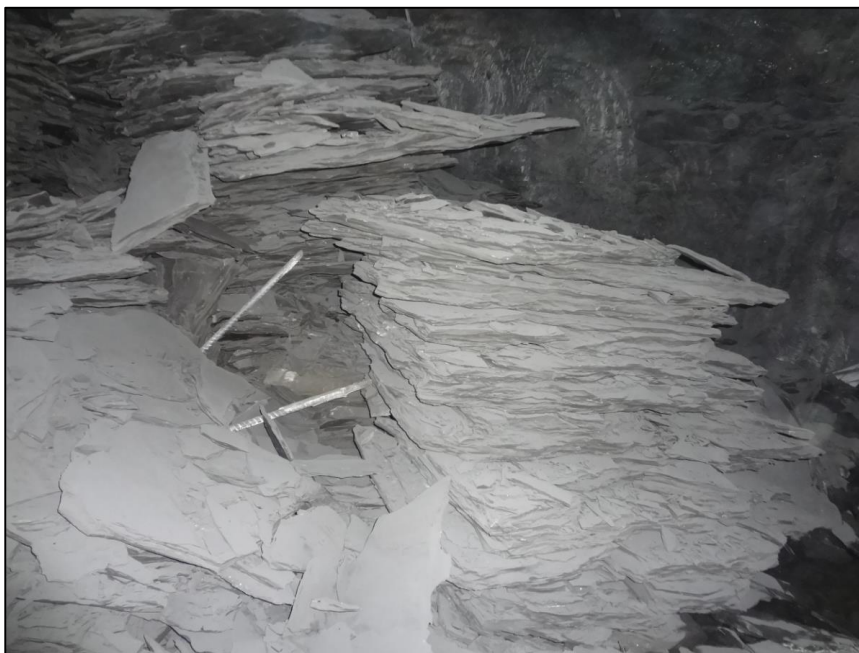
Figure 43: Large FOG in old area in the section. Picture taken to show the laminated nature of Shale and Coal in the roof

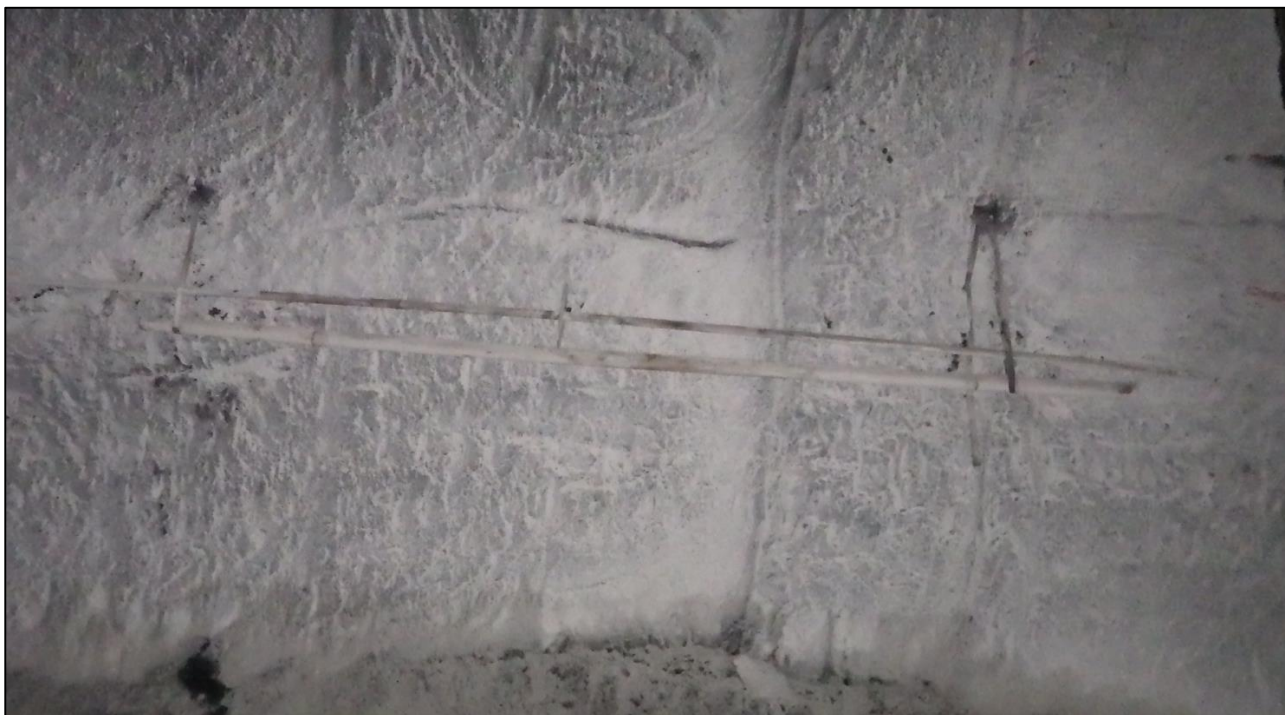
*Figure 47: Coal Barring Equipment*

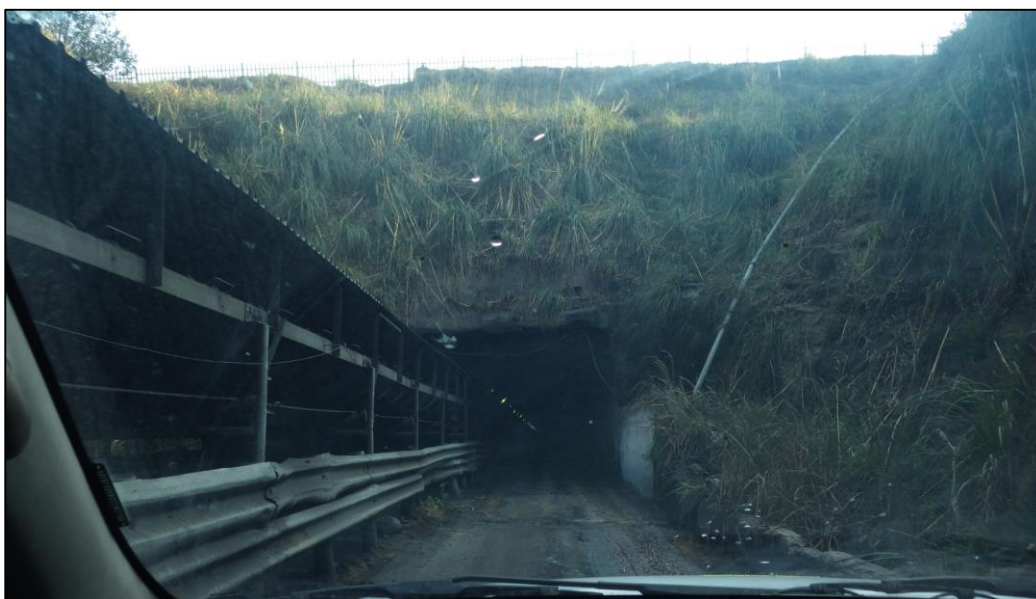
*Figure 52: Decline/ Portal entrance*

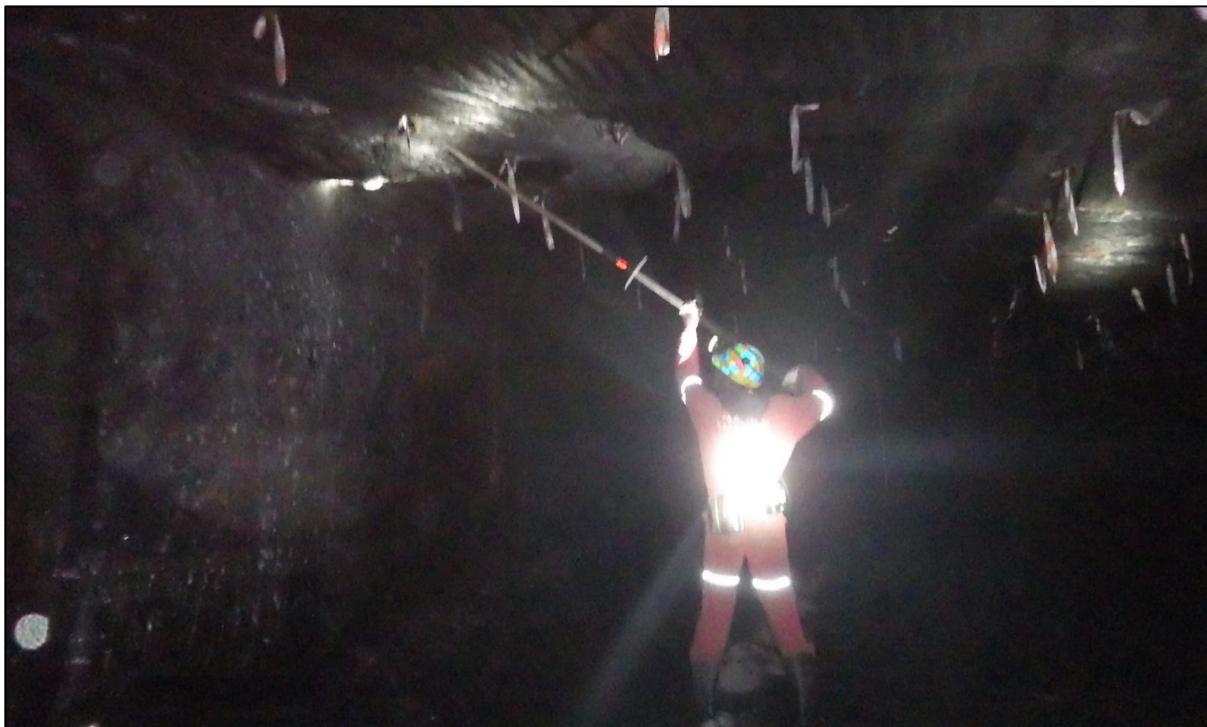
- Due to the installation of wire mesh against the roof in most roadways, there was not a great deal of roof to sound and bar.
- Personnel sometimes sounded the roof where wire mesh/ nets were installed.

*Figure 53: Barring being completed*

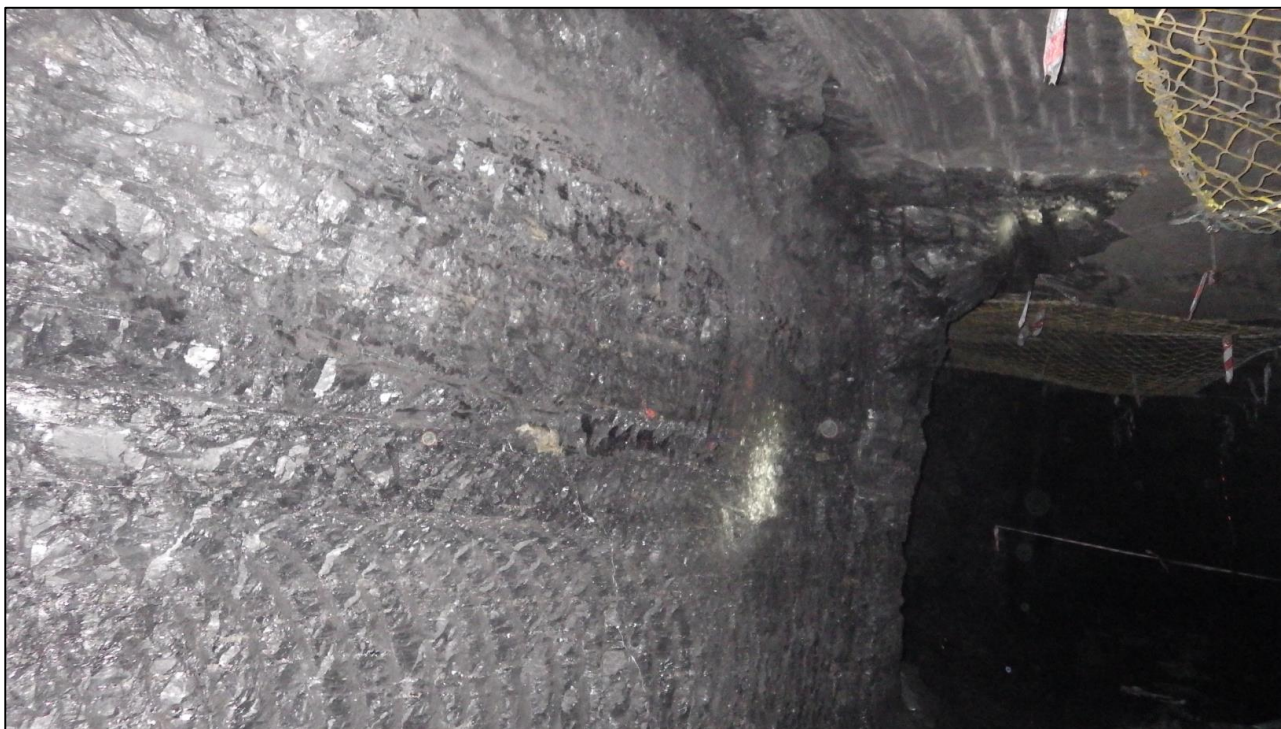
*Figure 54: Good Pillar conditions and nets tensioned against the roof*

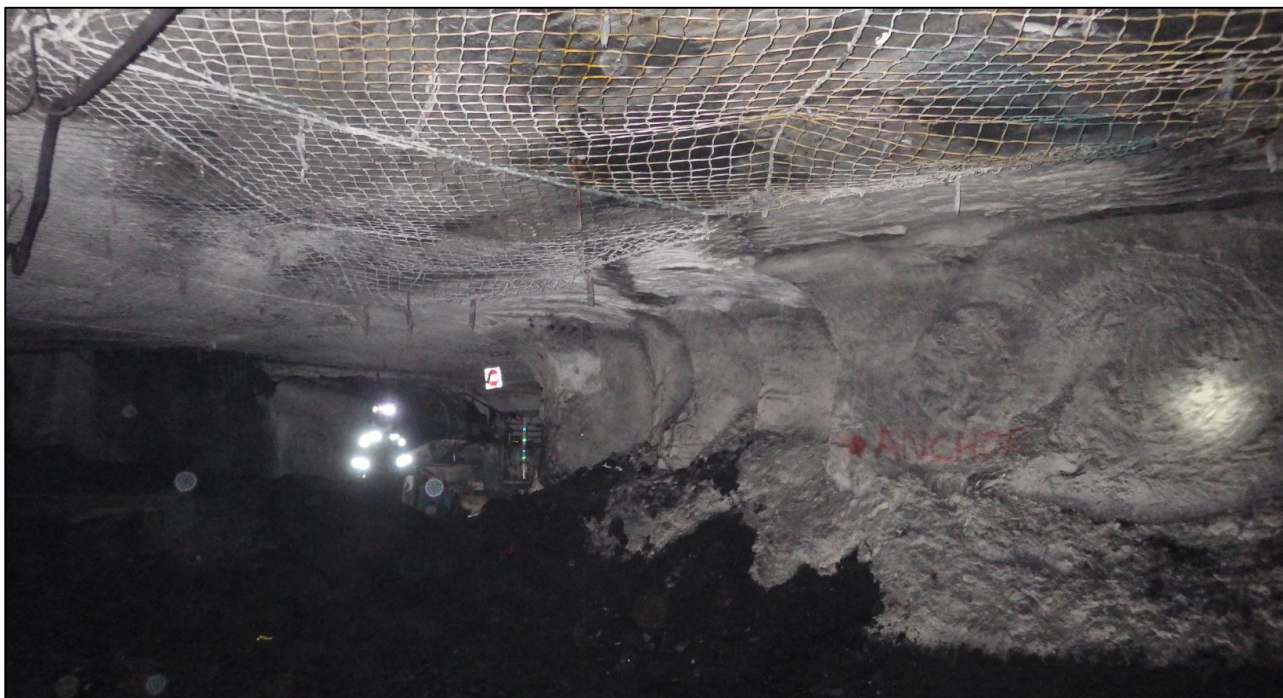
*Figure 55: Smooth roof conditions with installed nets*

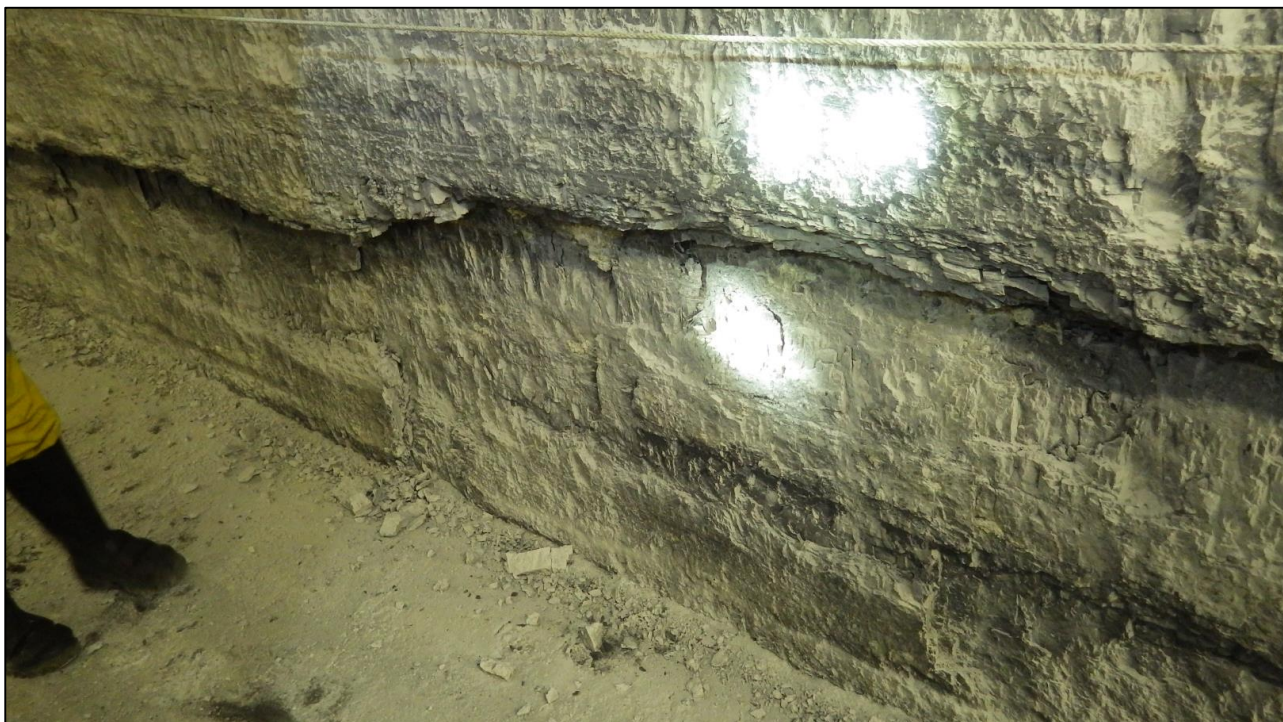
Figure 57: Scaling in rib sides

- The effectiveness of barring with the scaling machine is dependent on the skill of the operator. At times the operator was barring excessively into pillars and the roof.

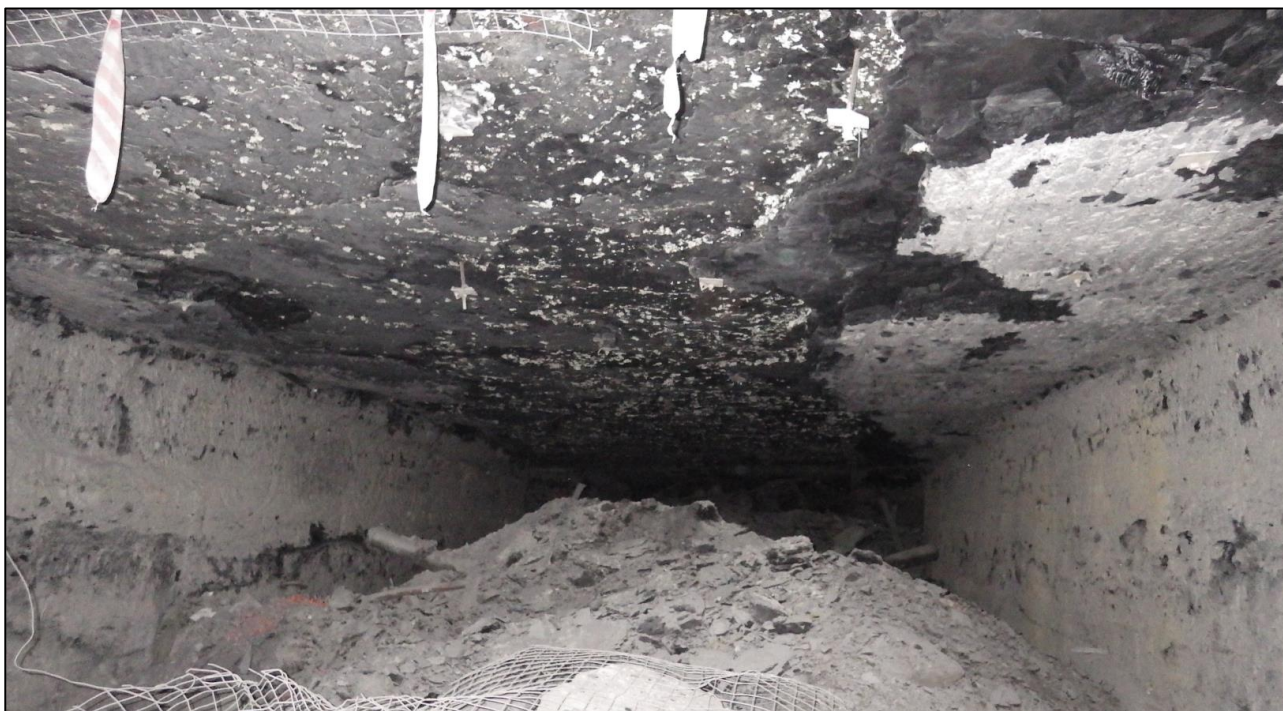
Figure 58: Scaling into roof by operator - Top RHS of picture

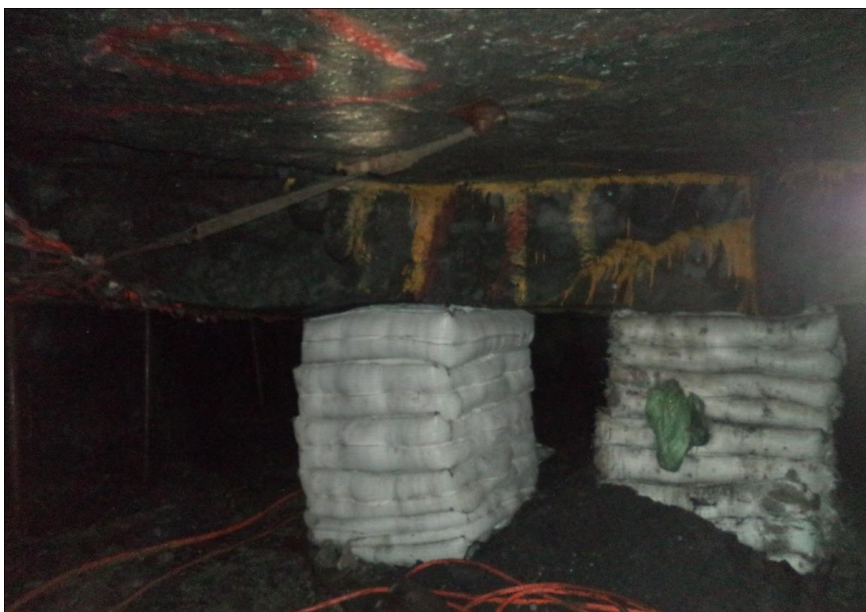
*Figure 60: Large Brow supported with Grout Packs*

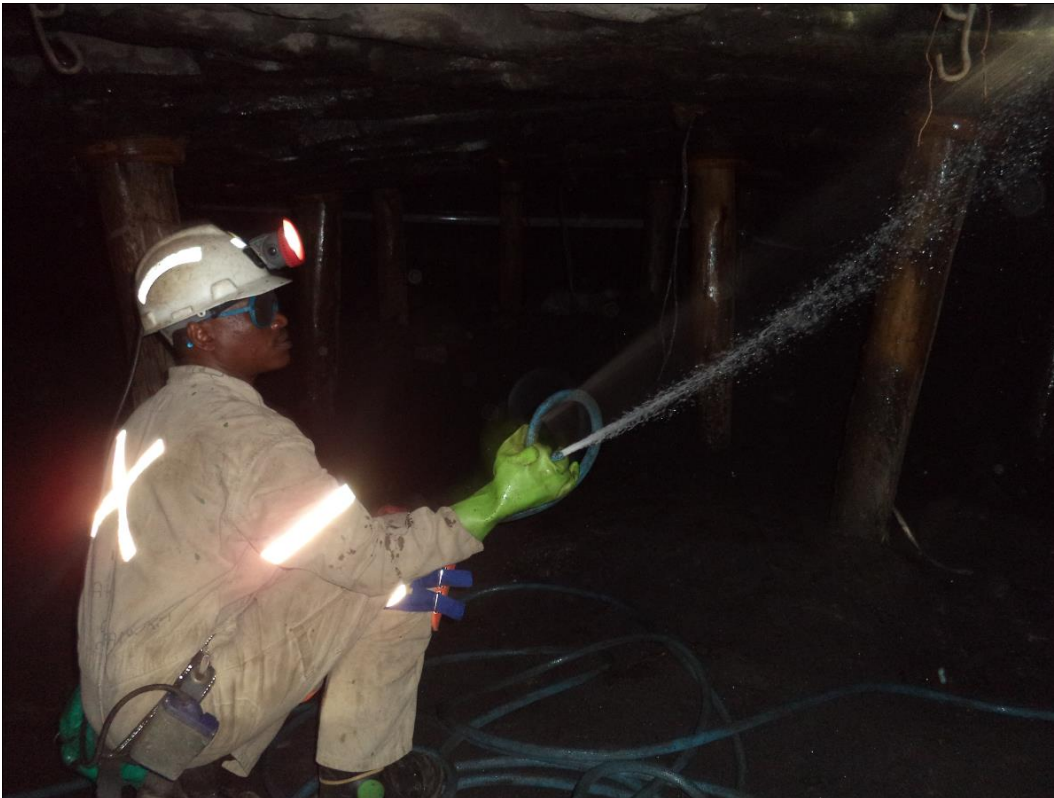
*Figure 62: Watering down prior to barring*

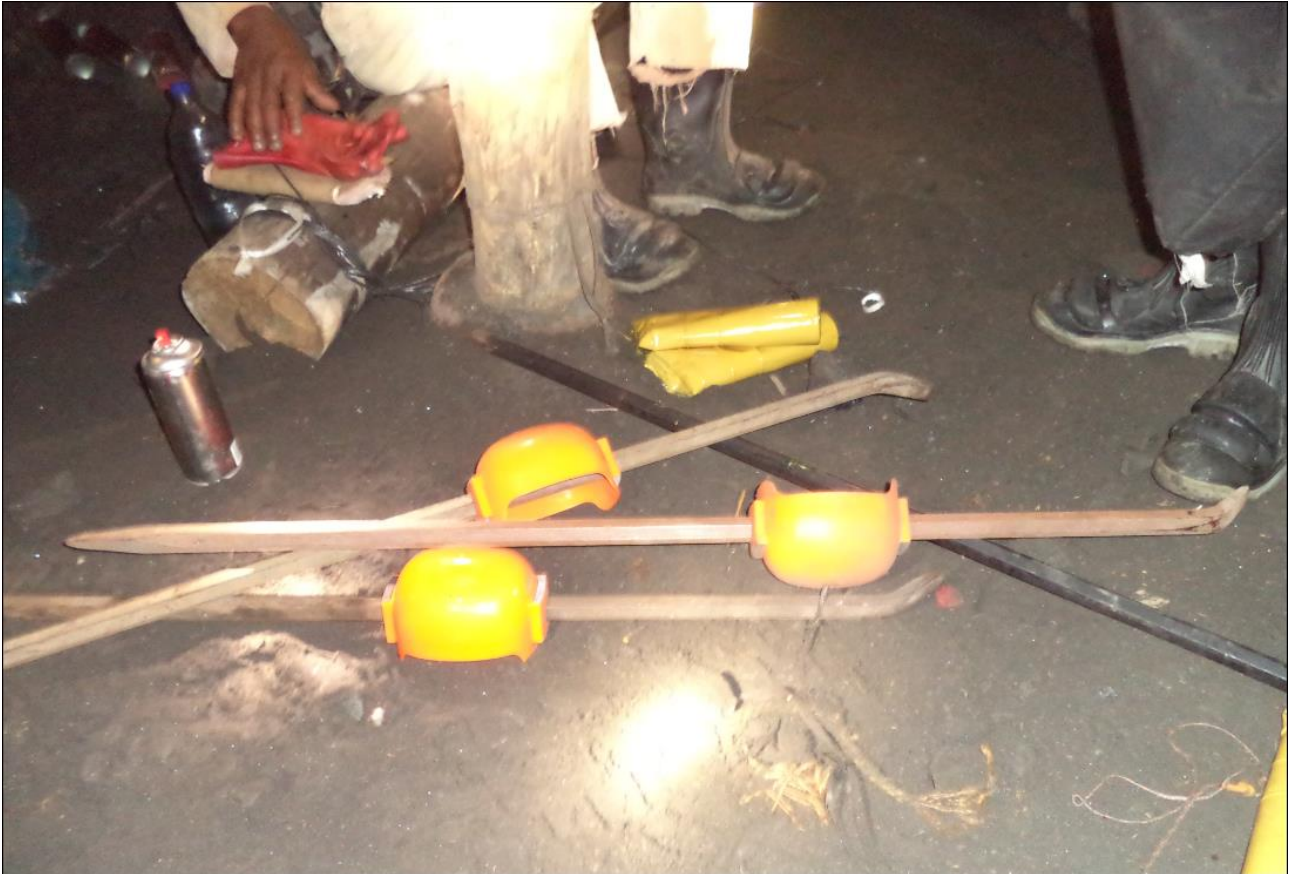
- Large rock blocks were barred down (1.2m x 0.7 x 0.3m) was barred down and fell alongside the scraper. Three people were needed to bar this down.
- One person took the wrong position, used the incorrect length pinch bar and didn't place his hands behind the pinch bar and attempted to bar. The shift boss stopped him and coached him.
- Orange gaskets are sometimes used. This is preferred because it is lighter and easier to get onto the pinch bar.

Figure 71: Orange gaskets on pinch bars

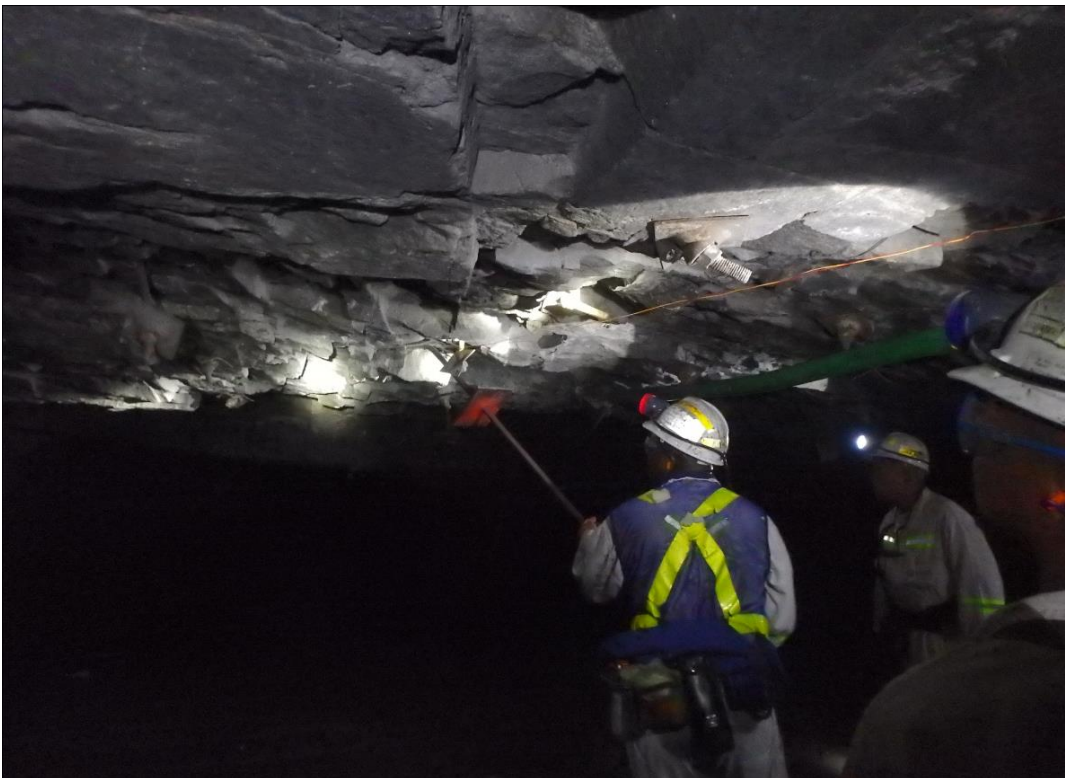
Figure 73: Barring blocky hanging wall

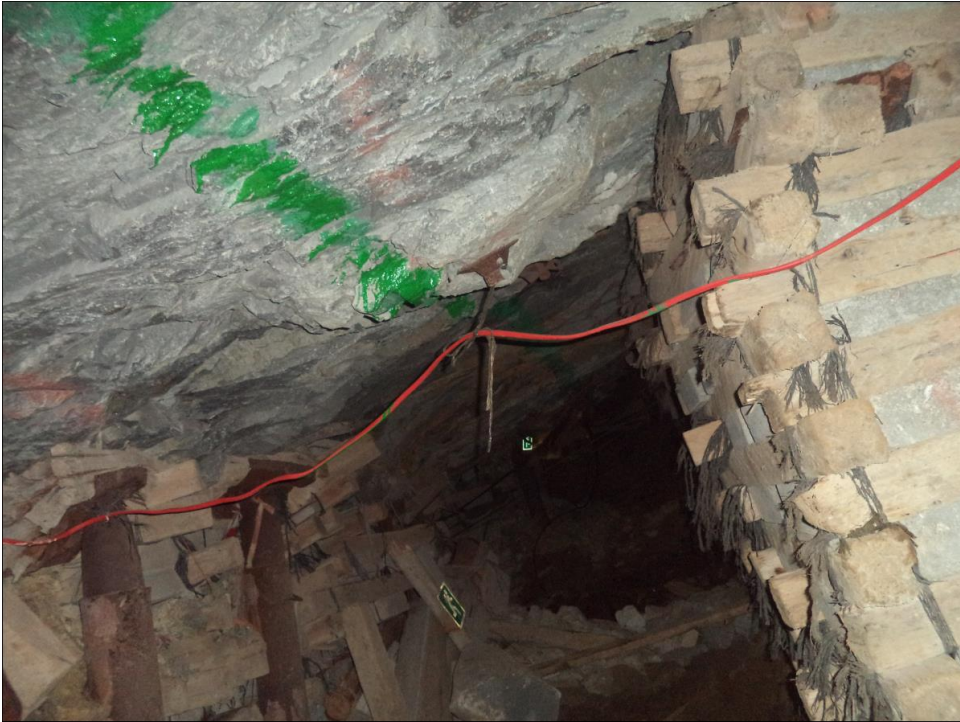
- Some barring was done in the travelling way; however it's still inadequate given the unfavourable joint orientations.
- Hanging wall is very blocky, closely spaced near vertical discontinuities with cross-cutting sets with varying shapes (wavy, some planar) and spacing forming the very blocky conditions.

Figure 77: Gully HW condition
