## **1.0 FIELD LOGS – FIELD ENGINEER\_AB**

### **1.1 Platinum Mines**

#### **1.1.1 Field Log 1**

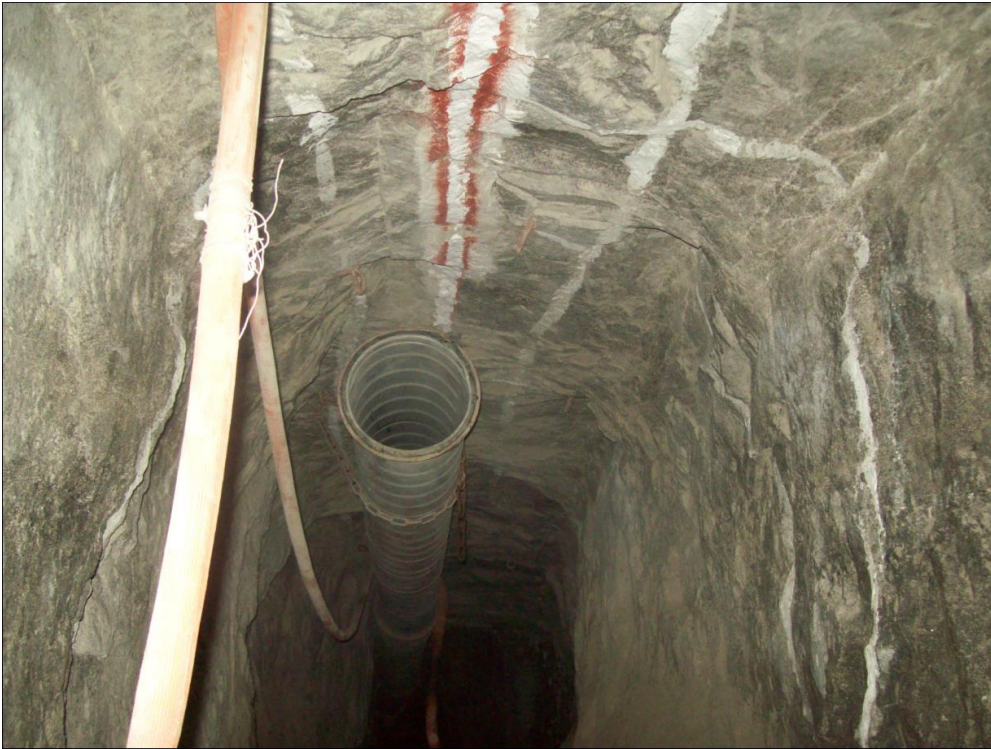
- Shift Supervisor/ Shift Boss did not even enter the working place. Researchers were accompanied to the waiting place and were escorted into the winze by the miner.
- Shift Sup. Was negative and did not allow researchers to talk to mining personnel. He was of the opinion that things cannot be improved that much, especially barring.
- 2.2m winze – Researchers did not go down with the shift and thus did not observe entry examination taking place. However, visual examination and the presence of barred rocks showed that barring was done at the face area.

Figure 3: Barred winze

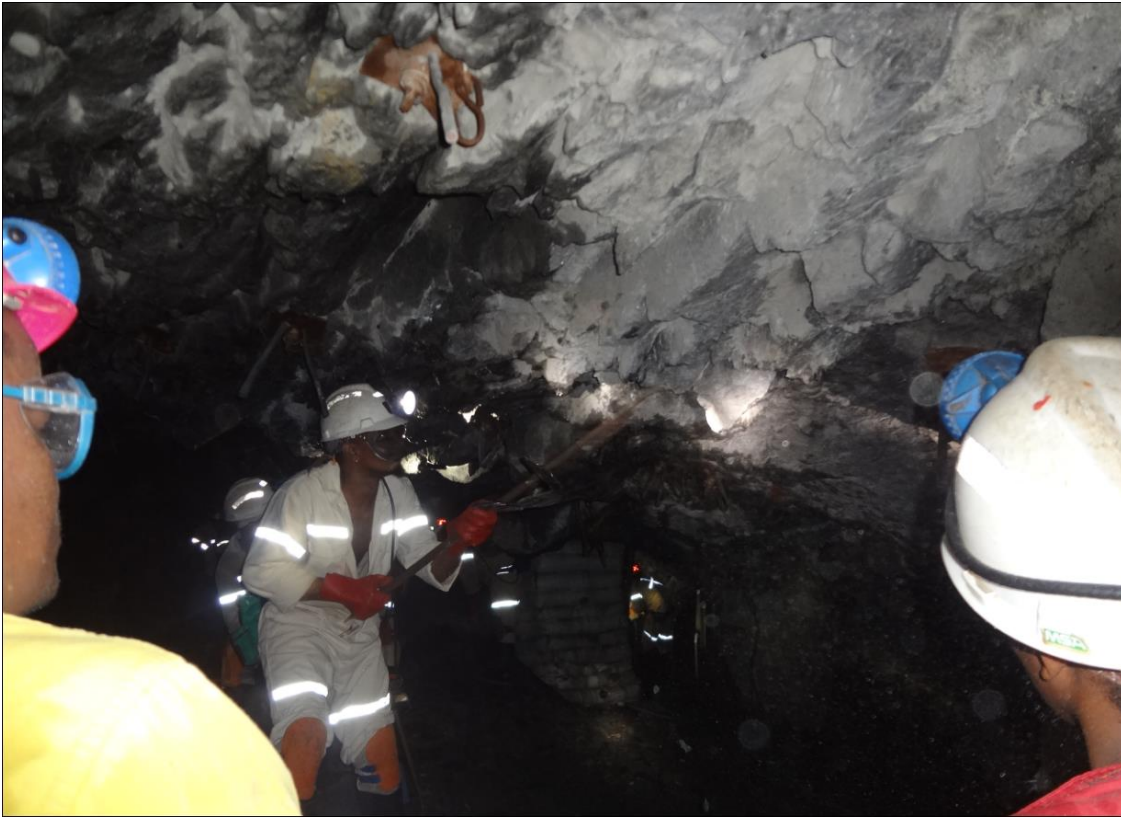
- Reef being mined is Merensky (881m below surface). Stopping width is between 1.4m to 1.6m.
- Hanging Wall is Pyroxenite and is very jointed and blocky.

*Figure 6: Blocky Pyroxenite Hanging wall*

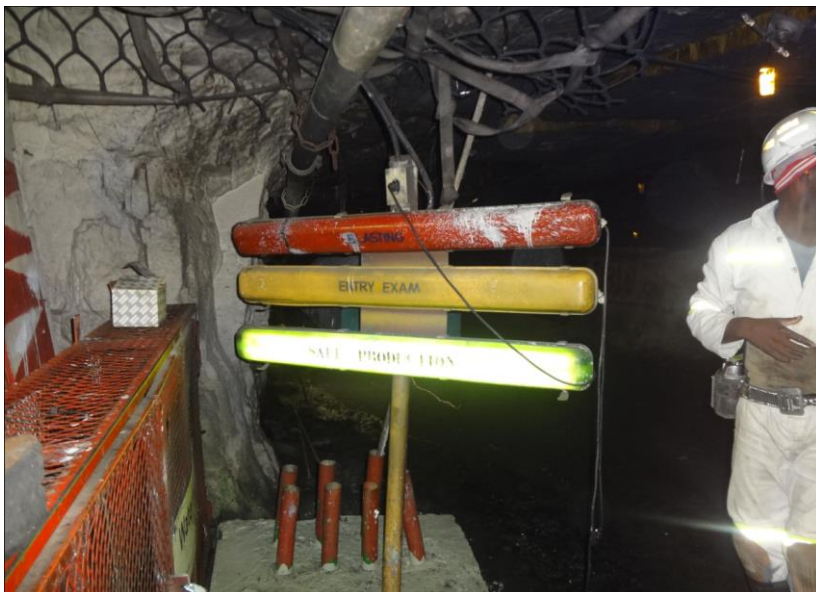
*Figure 13: Great concept of warning lights at waiting place*

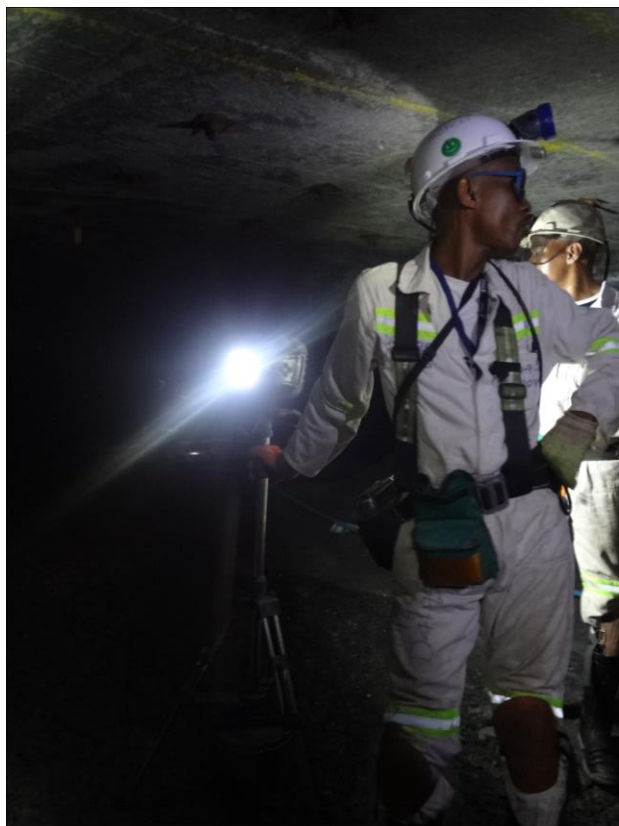
Figure 16: Use of entry examination light

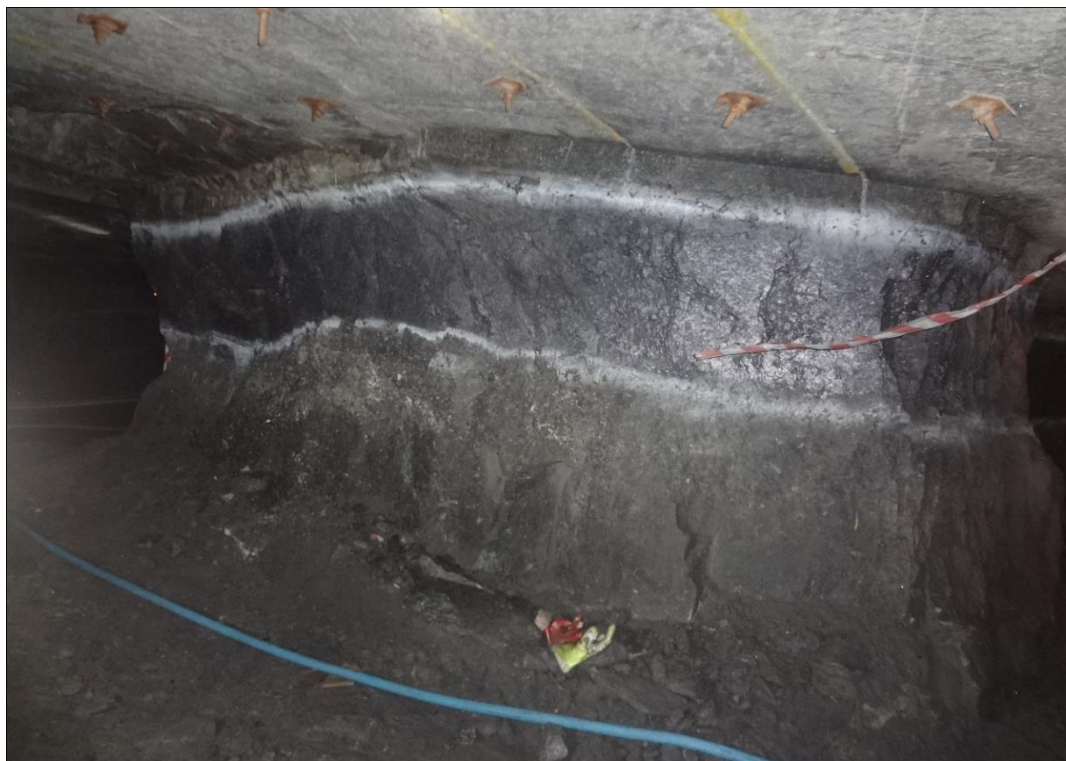
Figure 17: Fully illuminated pillar

- Hand placement behind gasket is good.

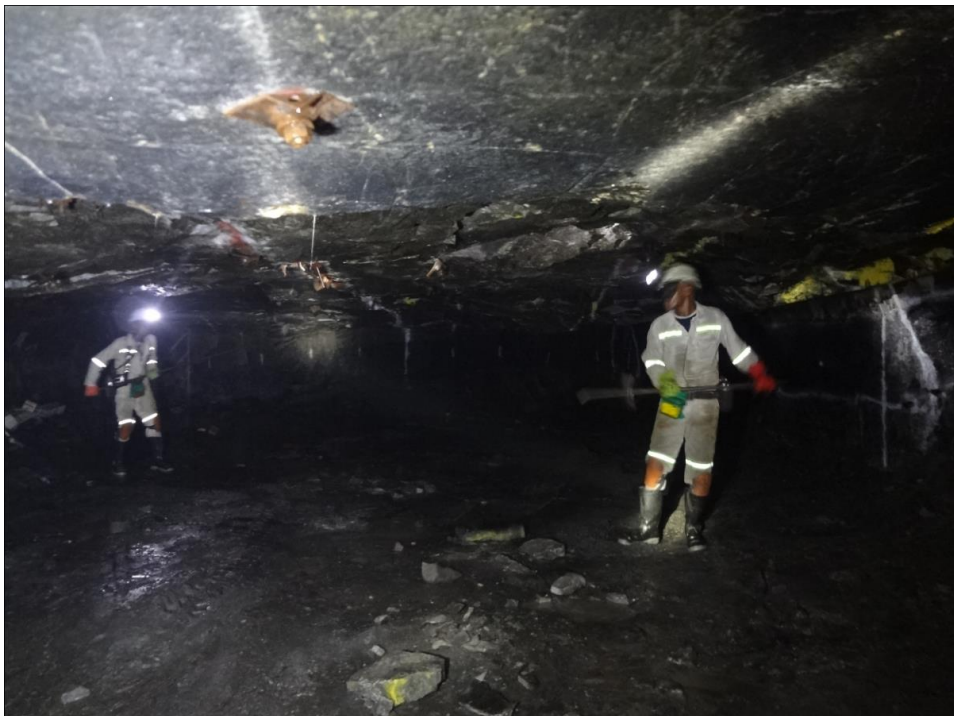
- Knowledge of the eleven rules is lacking by this crew.
- No defined route/process is followed, people walk easily into un-examined areas.

Figure 18: Multiple barriers

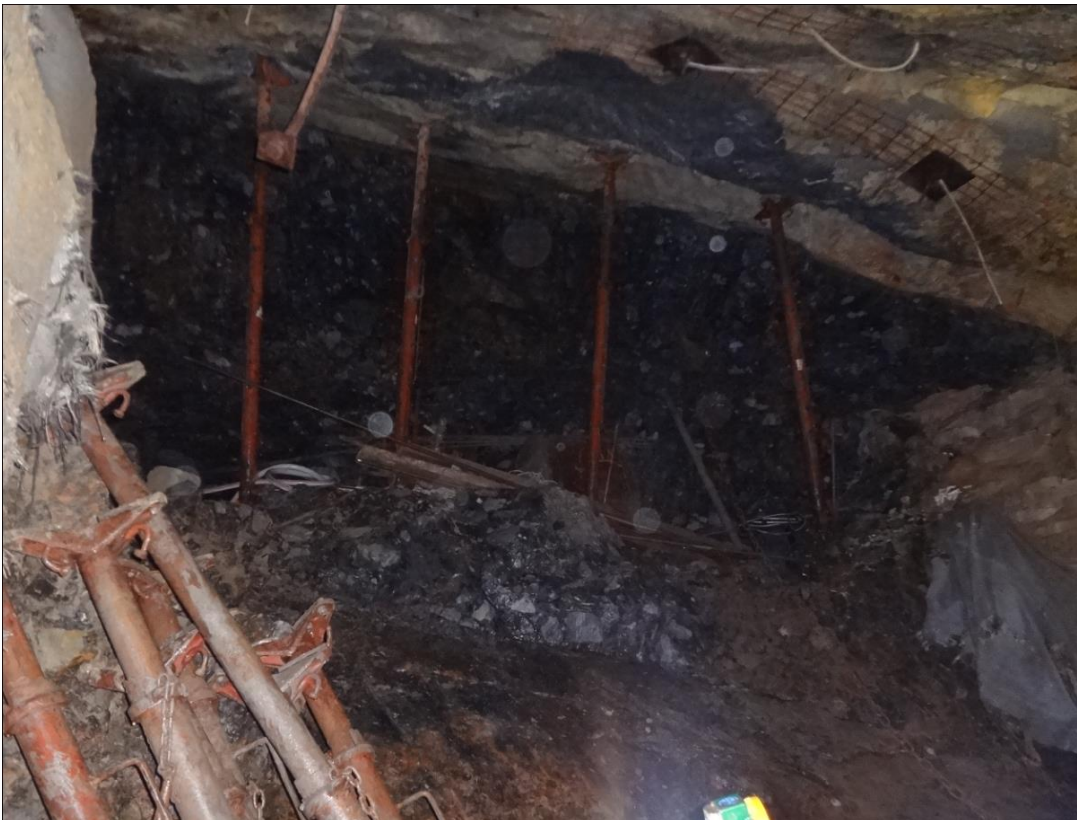
Figure 31: Top cut of Paddock area

- Observations on barring in the PADDOCK:
- Very high SW - 5 to 6 m in lower areas.
- Areas of the gully/ entrance and TW extend to beyond 10m high. 5.5m cable anchors and 2.3m long roof-bolt are used, as well as backfill.
- Barring was done well, but coaching addressed some minor issues.
- Buddy barring was good.

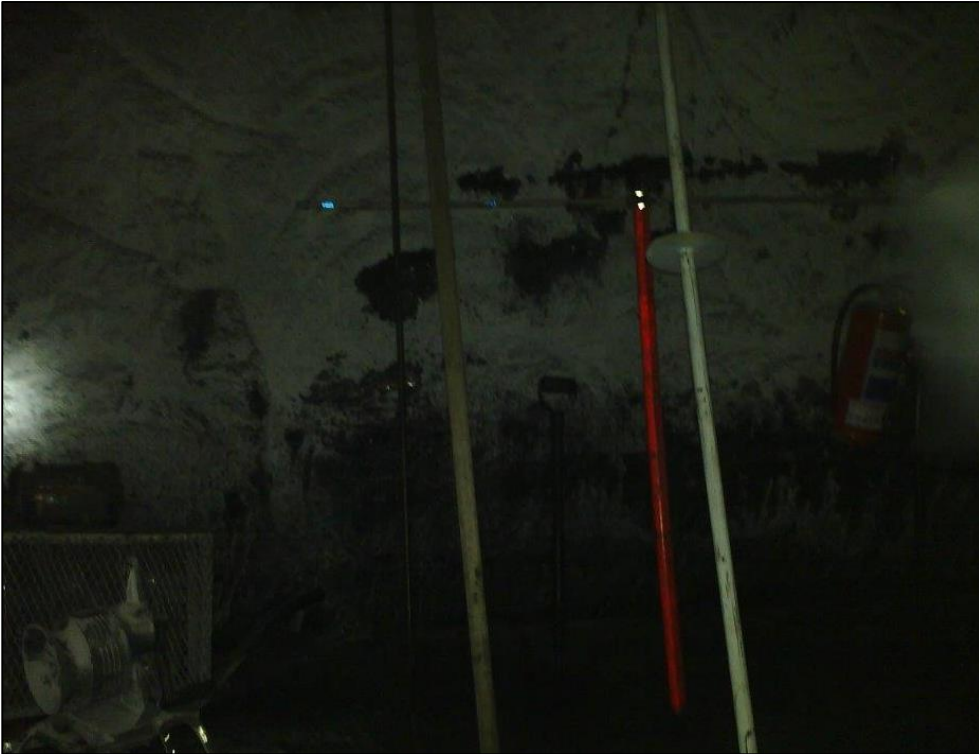
- Three people eventually started to sound and bar using a Combination stick and a conventional set comprising a sounding stick and pinch bar.
- Many areas at the edges of pillars were barred. Visual inspection was good, but there was little evidence of sounding marks from prior shifts.
- Ribs look scaled adequately.
- Roof conditions appear good to fair in certain roadways. Minor guttering.

Figure 37: Pinch Bar and Sounding Stick

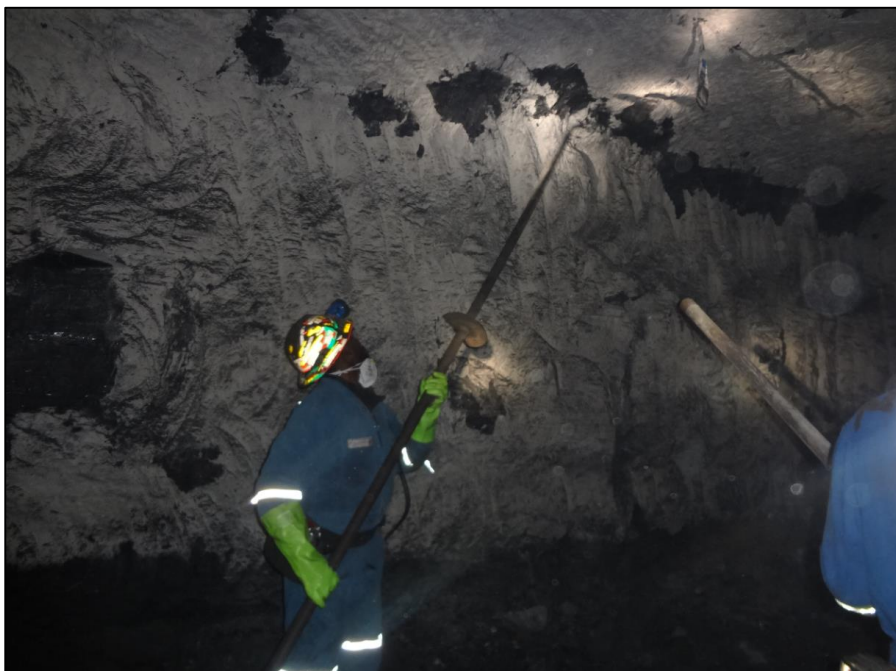
*Figure 40: Barring pillar corners*

- Barring was done well and thoroughly.

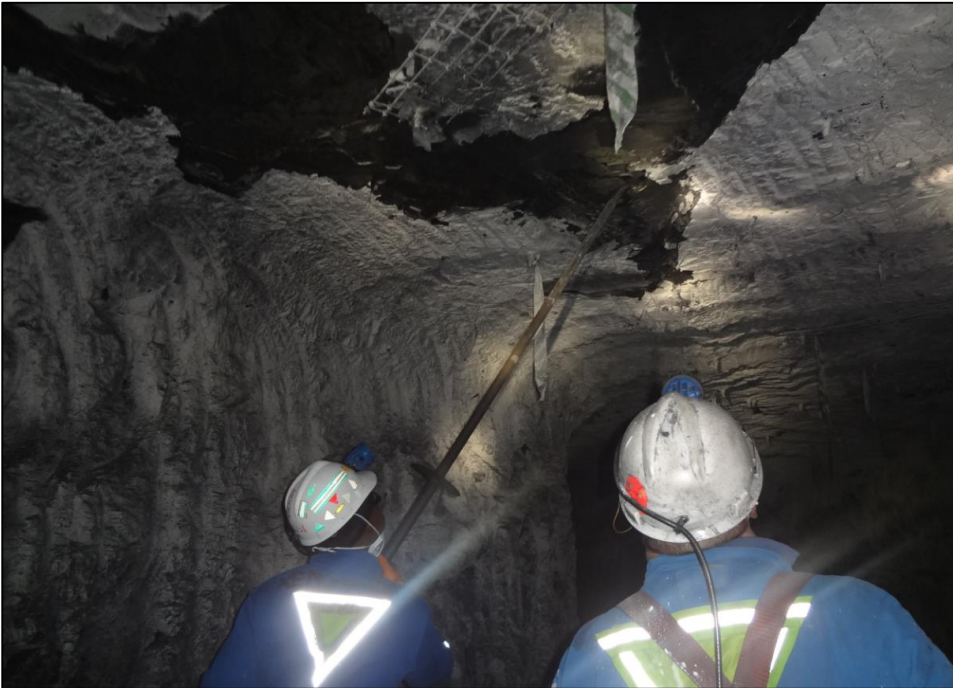
*Figure 42: Buddy barring in action*

- Sides of pillars are supported with roof bolts in special areas.
- Strips and anchors used at intersection points.
- Contractor and employees undergo the same training.
- Evidence of previous sounding due to marks observed on the roof.
- Stories about cat (nicknamed Mr. Mine Captain) and an owl living underground were told by the shift boss. Footprints or paw prints were seen but no picture was taken.

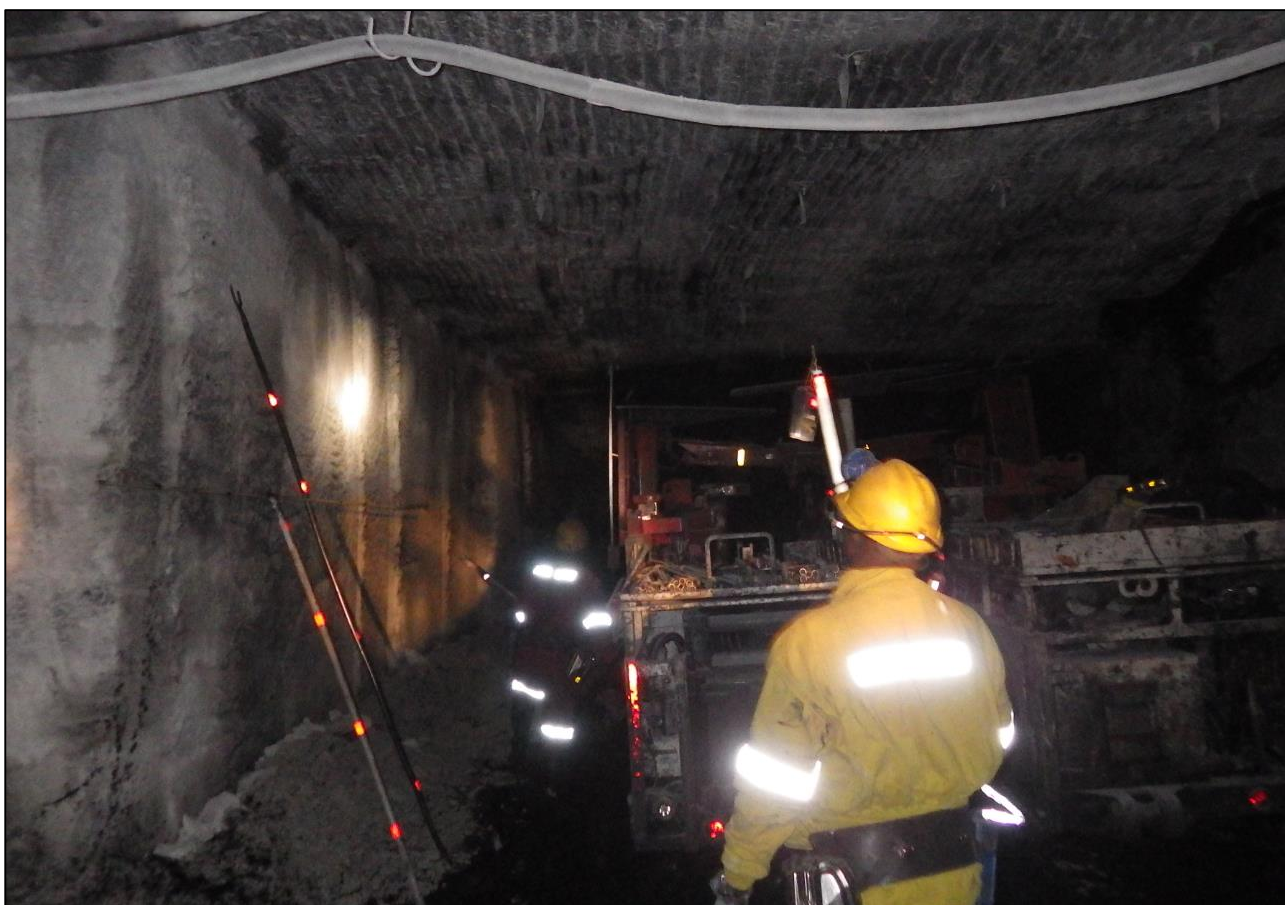
*Figure 48: Equipment made more visible with the addition of reflective tape on pinch bars and sounding sticks*

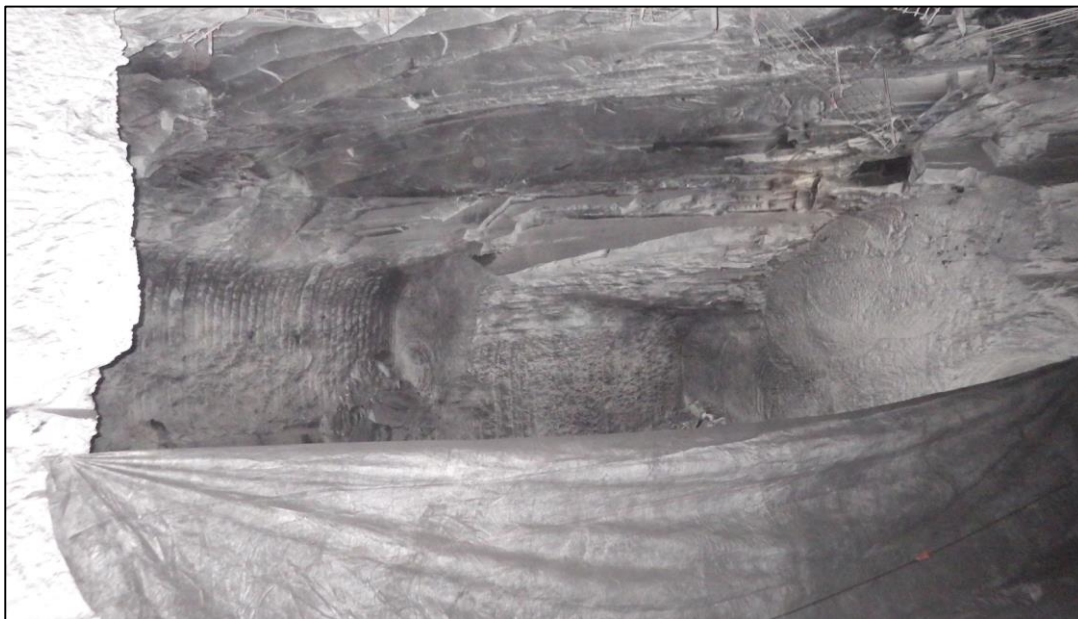
Figure 50: Roof laminations

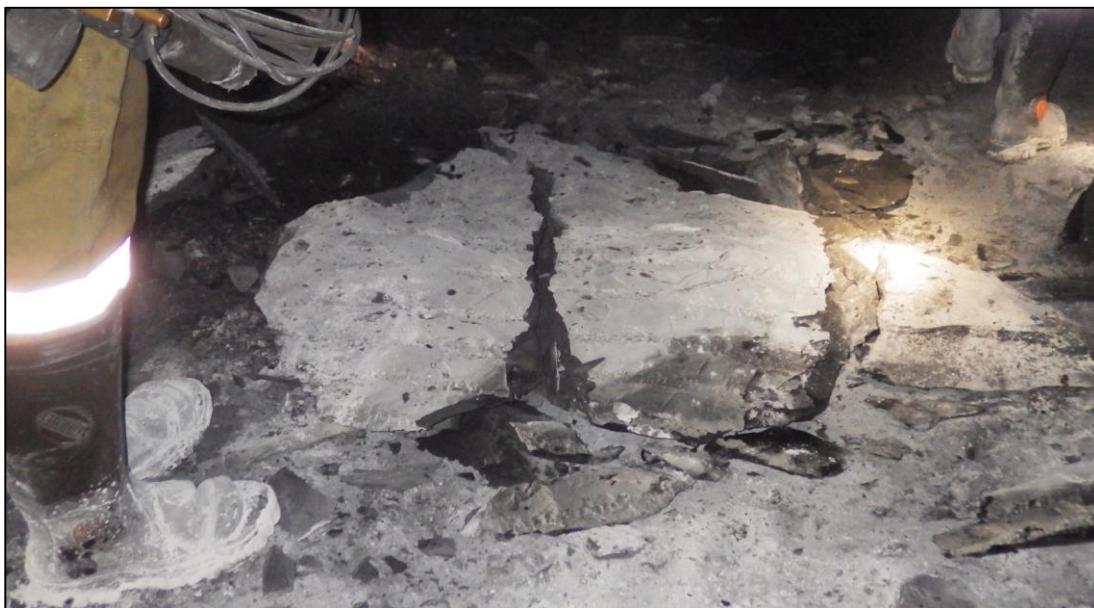
- Waiting Place meeting was held and crew proceeded to complete entry examination together.
- A Combination Fibreglass pinch bar and sounding stick was used.
- Roadways were extremely high at parts i.e. higher than could be reached with 4.5m pinch bars. The barrer thus strained to reach rocks that could be barred down. No attempt was made to fetch a longer pinch bar. It is suggested that perhaps a longer pinch bar was not available in the section.
- Barring and sounding was done in too sporadic a manner. Thus, many areas remained that would still require barring in future shifts.

*Figure 51: Size of rocks barred down*

- Visual examination was poor – the section was dark and cap lamps did little to illuminate very high areas.

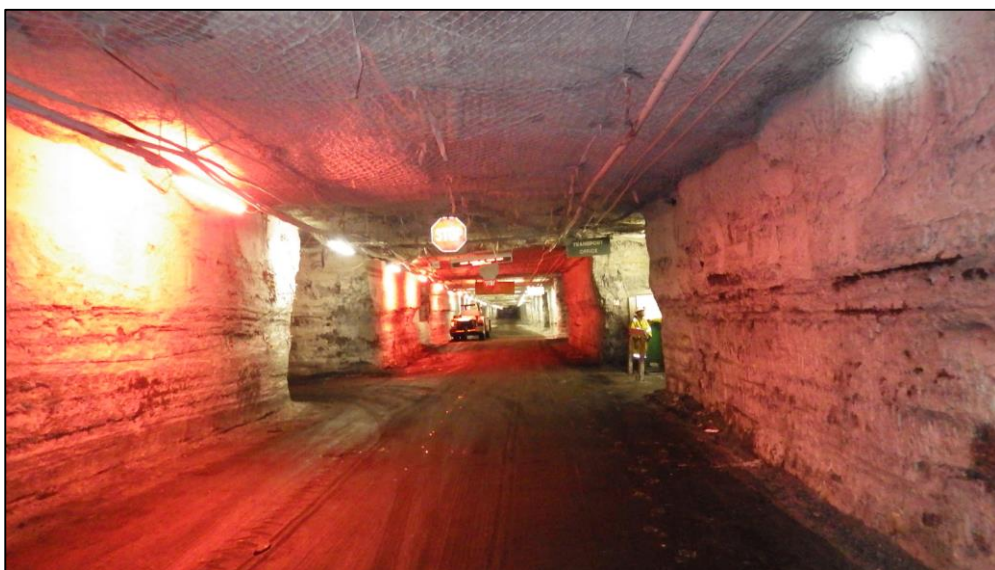
*Figure 56: Outbye area*

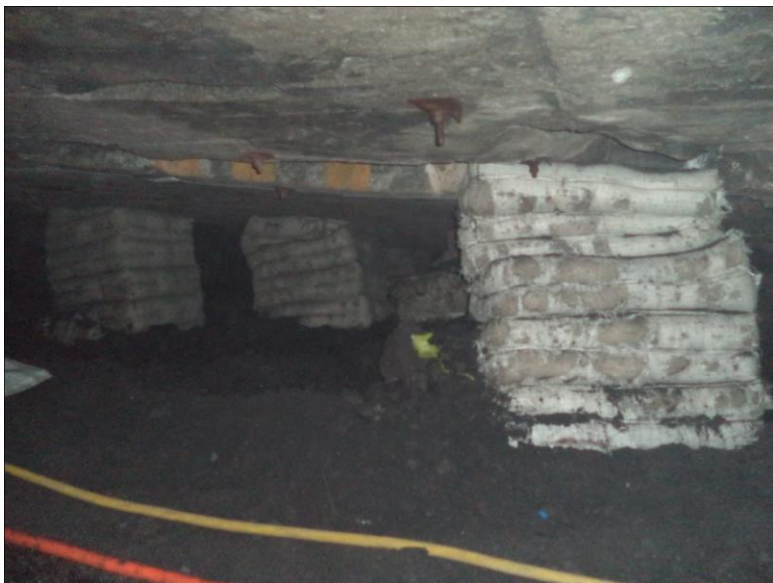
*Figure 59: Good HW conditions*

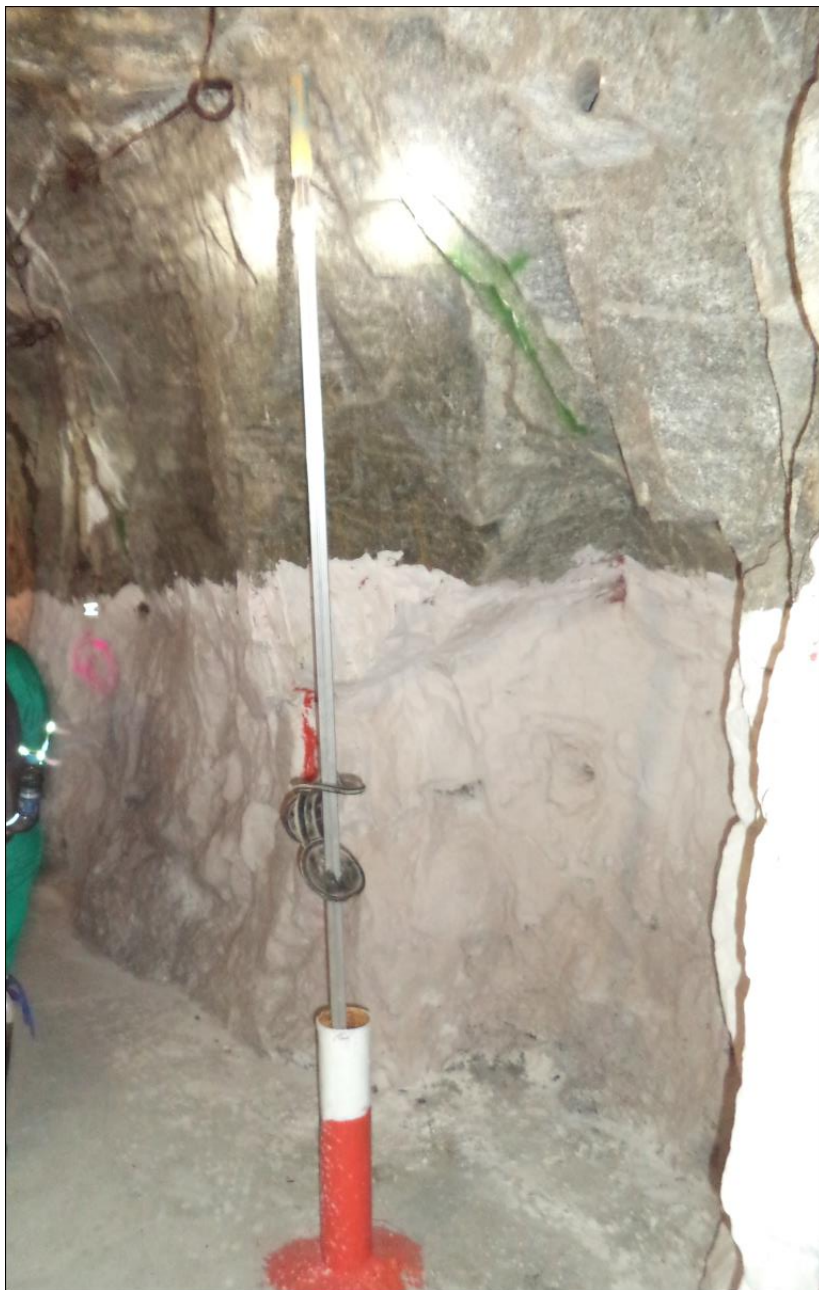
- Pinch bar condition was good.
- Training centre well equipped.
- Interviews with trainers and trainees.

*Figure 61: Pinch bars in haulage*

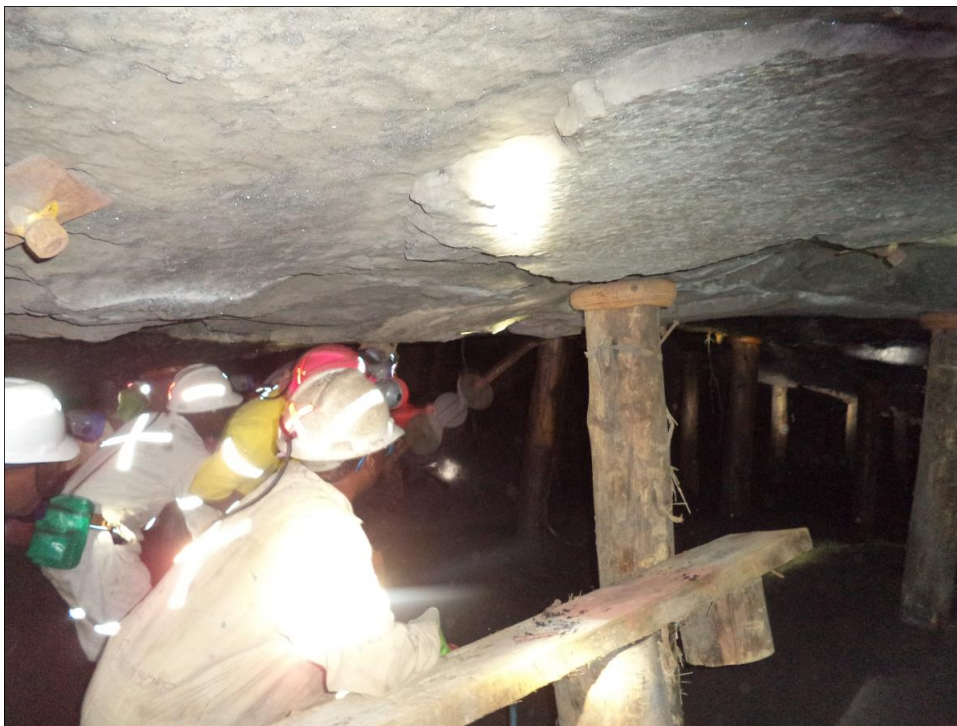
*Figure 63: Crew involvement and participation*

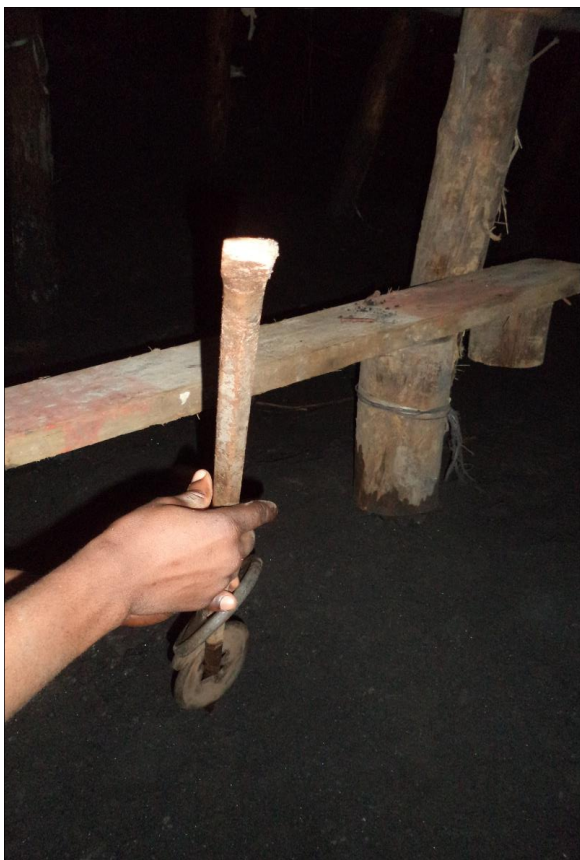
- Long meetings and discussions at the waiting place.
- Failed support observed in the panel, it was reported to the shift boss.
- Observed reef in hanging wall. More barring was needed in places.
- Blunt pinch bars in the panel. Safety rep to exchange these.
- Interviews with people in the stope. People know what's required of them but don't always feel safe.

*Figure 64: Blunt, old pinch bars*

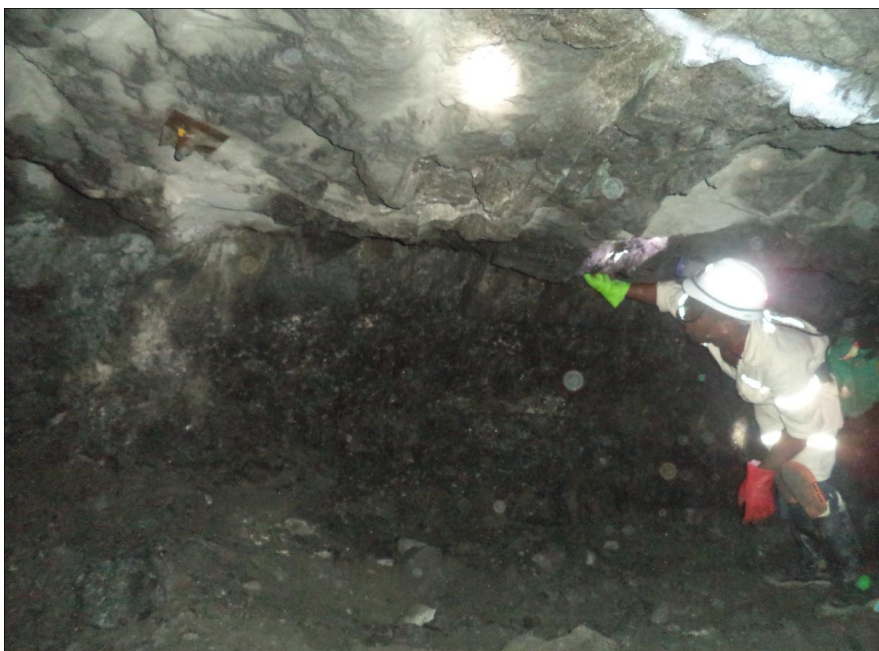
- More barring needs to take place. Some areas still needed barring.

*Figure 66: Blocky Pyroxenite HW*

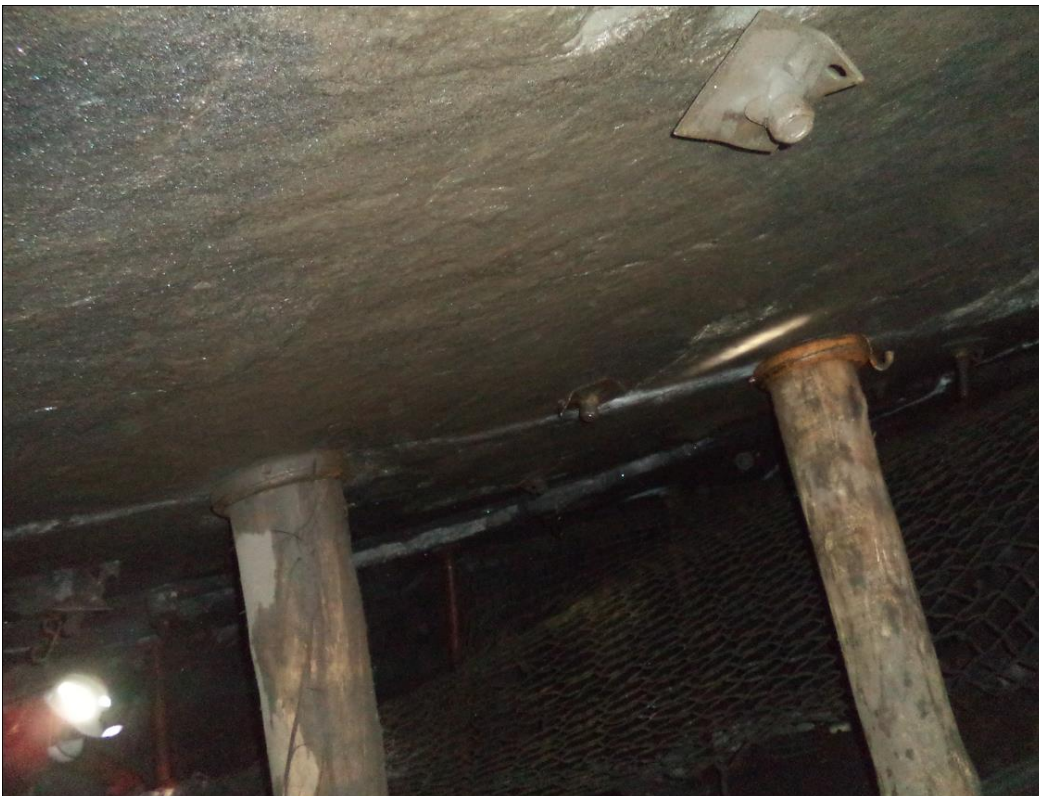
*Figure 67: Good Pyroxenite HW conditions*

- Blunt pinch bars are used.

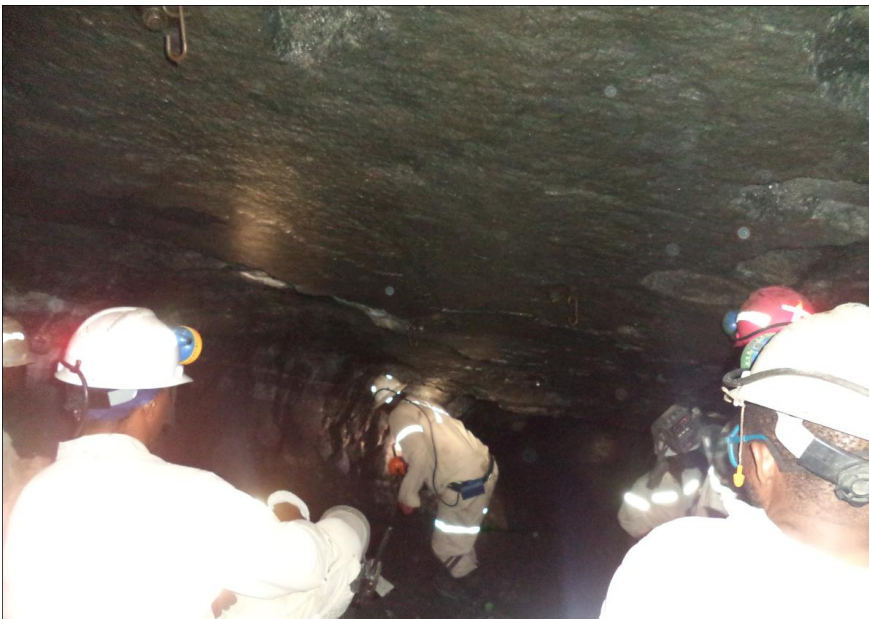
- Observed barring in steeply dipping panel. Entry examination began from the travelling way to the stope.
- People were aware of the barring rules and provided reasons as to why the rules don't apply in this particular environment. Positioning is not conventional in this environment due to the dipping strata and open fracture exposure orientation.
- Incorrect pinch bar length was used to bar the hanging wall in the gully. This was corrected when pointed out.
- People seem to have understood safe positioning when barring.
- UG2 being mined. Hanging wall is smooth, discontinuity sets parallel to the hanging wall.

*Figure 70: Smooth HW*

- Observed places where reef was in the hanging wall.

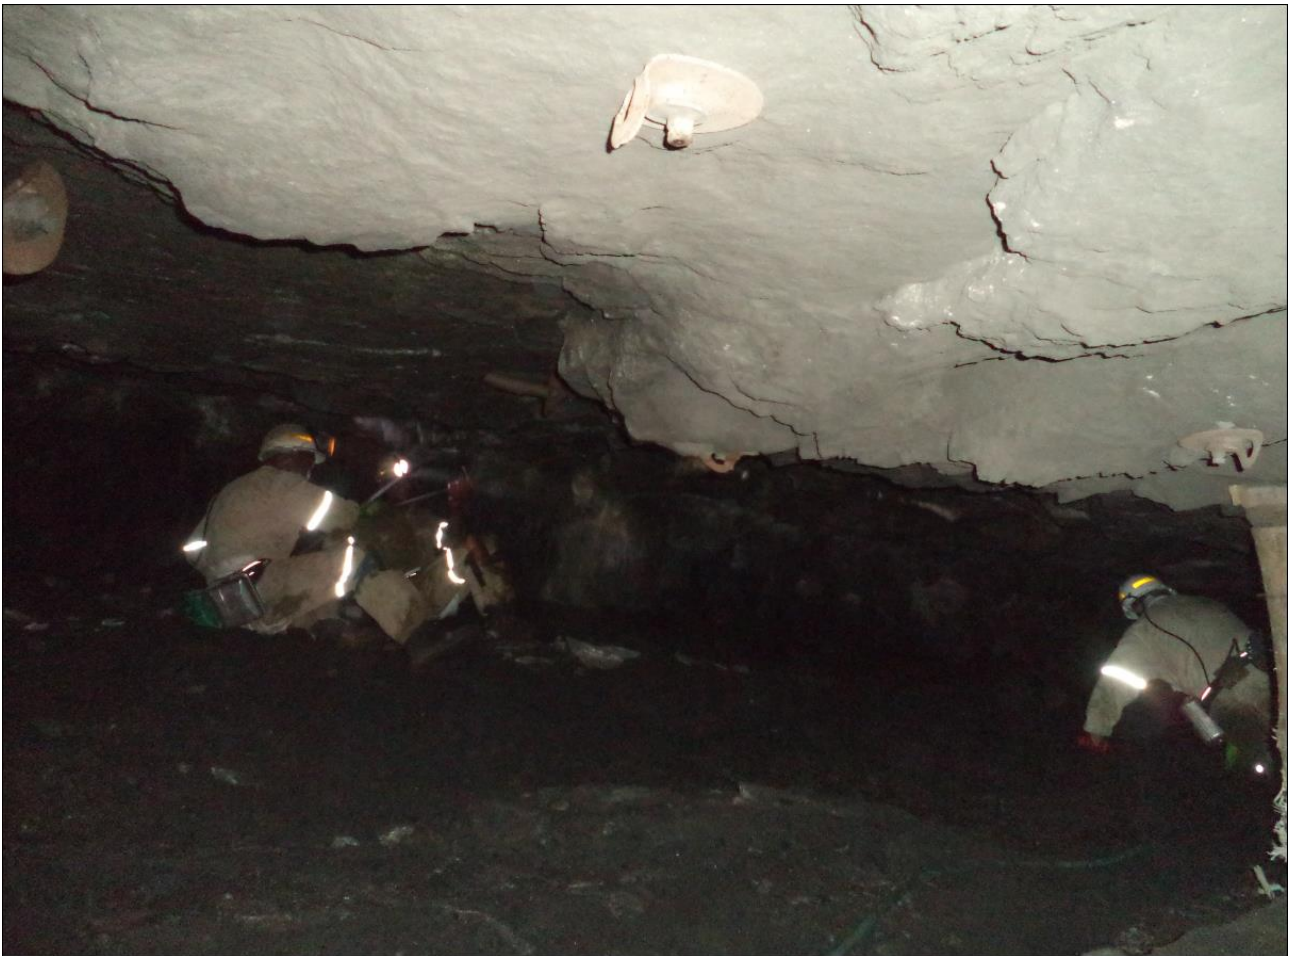
*Figure 74: Barring in-stope*

- Sidewall was mostly barred in the ASG.
- Stopping height reduced to 0.5 to 0.9m as it has not been cleaned.
- Support units have been damaged by the blast. These have been reported.
- Buddy barring of the entire panel from the top to the bottom. No splitting of the panel into sections.
- Barring carried out well and the barring rules were demonstrated.
- Barring for at least 30 minutes. Barring is tiring.
- Most places were barred, blocky conditions.

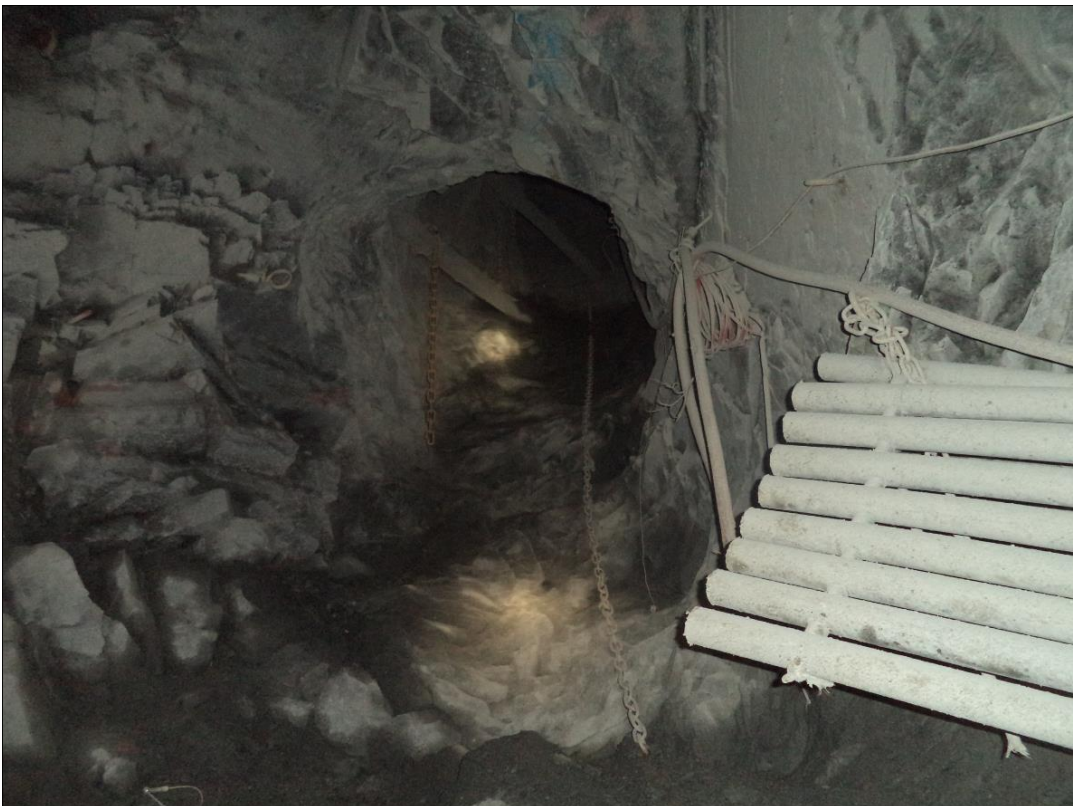
- Observed barring during entry examination.
- Not much barring was done and when it was, it was done so poorly. Barring observed in the travelling way.
- Pinch bar wasn't always at a safe angle away from the barrer, observers were too close, sometimes barring from the down-dip position instead of the side. No watering down.
- Support failure, mesh and lacing.
- Box hole barring: Shakes the chain from a safe position to dislodge any loose rocks. Climbs up from one-side of the box hole. Barring from top to the bottom.

Figure 79: TW entrance

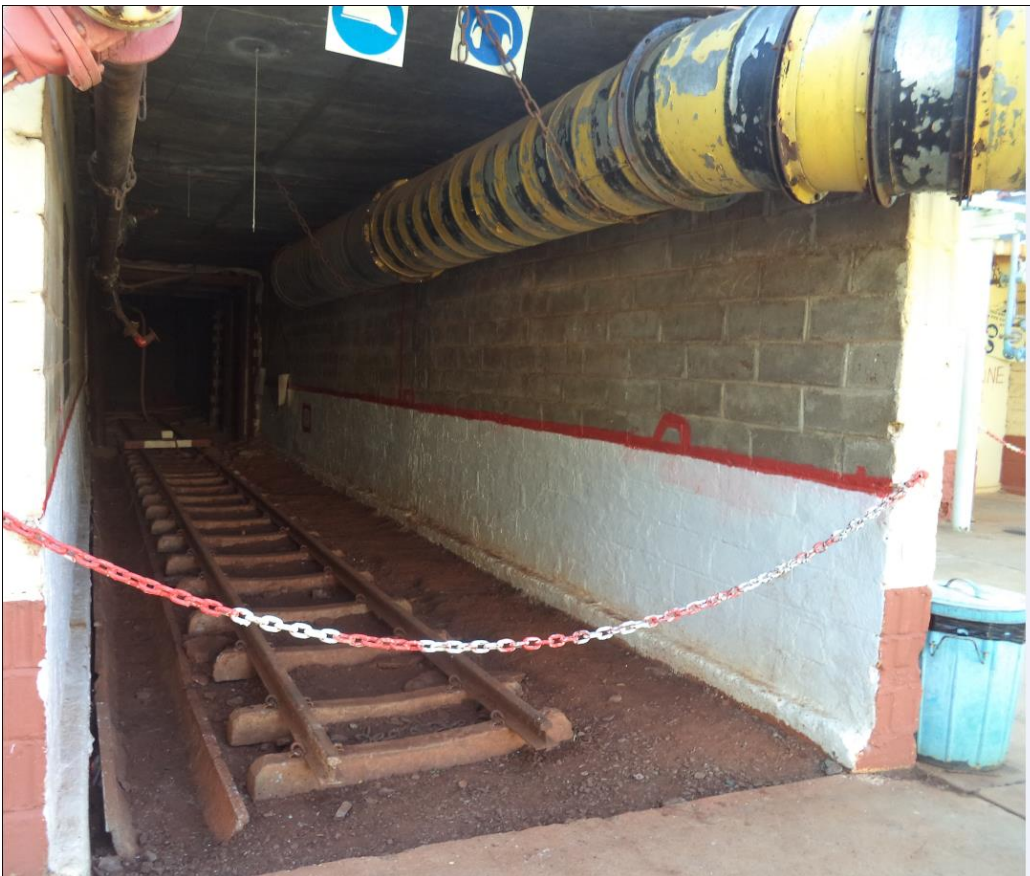
- General discussion with class of roughly 21 people about barring. Rules are adequate to carry out barring safely. Most are comfortable to complete barring after the training they receive.
- According to the class, barring accidents occur due to complacency (i.e. people get used to their environment and dangers).
- Classroom contains props. Mock-ups standard.

*Figure 80: development Mock Up*

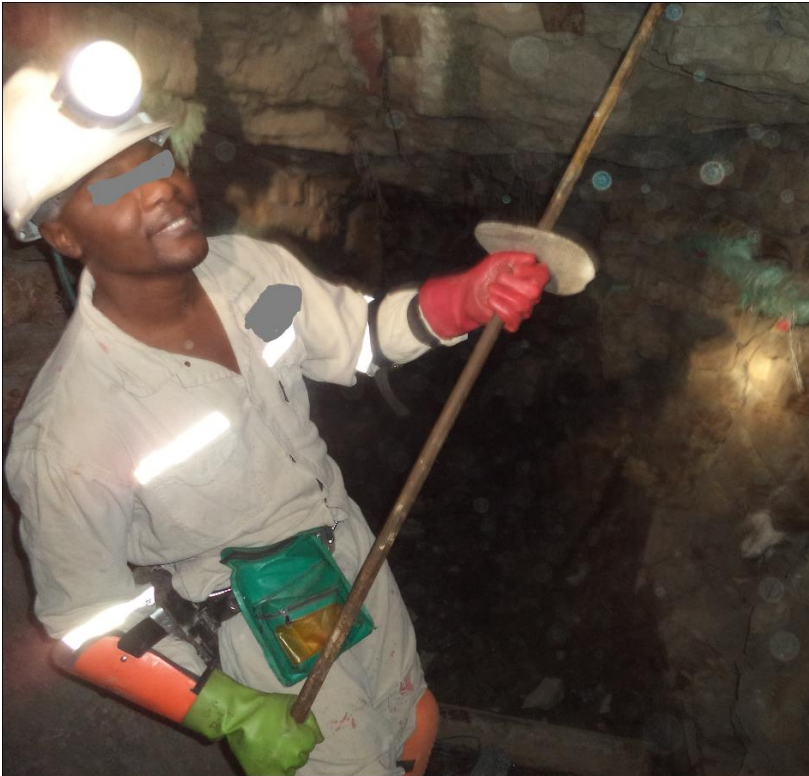
- Pillar Mining. Mining Ventersdorp. Mining up-dip.
- Accompanying person: Shift boss
- Observed entry examination done to standard. Barring carried out to standard with participation from the entire crew.
- Panel has not been cleaned. Rolling reef.
- Hanging wall conditions – mostly smooth with a discontinuities. Some places can be blocky.
- Some concerns include positioning at times. Some of the pinch bars appear to be old and blunt.

*Figure 81: Barring a blocky area*

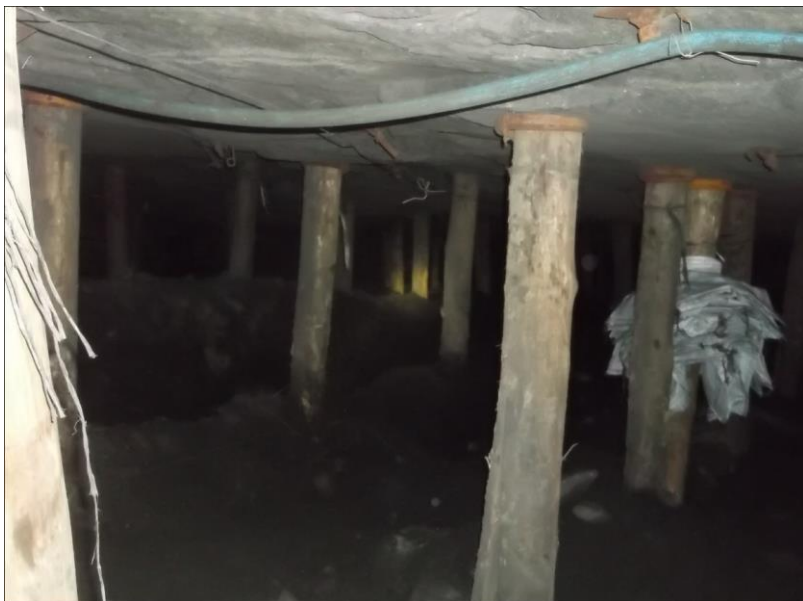
- Accompanying persons: Shift Supervisor and Rock Engineer
- EE completed from secondary waiting place into the stope area.
- Barring was carried out to standard. However, an incorrect length pinch bar was used in this stoping area.
- Observed less assessment of the hanging wall and sidewall along the travelling way.

*Figure 83: Smooth HW condition*

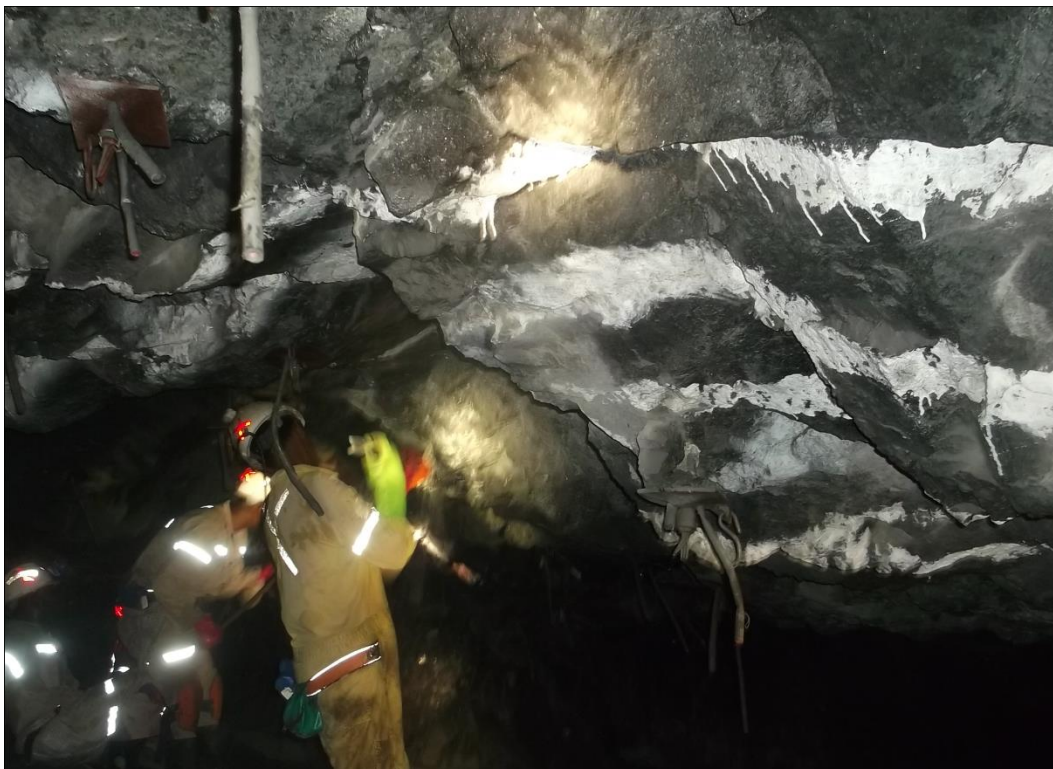
Figure 85: Barring in-stope

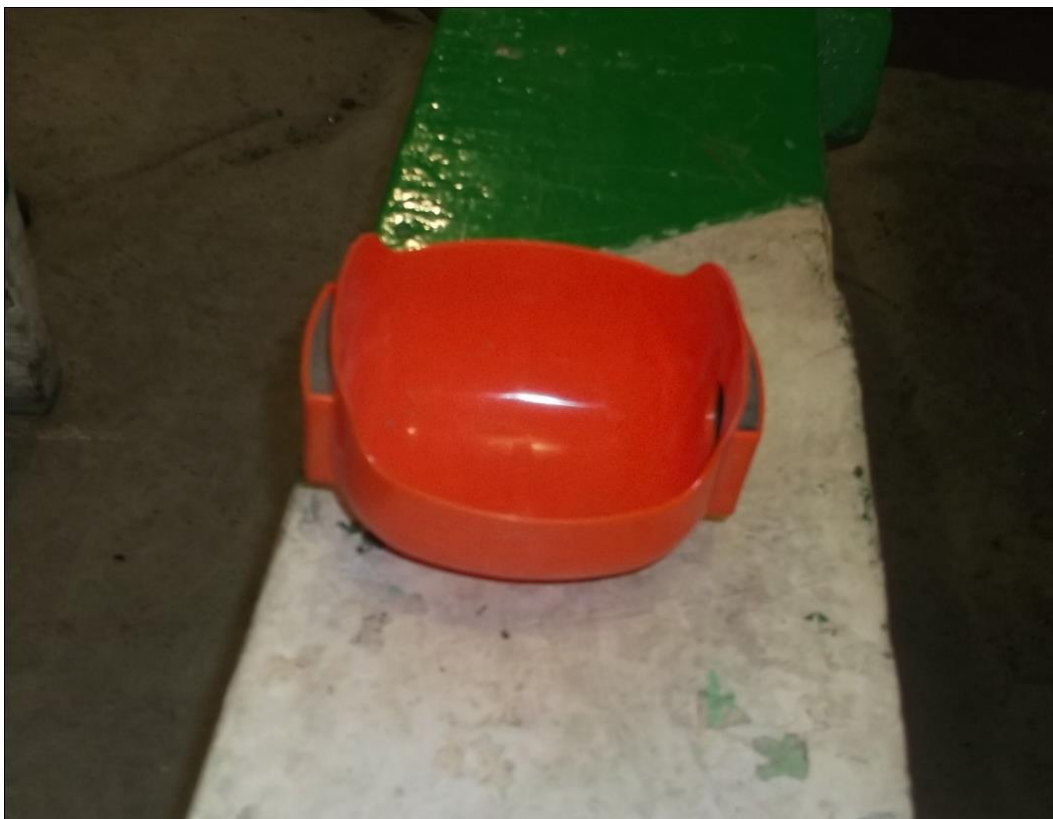
Figure 86: Orange coloured glove-like gasket
