## **1.0 FIELD LOGS – FIELD ENGINEER\_AB**

### **1.1 Platinum Mines**

#### **1.1.1 Field Log 1**

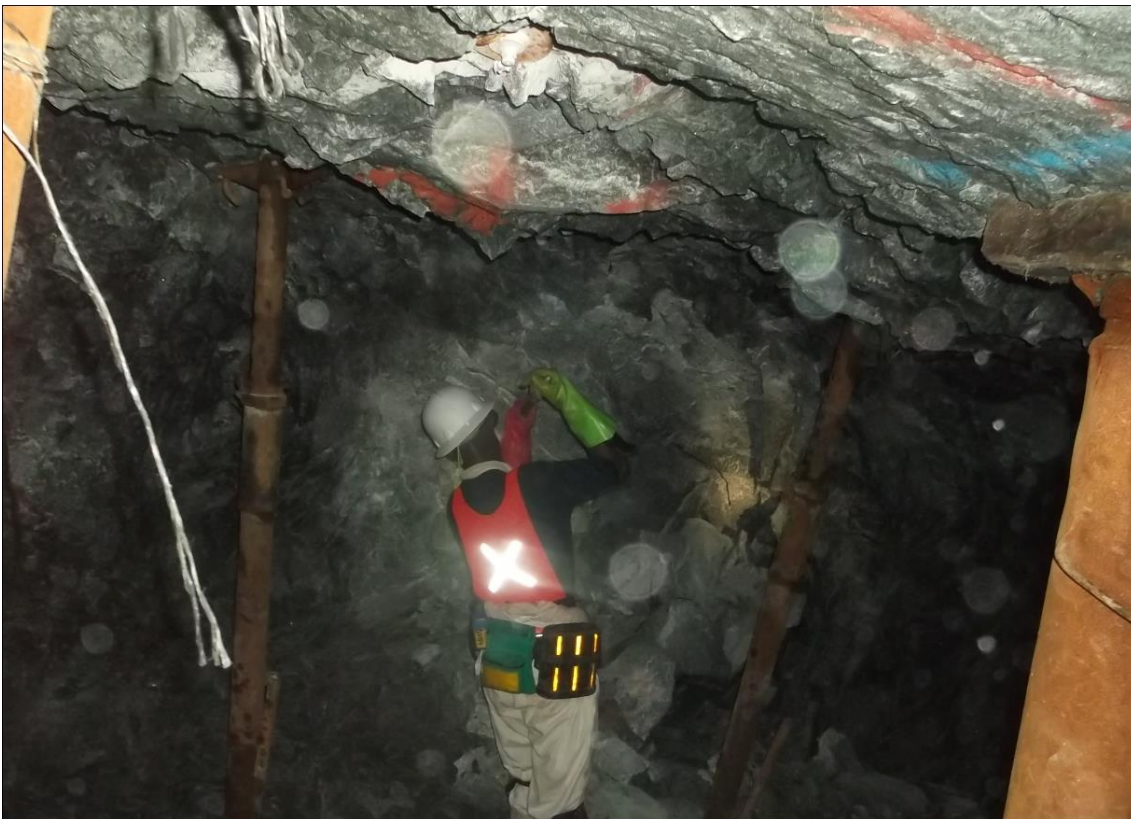
- Observed barring at travelling way and stope.
- The Team seems to understand the benefit of making safe or barring before entering the working area.
- During early entry examination the team entered the panel and install temporary support then bar down which lead to sub-standard barring.
- The significant amount of rock where barred down at the face and it was noted that a good condition hangingwall received little barring.

*Figure 87: Barring at the face*

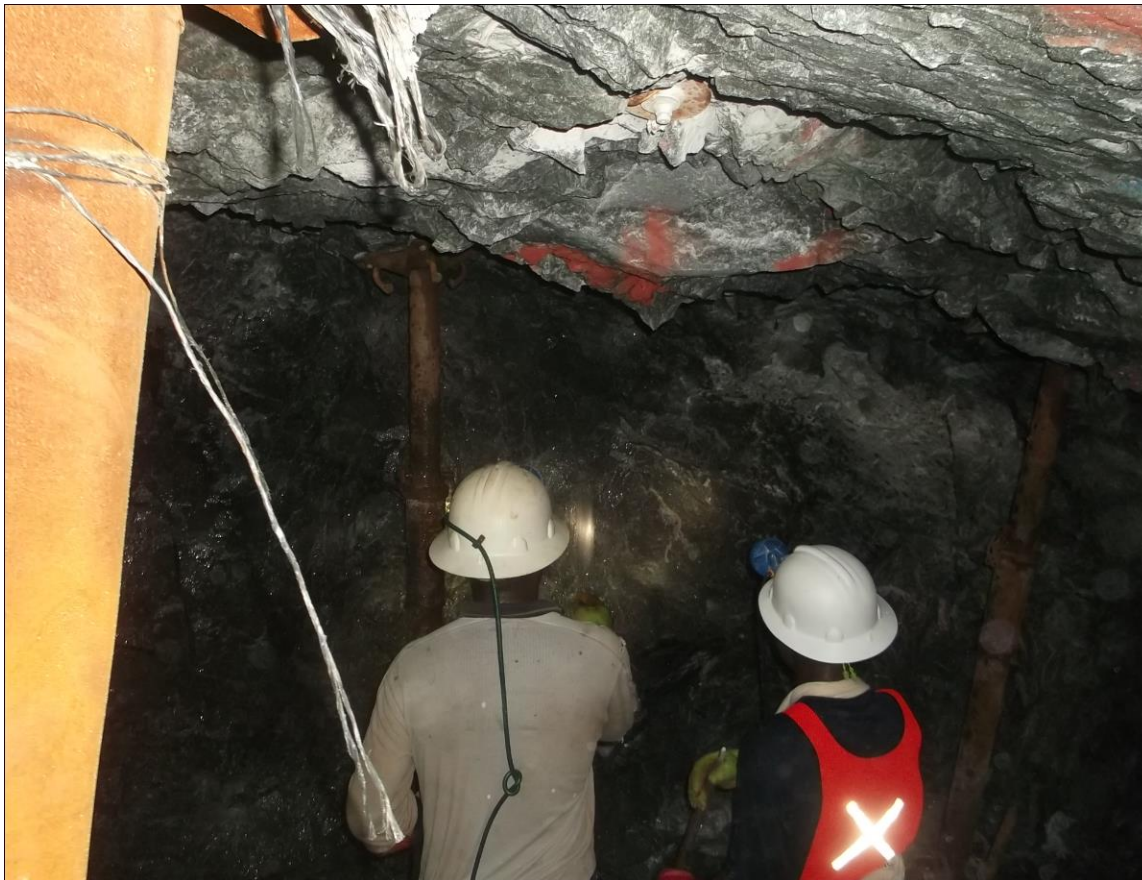
*Figure 88: Watering down at the face*

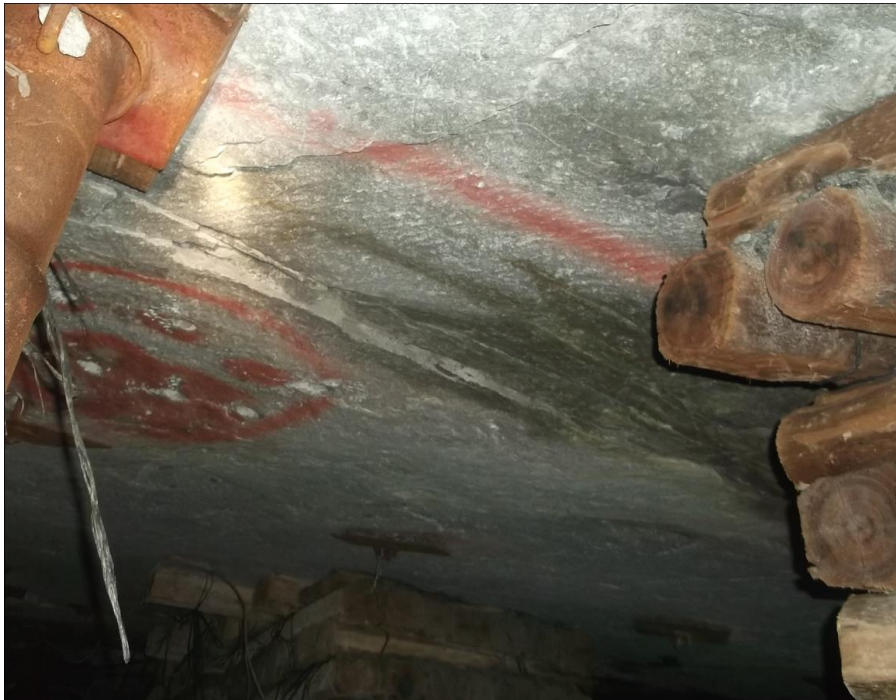
*Figure 90: Good Quartzite HW conditions in the back area*

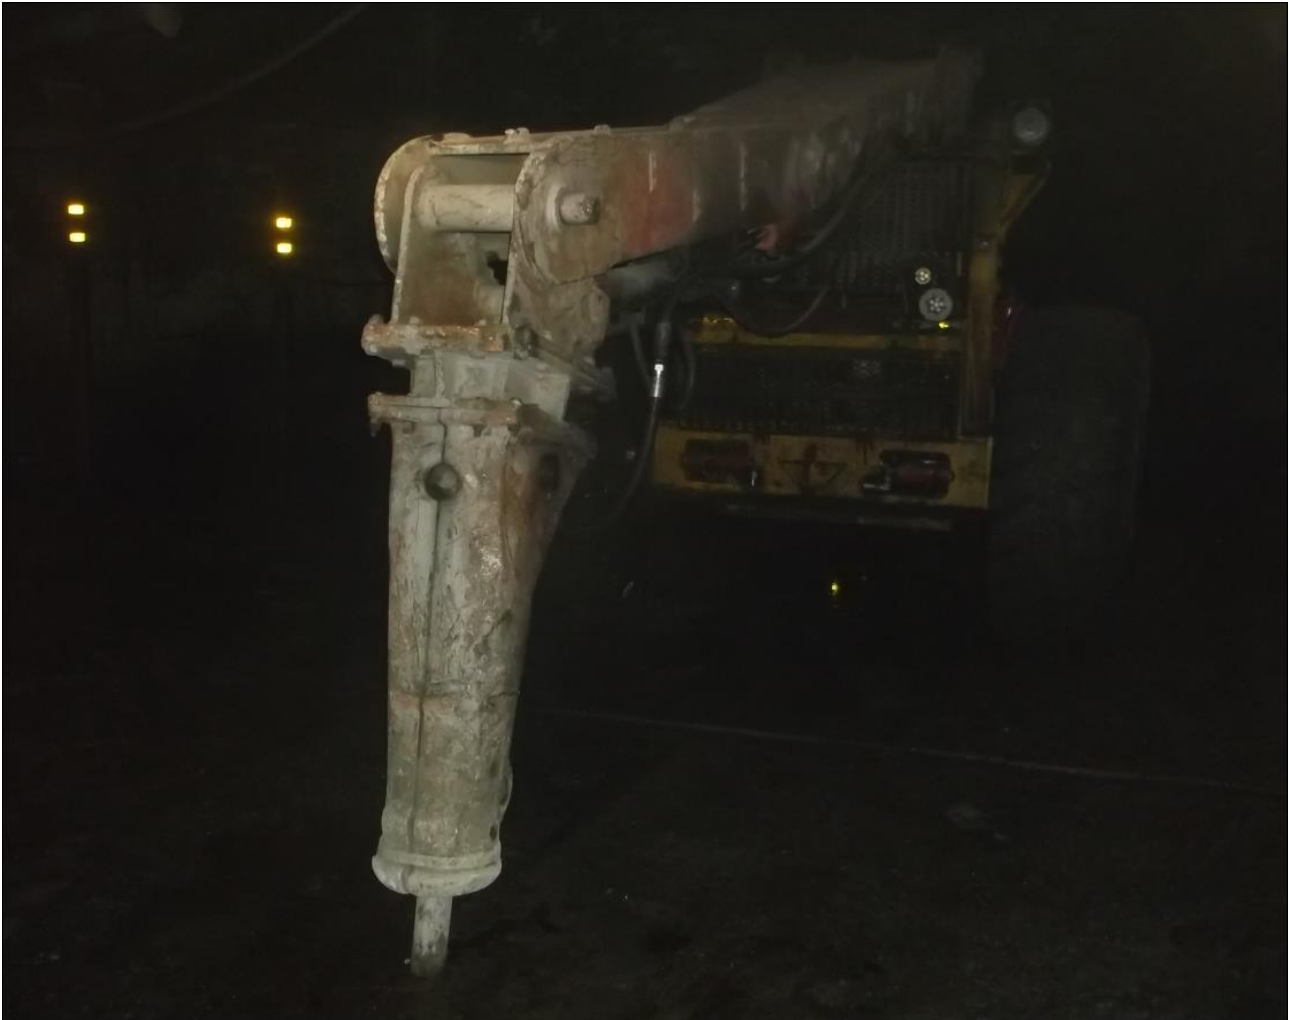
- Miner commented that mechanical scaling create new loose fragments and on many occasions. Manual/ conventional barring has been necessary after mechanical barring to reach an acceptable safety standard.

Figure 95: Mechanical Scaler
